# Solihull Community Housing

## Asbestos Management Survey Report

**I-51 Newnham House  
(Communal)  
Sheppey Drive  
Smiths Wood  
B36 0LU**

**Date of Report: 22 Apr 2015**

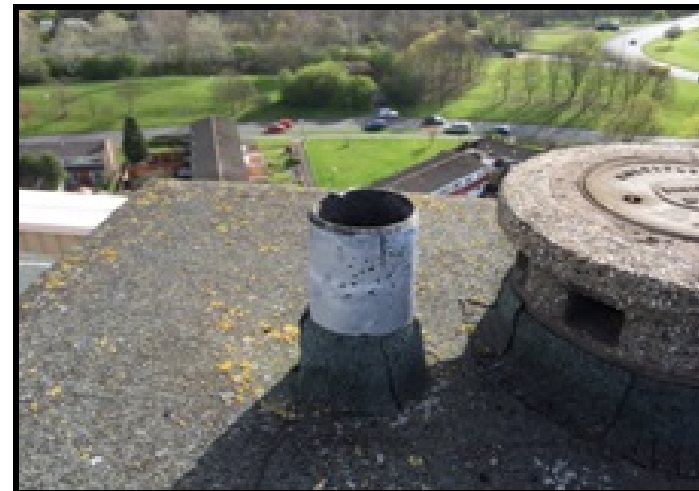
## SAMPLE REFERENCE 001

**Asbestos detected in Sample**

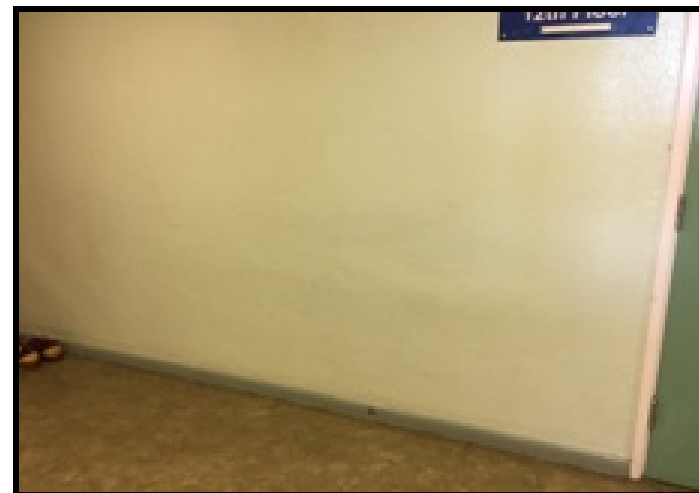
## SAMPLE REFERENCE 017

**No Asbestos Presumed in Sample**

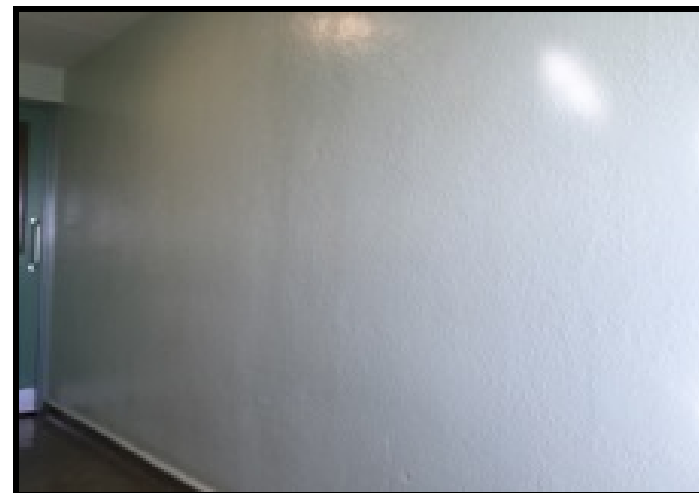
## SAMPLE REFERENCE 019

**No Asbestos Presumed in Sample**

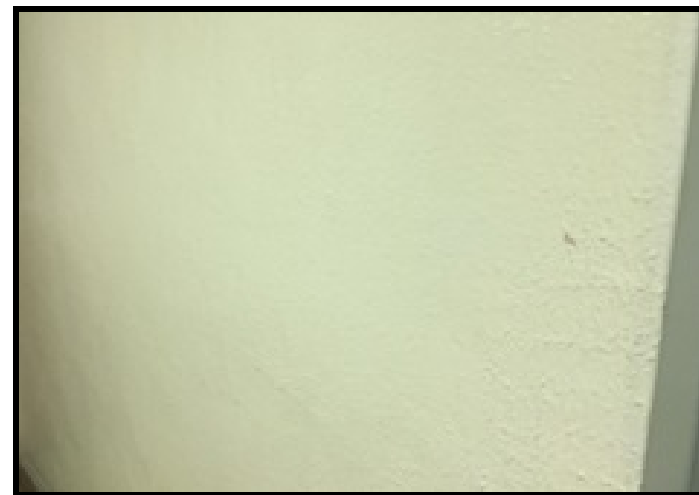
## SAMPLE REFERENCE 024

**No Asbestos Presumed in Sample**

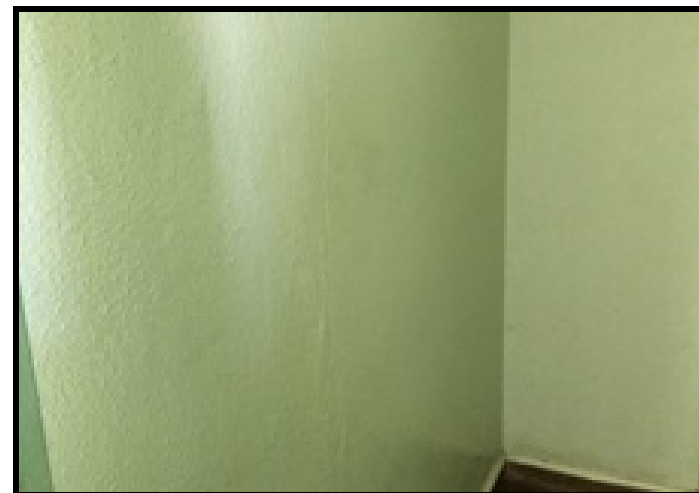
## SAMPLE REFERENCE 025

**No Asbestos Presumed in Sample**

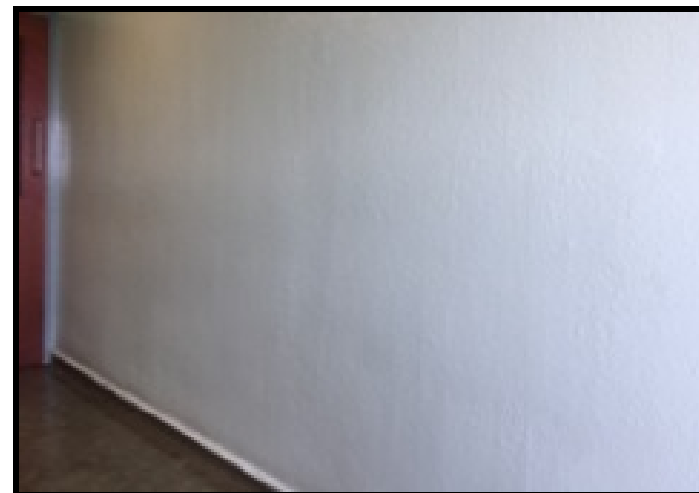
## SAMPLE REFERENCE 028

**No Asbestos Presumed in Sample**

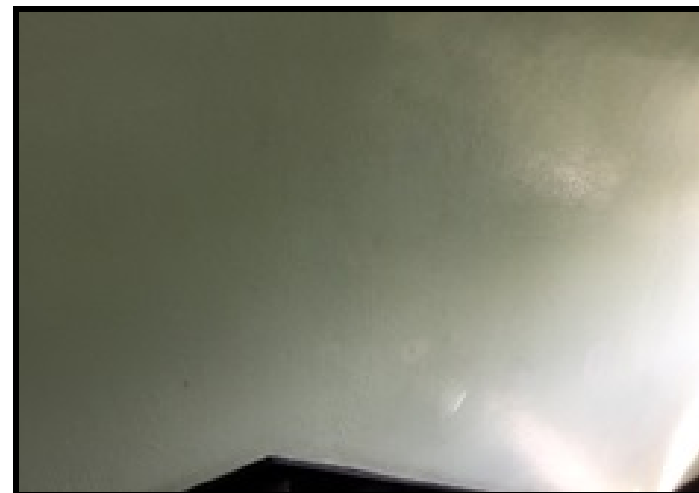
## SAMPLE REFERENCE 030

**No Asbestos Presumed in Sample**

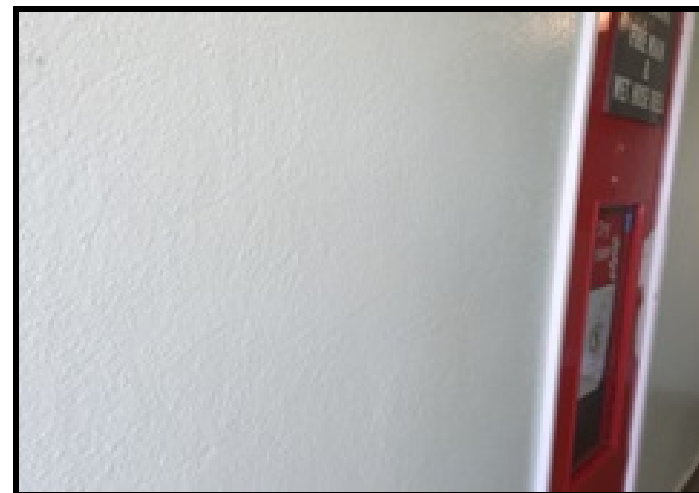
## SAMPLE REFERENCE 035

**No Asbestos Presumed in Sample**

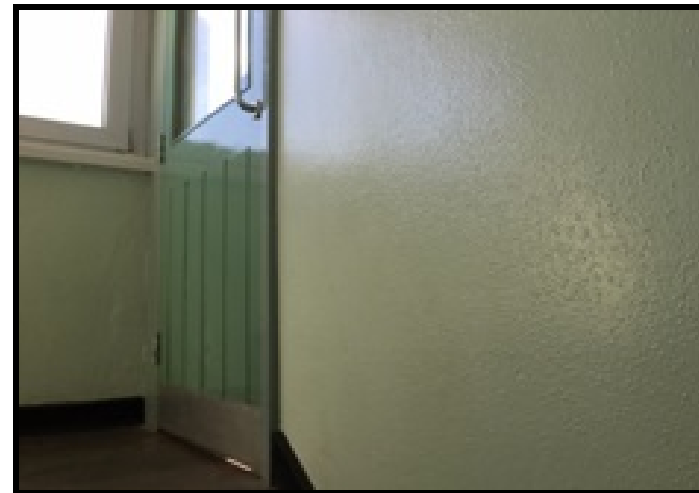
## SAMPLE REFERENCE 037

**No Asbestos Presumed in Sample**

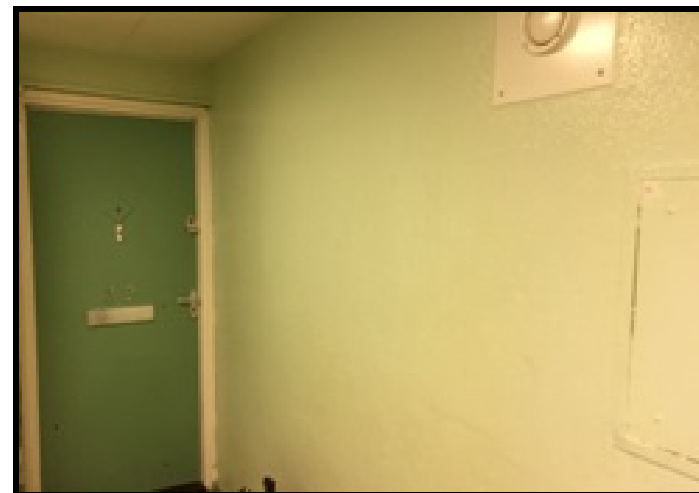
## SAMPLE REFERENCE 040

**No Asbestos Presumed in Sample**

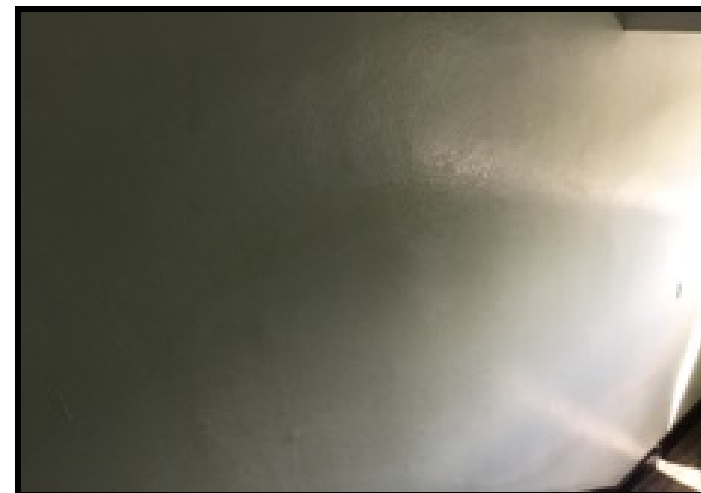
## SAMPLE REFERENCE 045

**No Asbestos Presumed in Sample**

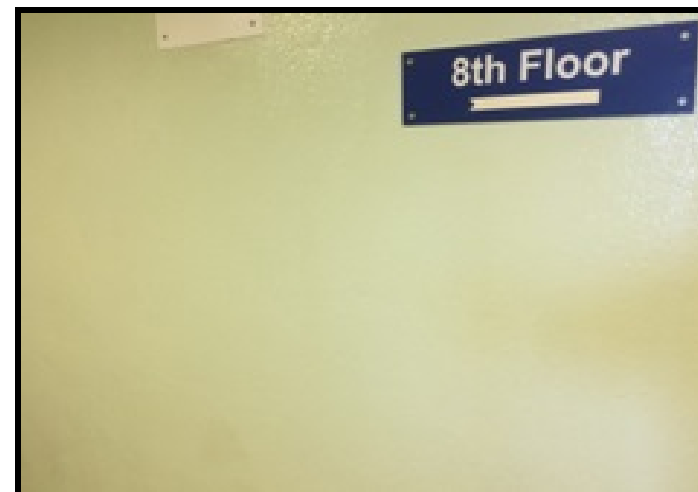
## SAMPLE REFERENCE 048

**No Asbestos Presumed in Sample**

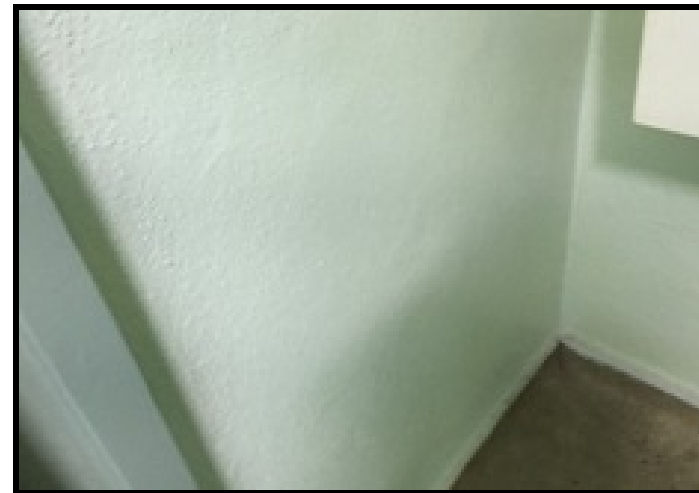
## SAMPLE REFERENCE 050

**No Asbestos Presumed in Sample**

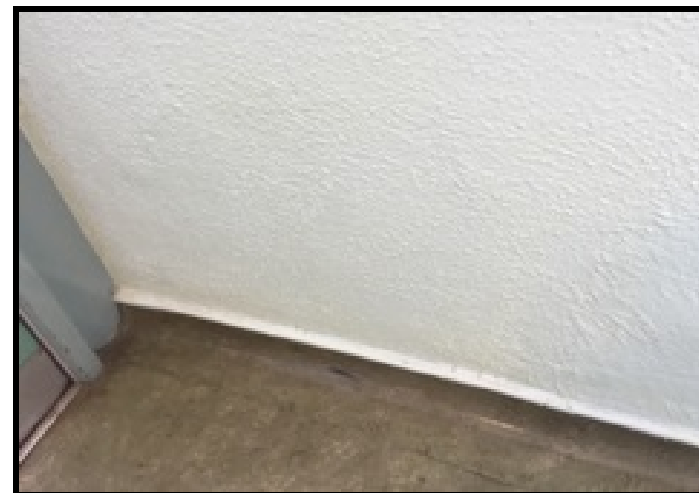
## SAMPLE REFERENCE 052

**No Asbestos Presumed in Sample**

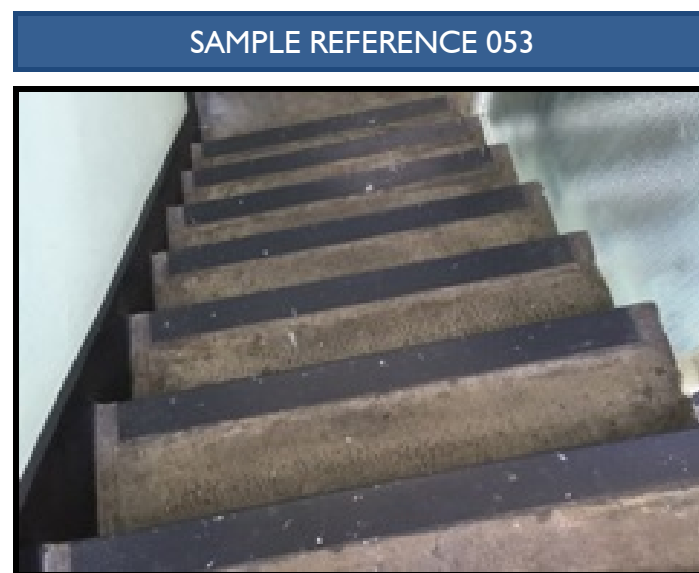
## SAMPLE REFERENCE 053

Building	Floor	Room	Location		
Main Building	Eighth Floor	Stairwell	Floor		
Description	Concrete and Textured Coating walls, concrete floor and ceiling, suspended supalux ceiling tiles, timber door and window sill, no access into MMMF riser boxing, Supalux boxing to underside of stairs and above Supalux ceiling tiles				
MATERIAL ASSESSMENT					SCORE
Product Type	Resin	Extent of Damage	Low damage		2
Asbestos Type	Chrysotile	Surface Treatment	Composite materials		
PRIORITY ASSESSMENT					SCORE
Occupant Activity	Not Applicable	Extent / Amount	14.00 small item(s)		1
Accessibility	Easily disturbed	Location	Not Applicable		
Avg Time in Use	Not Applicable	Frequency of Use	Not Applicable		
No. of Occupants	Not Applicable	Secondary Activity	Not Applicable		
Maintenance	Not Applicable	Maintenance Frequency	Not Applicable		
MANAGEMENT ACTION					SCORE
Recommendation	LABEL & MONITOR				3
Recommendation Due		Next Inspection	14 Apr 2016

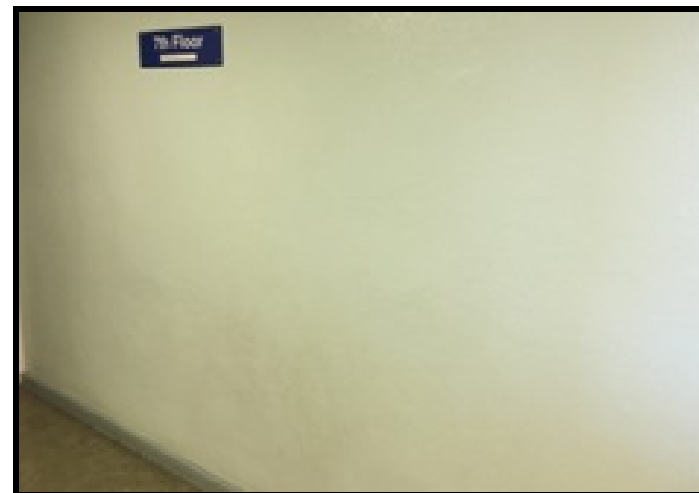
## SAMPLE REFERENCE 057

**No Asbestos Presumed in Sample**

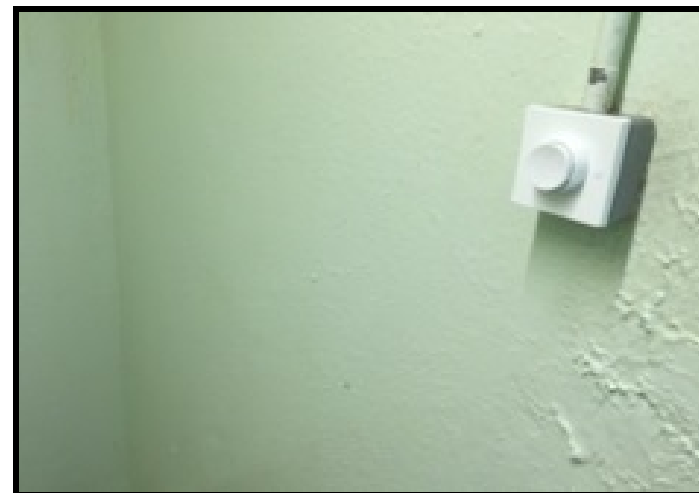
## SAMPLE REFERENCE 058

**No Asbestos Presumed in Sample**

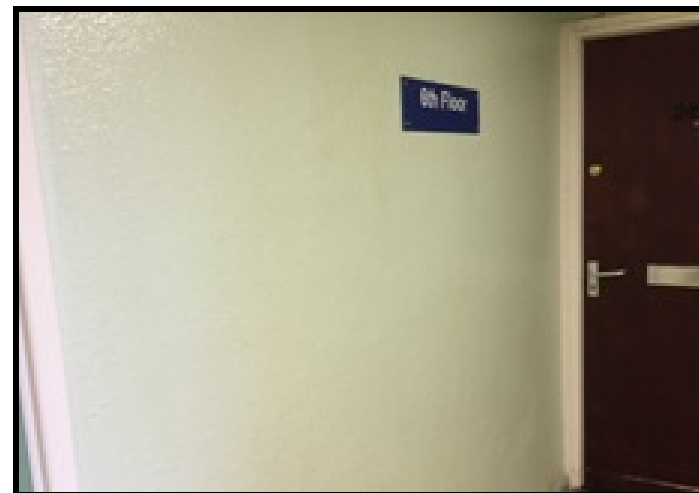
## SAMPLE REFERENCE 064

**No Asbestos Presumed in Sample**

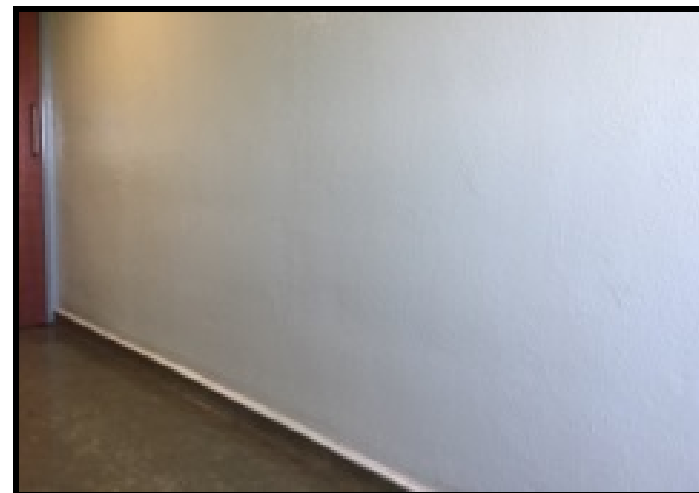
## SAMPLE REFERENCE 067

**No Asbestos Presumed in Sample**

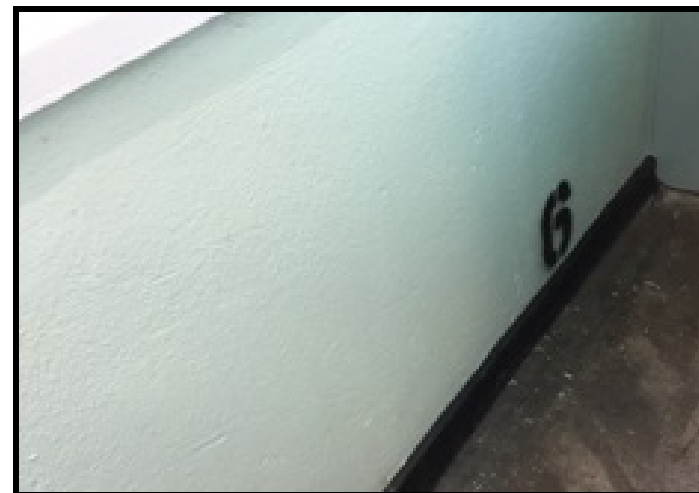
## SAMPLE REFERENCE 069

**No Asbestos Presumed in Sample**

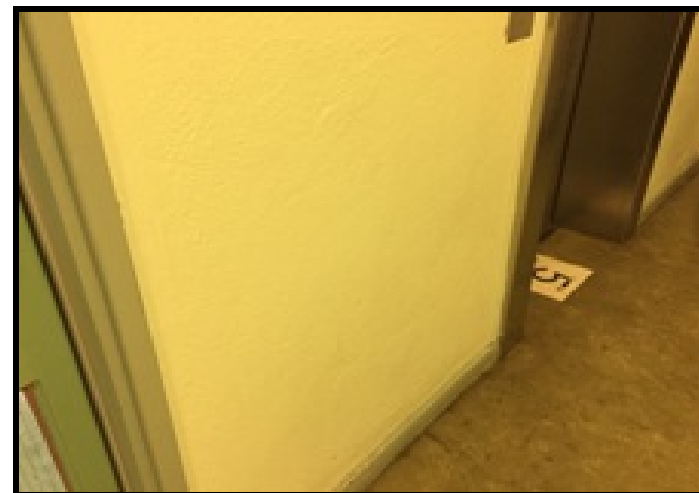
## SAMPLE REFERENCE 072

**No Asbestos Presumed in Sample**

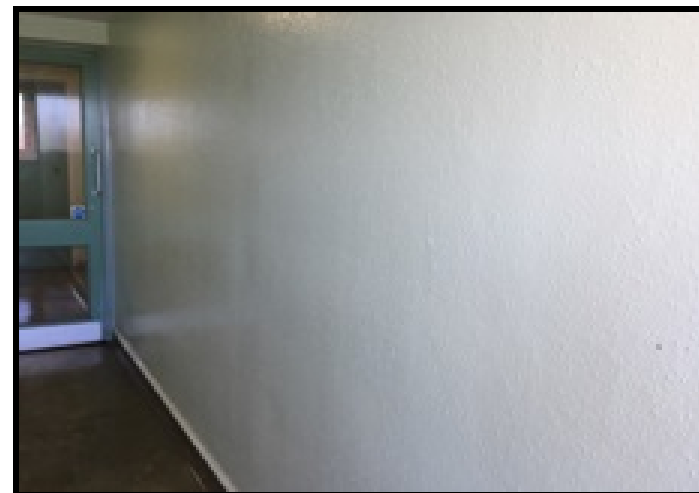
## SAMPLE REFERENCE 076

**No Asbestos Presumed in Sample**

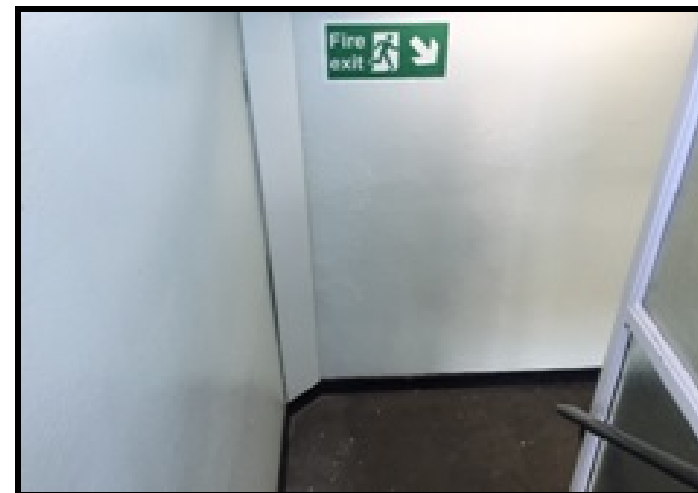
## SAMPLE REFERENCE 078

**No Asbestos Presumed in Sample**

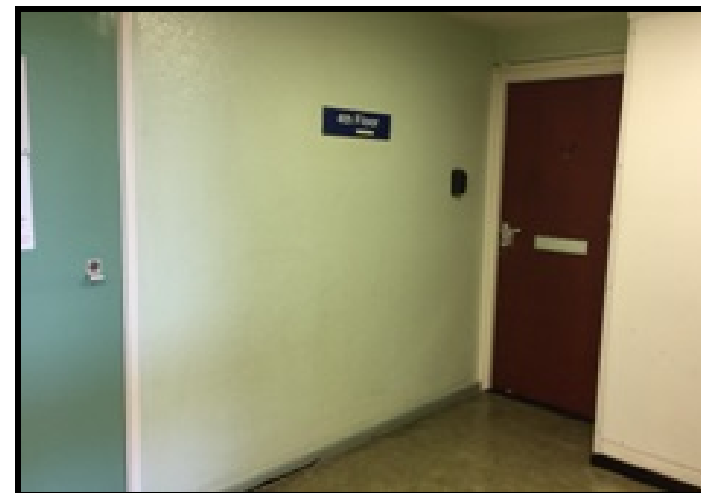
## SAMPLE REFERENCE 081

**No Asbestos Presumed in Sample**

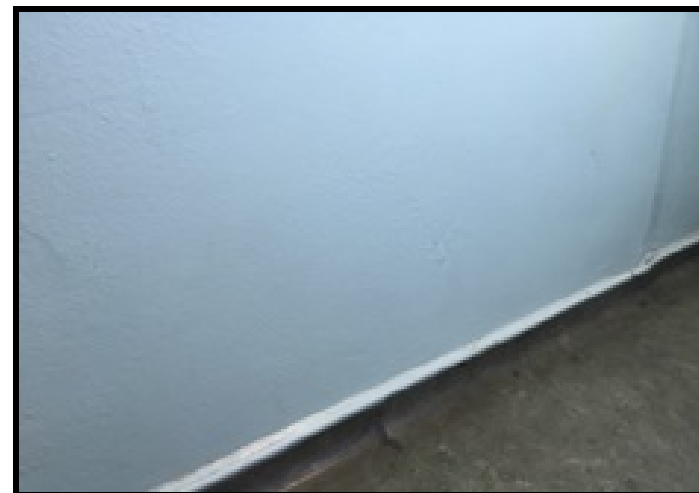
## SAMPLE REFERENCE 083

**No Asbestos Presumed in Sample**

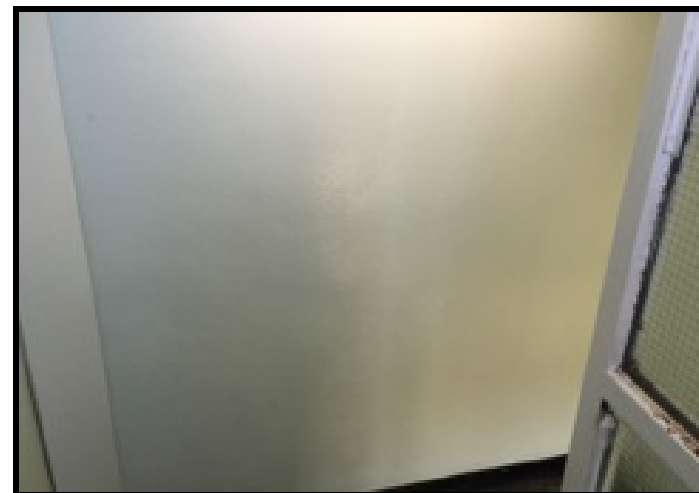
## SAMPLE REFERENCE 085

**No Asbestos Presumed in Sample**

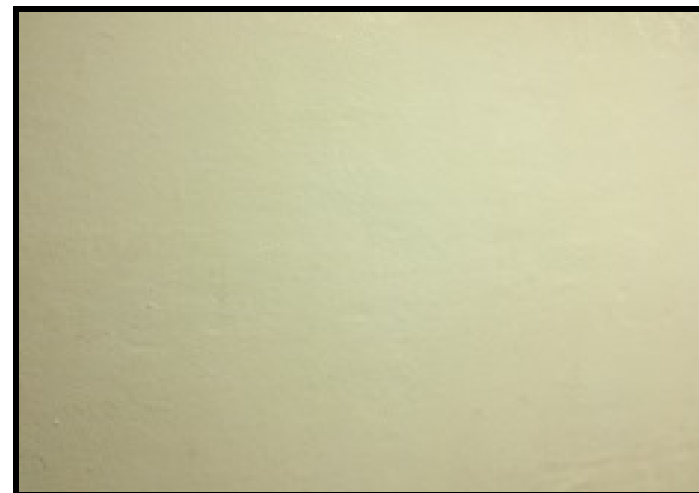
## SAMPLE REFERENCE 088

**No Asbestos Presumed in Sample**

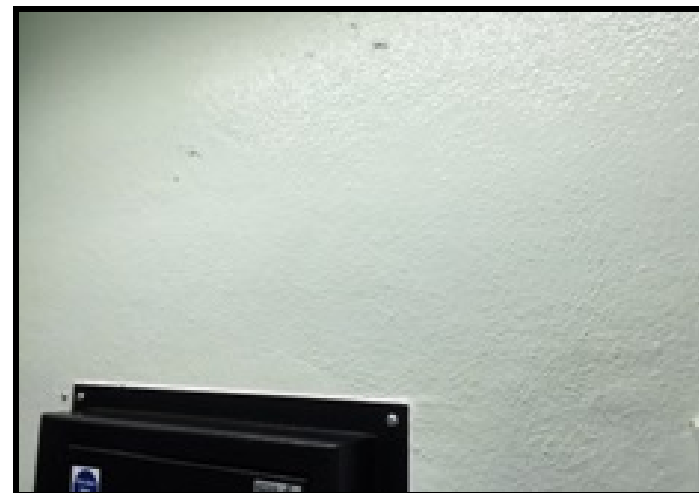
## SAMPLE REFERENCE 090

**No Asbestos Presumed in Sample**

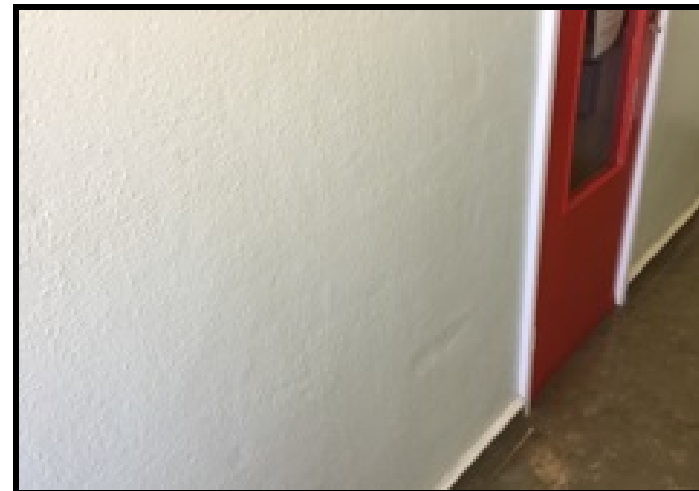
## SAMPLE REFERENCE 091

**No Asbestos Presumed in Sample**

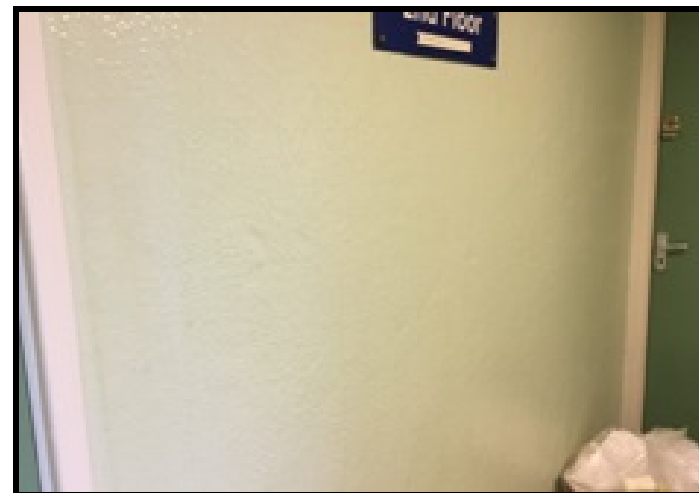
## SAMPLE REFERENCE 096

**No Asbestos Presumed in Sample**

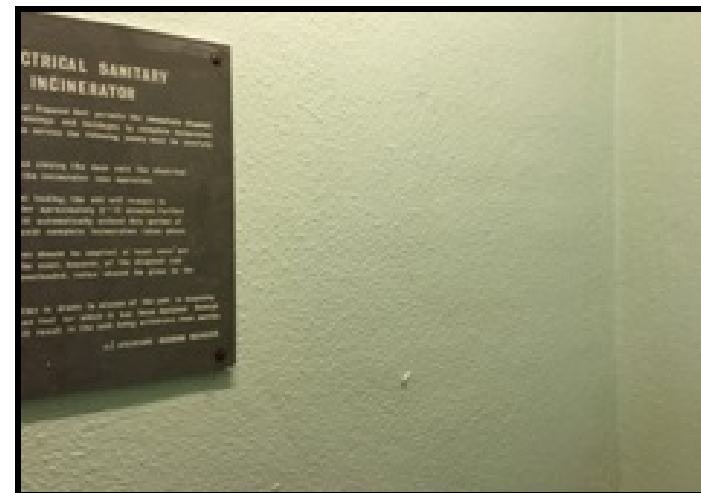
## SAMPLE REFERENCE 098

**No Asbestos Presumed in Sample**

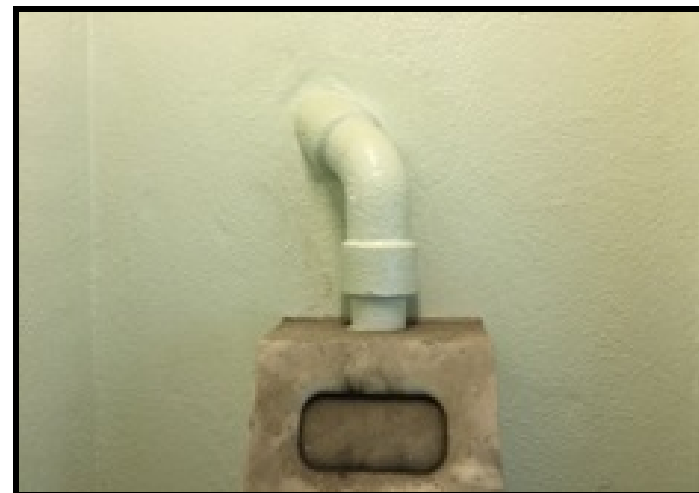
## SAMPLE REFERENCE 099

Asbestos Presumed

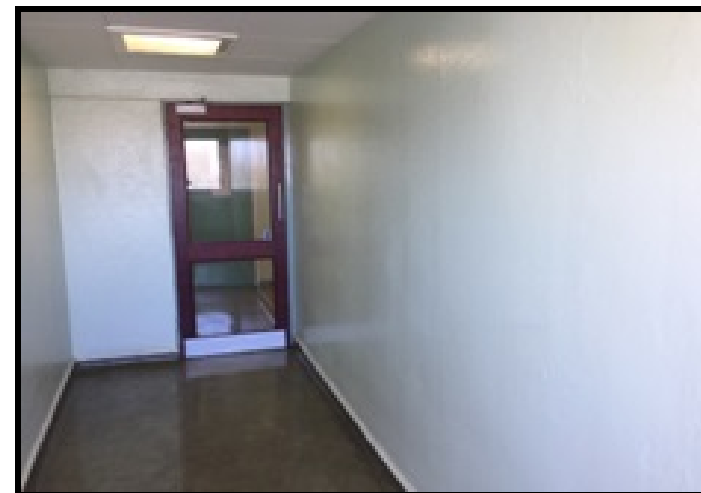
## SAMPLE REFERENCE 100

**No Asbestos Presumed in Sample**

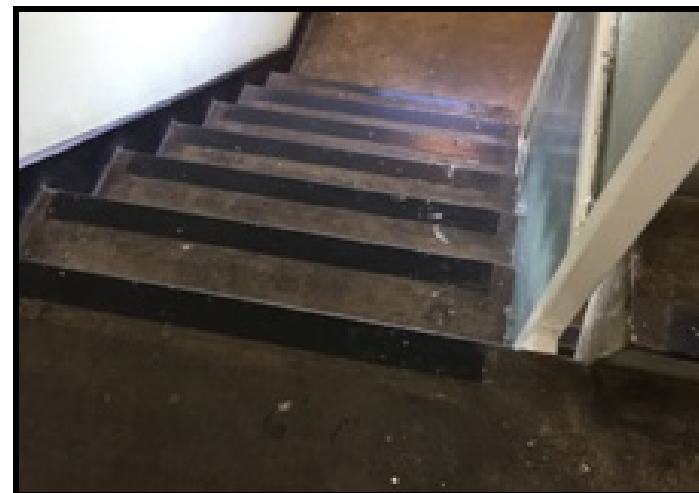
## SAMPLE REFERENCE 101

Asbestos Presumed

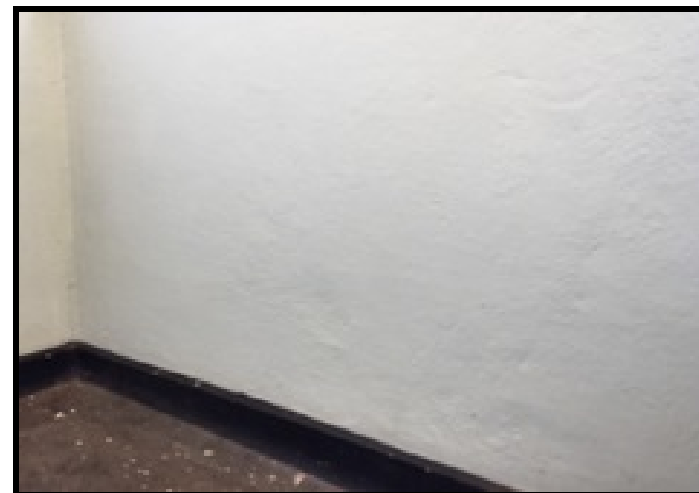
## SAMPLE REFERENCE 102

**No Asbestos Presumed in Sample**

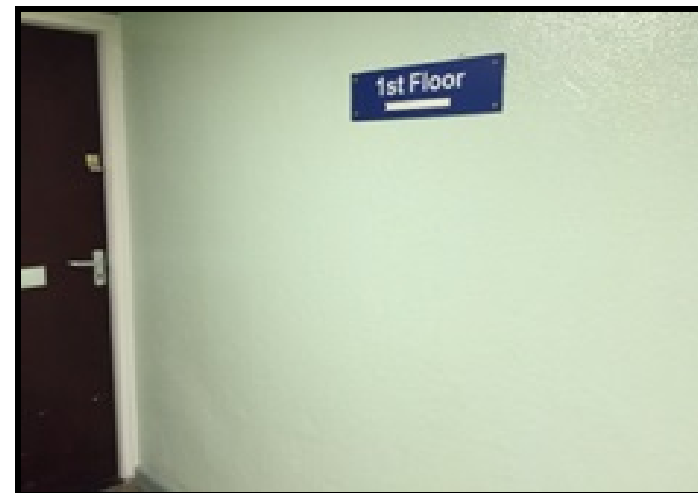
## SAMPLE REFERENCE 105

**No Asbestos Presumed in Sample**

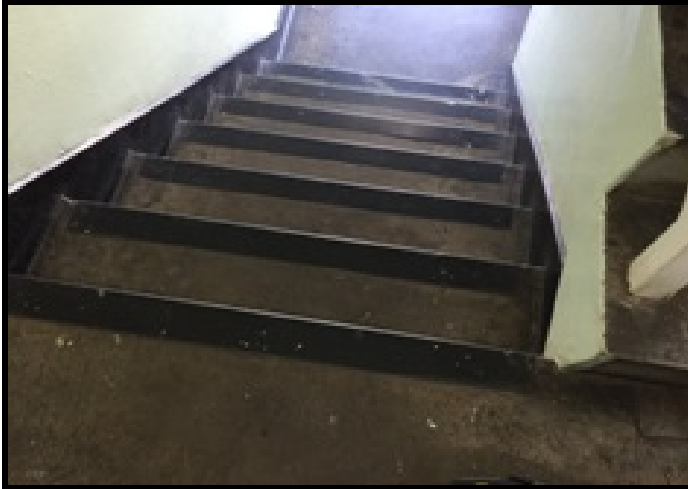
SAMPLE REFERENCE 109

SURVEYORS COMMENTS	
<b>Asbestos Presumed</b>

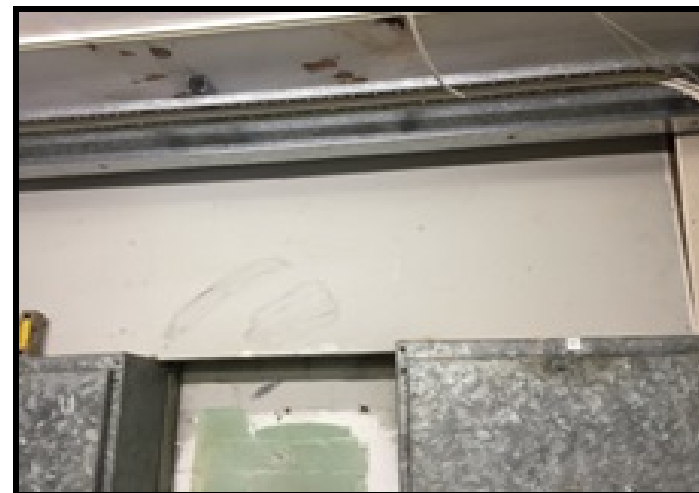
## SAMPLE REFERENCE 113

Asbestos detected in Sample

MATERIAL ASSESSMENT				SCORE
<b>Product Type</b>	Flash Pad	<b>Extent of Damage</b>	Low damage	<b>6</b>
<b>Asbestos Type</b>	<b>Presumed ACM</b>	<b>Surface Treatment</b>	Sealed (0)

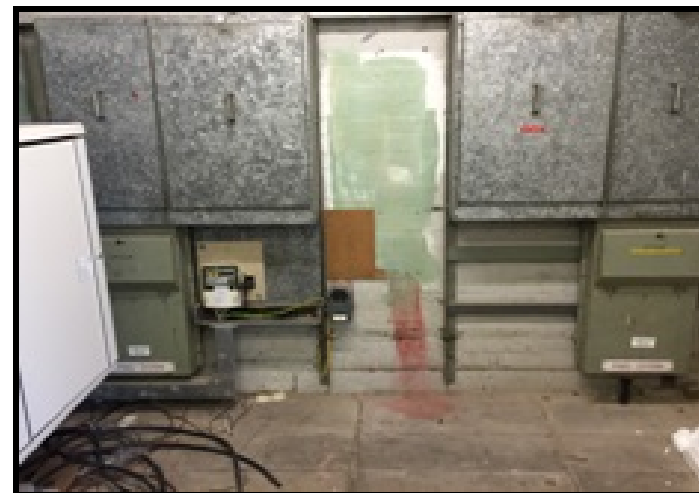
## SAMPLE REFERENCE 114

**Asbestos Presumed**

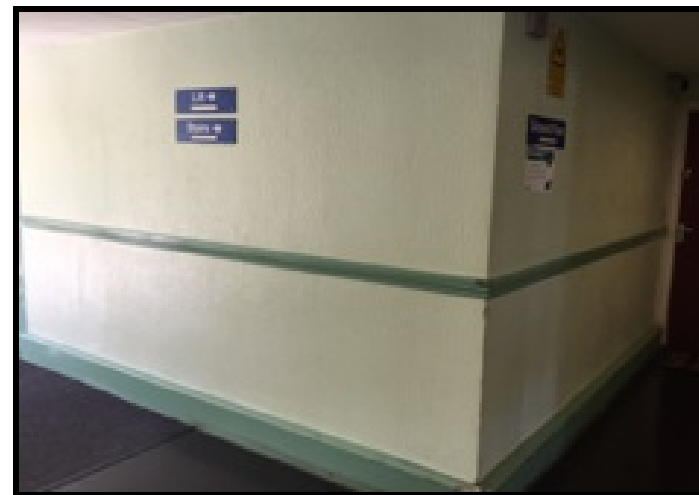
## SAMPLE REFERENCE I I 5

**No Asbestos Presumed in Sample**

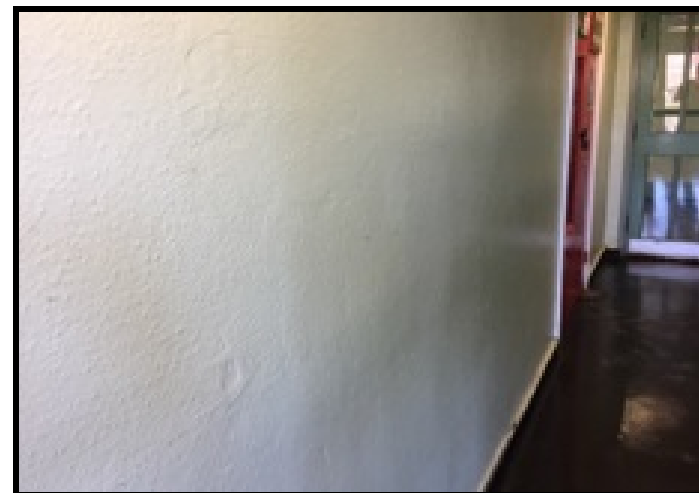
## SAMPLE REFERENCE I 16

**No Asbestos Presumed in Sample**
