# **Solihull Community Housing**

## **Asbestos Management Survey Report**

**Oriel House  
Blackcat Close  
Chelmsley Wood  
B37 5DG**

**Date of Report: 14 May 2012**

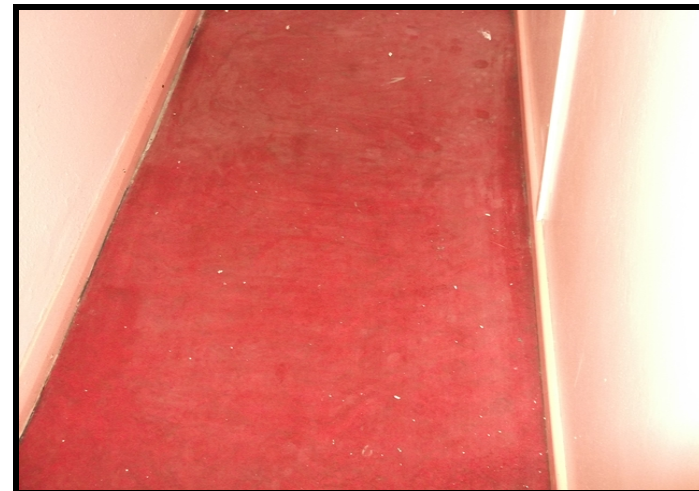
## SAMPLE REFERENCE 012

| Unique Sample No. | Building Reference (Floor) | Room Area | Description of Location | Product Description | Asbestos Type | Approx. Quantity | Material Condition | Surface Treatment | Material Risk Score | Priority Risk Score | Total Risk Score | Management Action | Next Review Date |
|---|---|---|---|---|---|---|---|---|---|---|---|---|---|
| 012 | Main Building (Tenth Floor) | Bin Shoot | Floor | Paper | No Asbestos Detected | 3.00m2 | Low damage | Sealed (0) | - | - | - | NO ACTION REQUIRED | |

**No Asbestos Presumed in Sample**

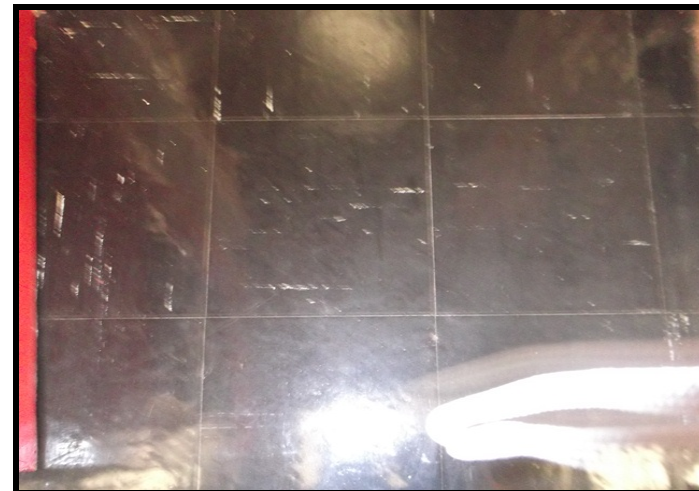
## SAMPLE REFERENCE 021

| Unique Sample No. | Building Reference (Floor) | Room Area | Description of Location | Product Description | Asbestos Type | Approx. Quantity | Material Condition | Surface Treatment | Material Risk Score | Priority Risk Score | Total Risk Score | Management Action | Next Review Date |
|---|---|---|---|---|---|---|---|---|---|---|---|---|---|
| 021 | Main Building (Nineth Floor) | Corridor 3 | Floor | Paper | No Asbestos Detected | 15.00m2 | Low damage | Sealed (0) | - | - | - | NO ACTION REQUIRED | |

**No Asbestos Presumed in Sample**

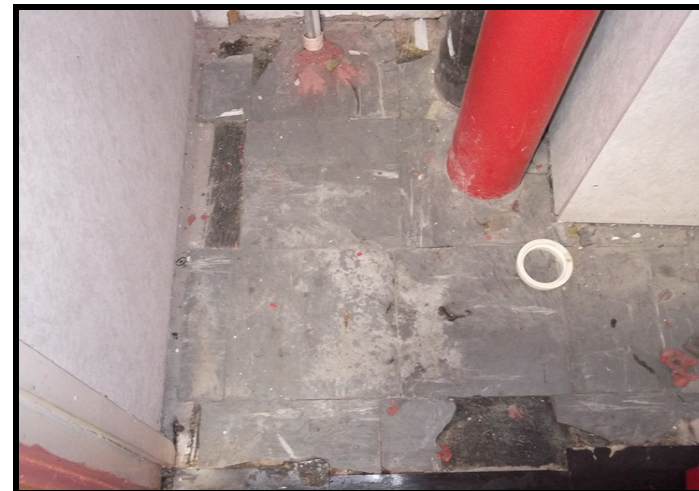
## SAMPLE REFERENCE 023

| Unique Sample No. | Building Reference (Floor) | Room Area | Description of Location | Product Description | Asbestos Type | Approx. Quantity | Material Condition | Surface Treatment | Material Risk Score | Priority Risk Score | Total Risk Score | Management Action | Next Review Date |
|---|---|---|---|---|---|---|---|---|---|---|---|---|---|
| 023 | Main Building (Nineth Floor) | Dry Riser | Floor | Floor Tiles & Adhesive | Chrysotile | 1.00m2 | Low damage | Composite materials | 3 | 1 | 4 | LABEL & MONITOR | 22 Mar 2013 |

**Asbestos detected in Sample**

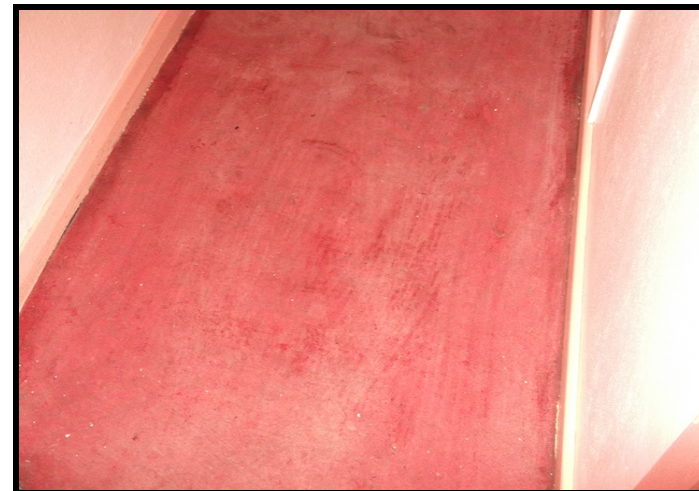
## SAMPLE REFERENCE 024

| Unique Sample No. | Building Reference (Floor) | Room Area | Description of Location | Product Description | Asbestos Type | Approx. Quantity | Material Condition | Surface Treatment | Material Risk Score | Priority Risk Score | Total Risk Score | Management Action | Next Review Date |
|---|---|---|---|---|---|---|---|---|---|---|---|---|---|
| 024 | Main Building (Nineth Floor) | Bin Shaft | Floor | Paper | No Asbestos Detected | 12.00m2 | Low damage | Sealed (0) | - | - | - | NO ACTION REQUIRED | |

**No Asbestos Presumed in Sample**

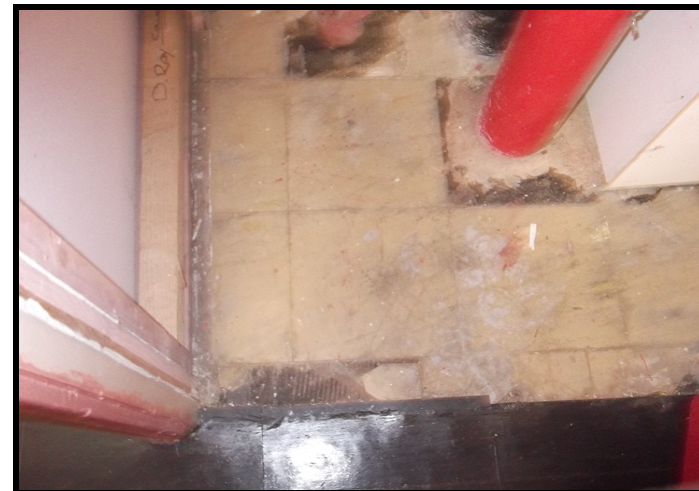
## SAMPLE REFERENCE 030

**No Asbestos Presumed in Sample**

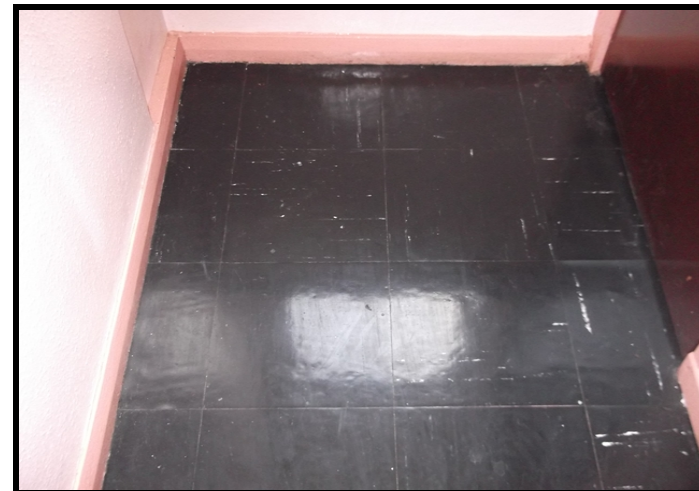
## SAMPLE REFERENCE 033

**No Asbestos Presumed in Sample**

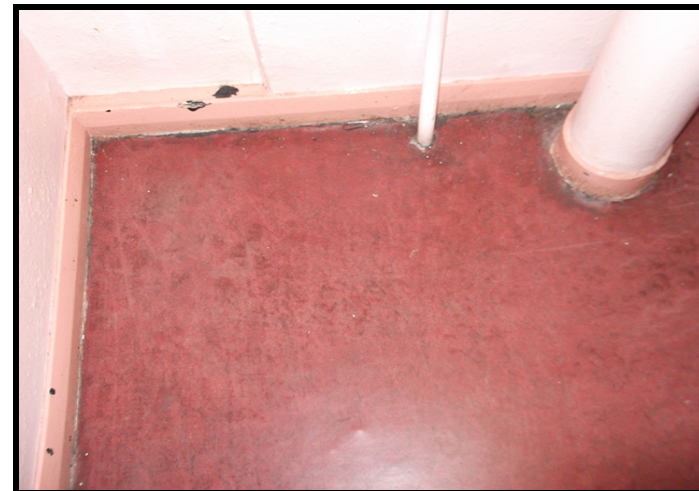
## SAMPLE REFERENCE 037

| Unique Sample No. | Building Reference (Floor) | Room Area | Description of Location | Product Description | Asbestos Type | Approx. Quantity | Material Condition | Surface Treatment | Material Risk Score | Priority Risk Score | Total Risk Score | Management Action | Next Review Date |
|---|---|---|---|---|---|---|---|---|---|---|---|---|---|
| 037 | Main Building (Eighth Floor) | Bin Shoot | Floor | Paper | No Asbestos Detected | 12.00m2 | Low damage | Sealed (0) | - | - | - | NO ACTION REQUIRED | |

**No Asbestos Presumed in Sample**

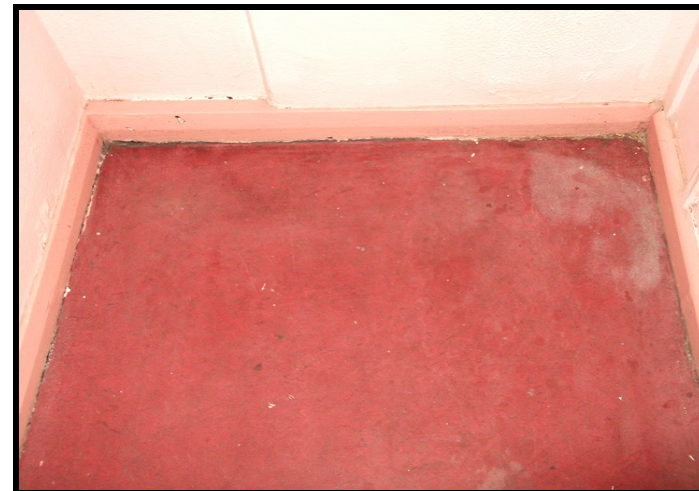
## SAMPLE REFERENCE 046

**No Asbestos Presumed in Sample**

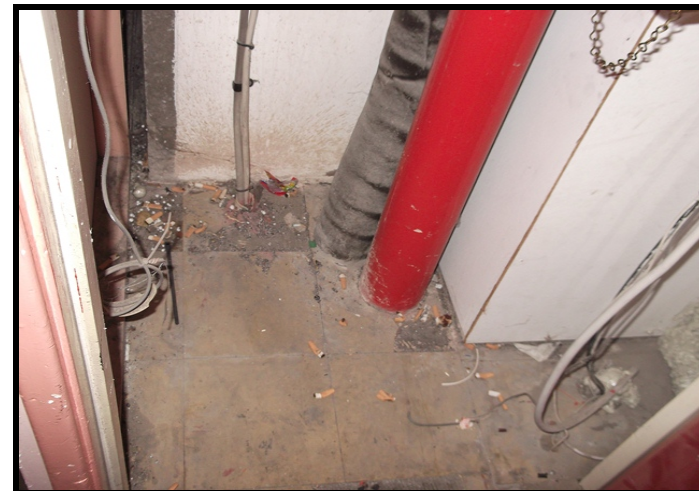
## SAMPLE REFERENCE 059

**Asbestos Presumed in Sample**

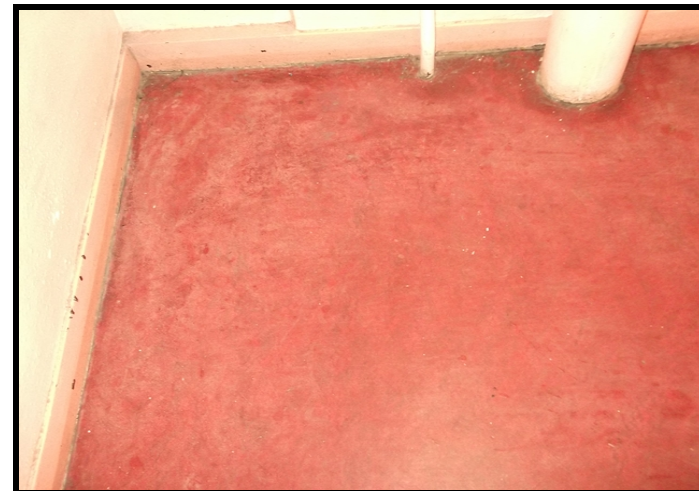
## SAMPLE REFERENCE 062

**No Asbestos Presumed in Sample**

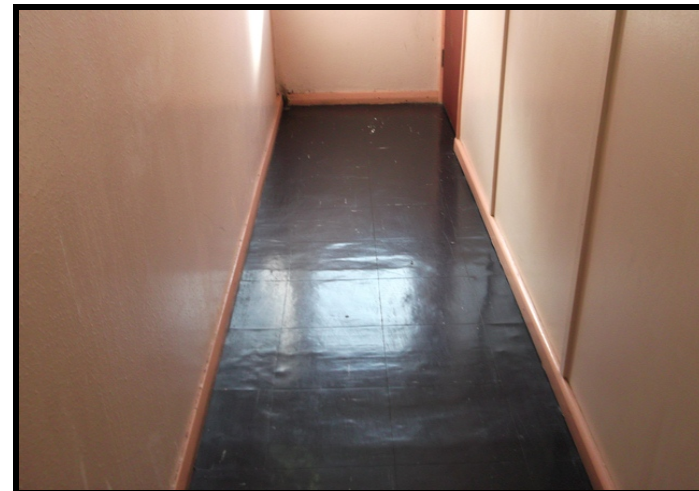
## SAMPLE REFERENCE 070

**No Asbestos Presumed in Sample**

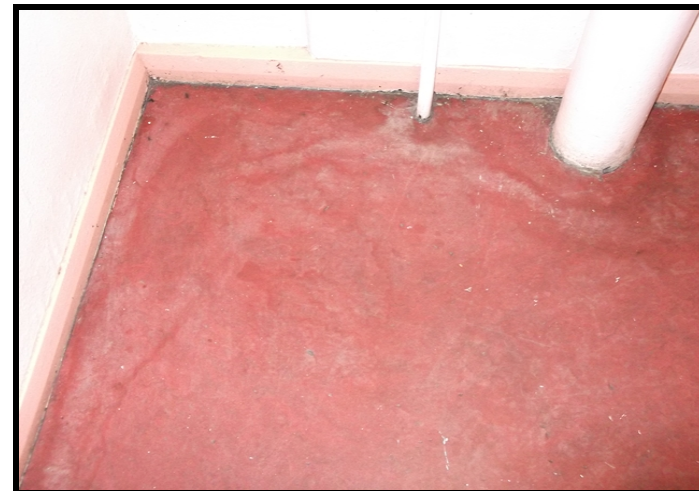
## SAMPLE REFERENCE 073

**No Asbestos Presumed in Sample**

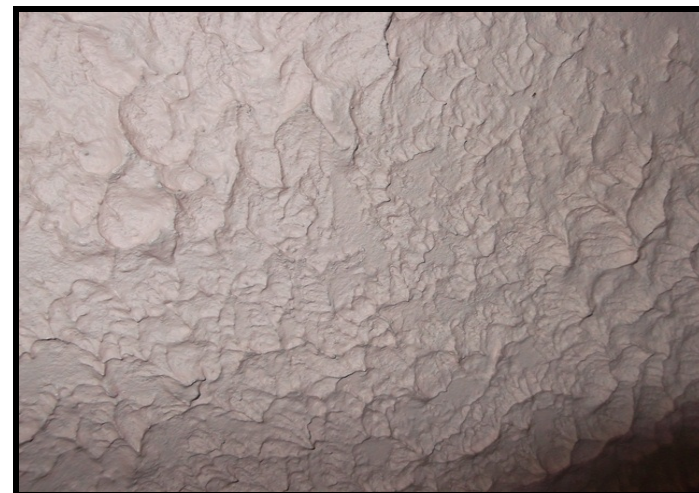
## SAMPLE REFERENCE 076

**No Asbestos Presumed in Sample**

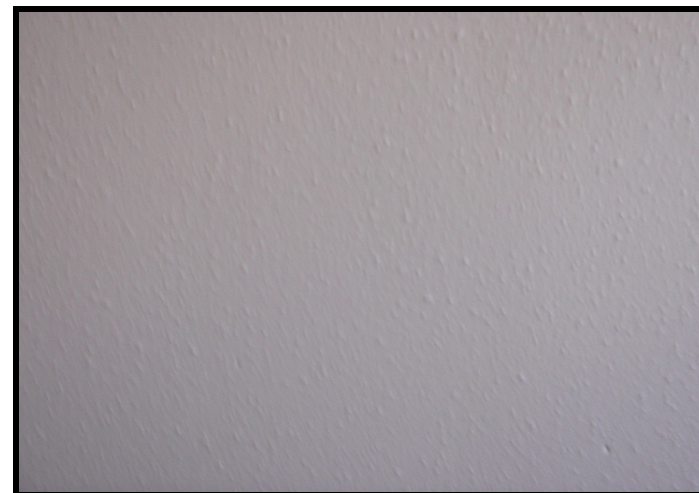
## SAMPLE REFERENCE 078

**No Asbestos Presumed in Sample**

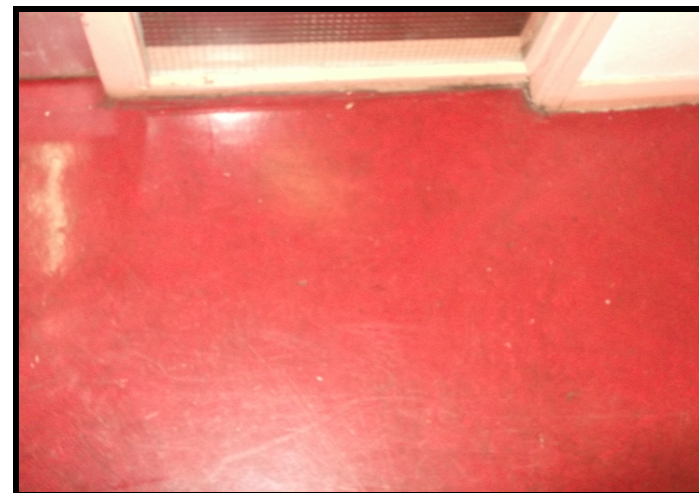
## SAMPLE REFERENCE 080

**No Asbestos Presumed in Sample**

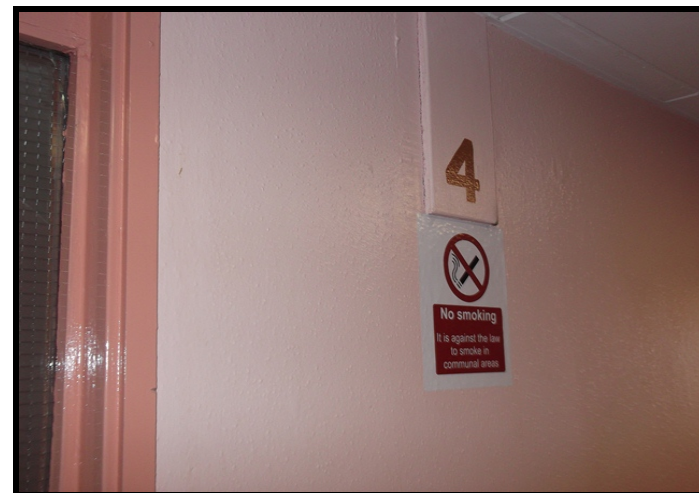
## SAMPLE REFERENCE 081

**No Asbestos Presumed in Sample**

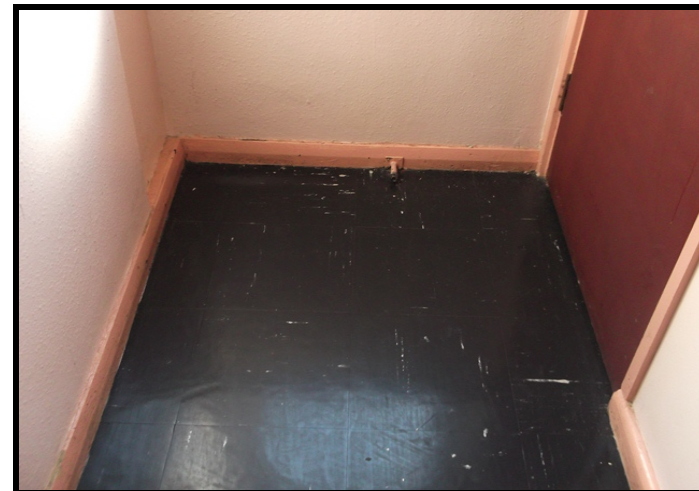
## SAMPLE REFERENCE 082

**No Asbestos Presumed in Sample**

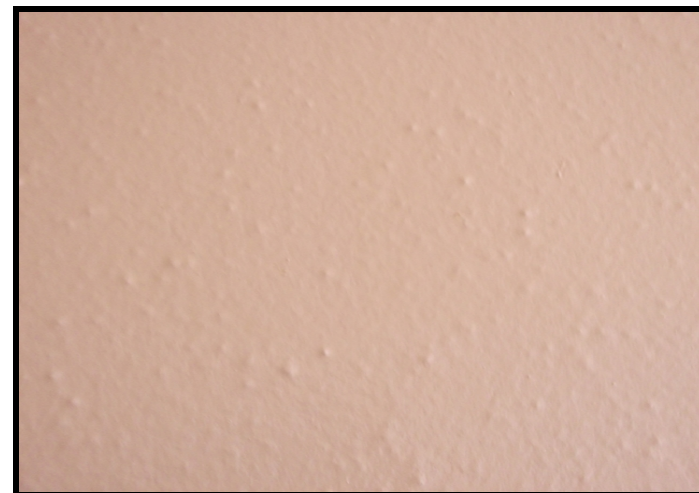
## SAMPLE REFERENCE 083

**No Asbestos Presumed in Sample**

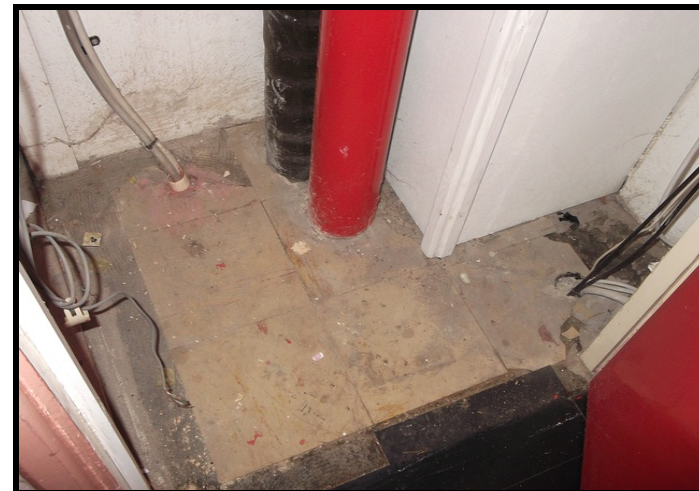
## SAMPLE REFERENCE 084

Asbestos Presumed in Sample

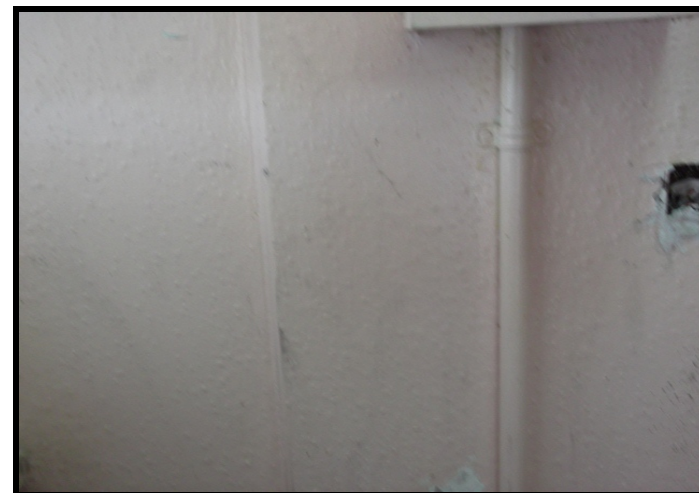
## SAMPLE REFERENCE 086

**No Asbestos Presumed in Sample**

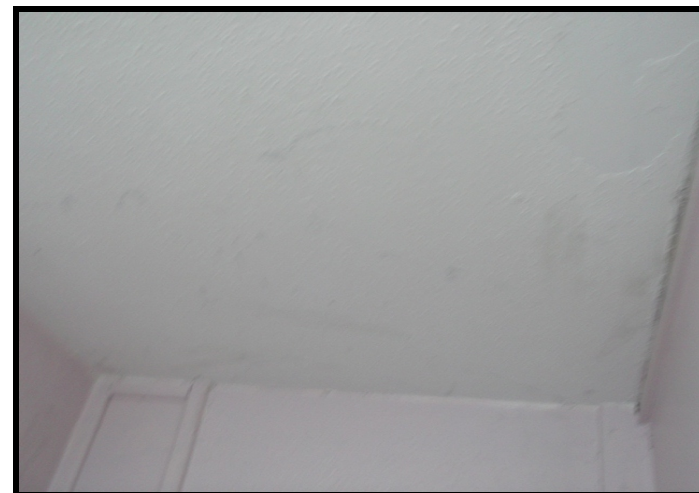
## SAMPLE REFERENCE 087

**No Asbestos Presumed in Sample**

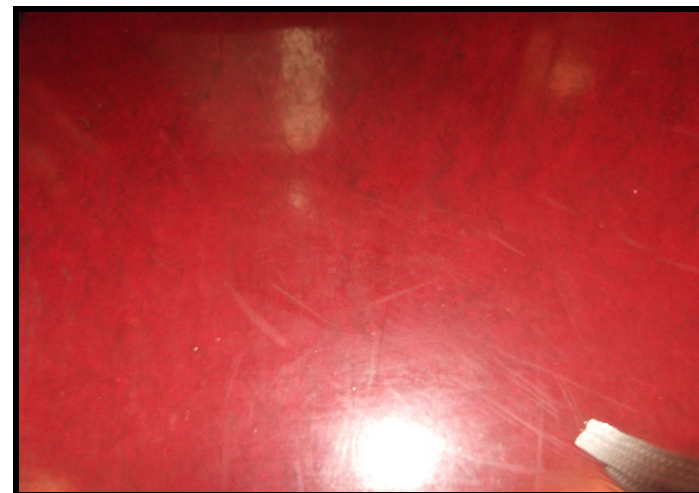
## SAMPLE REFERENCE 092

**No Asbestos Presumed in Sample**

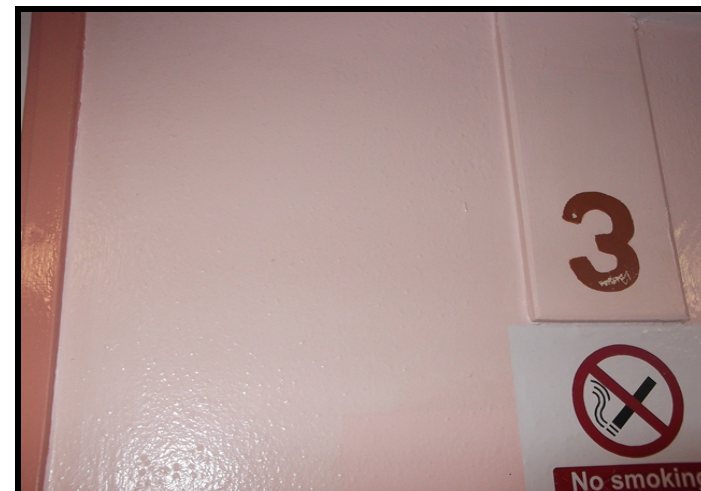
## SAMPLE REFERENCE 093

**No Asbestos Presumed in Sample**

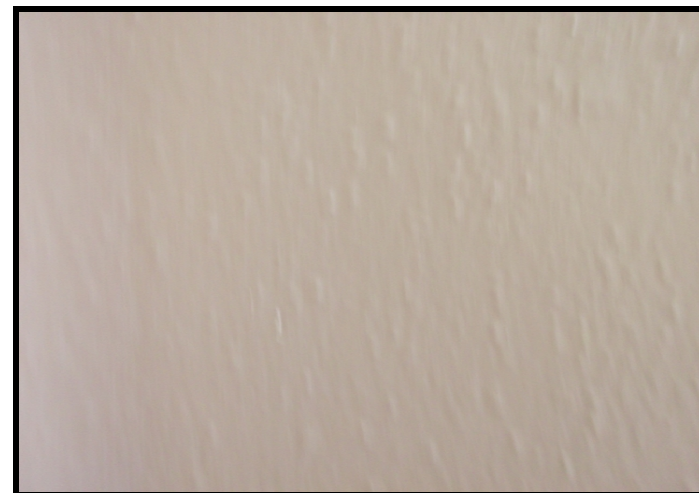
## SAMPLE REFERENCE 094

**No Asbestos Presumed in Sample**

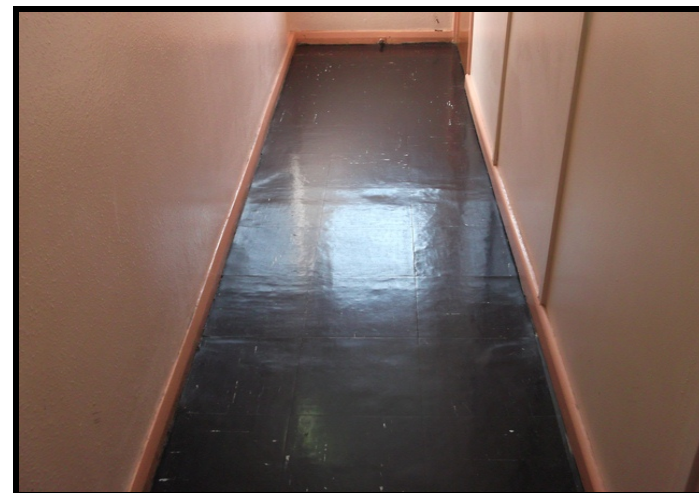
## SAMPLE REFERENCE 095

**No Asbestos Presumed in Sample**

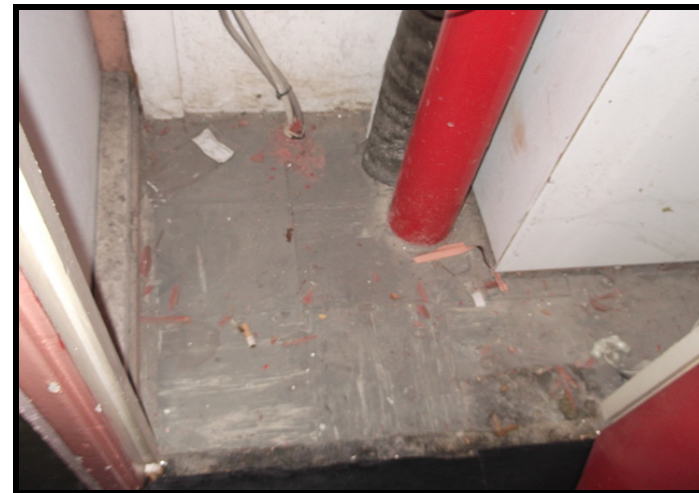
## SAMPLE REFERENCE 096

**No Asbestos Presumed in Sample**

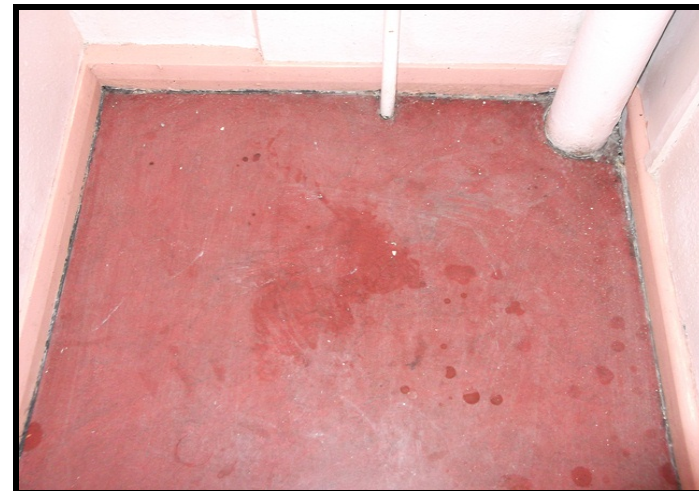
SAMPLE REFERENCE 097

**No Asbestos Presumed in Sample**

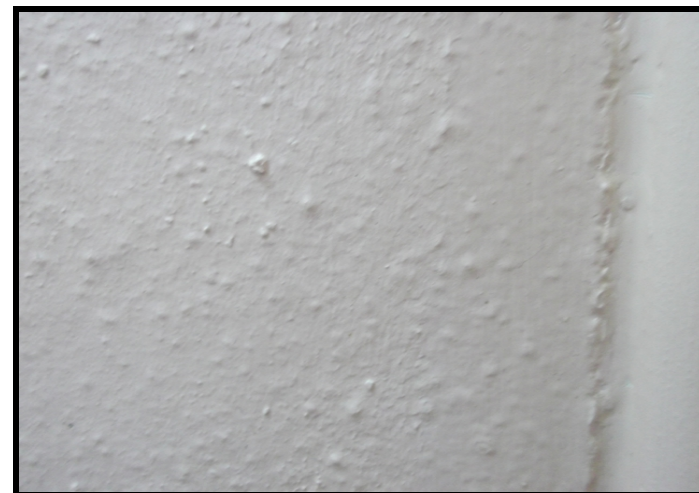
## SAMPLE REFERENCE 098

**No Asbestos Presumed in Sample**

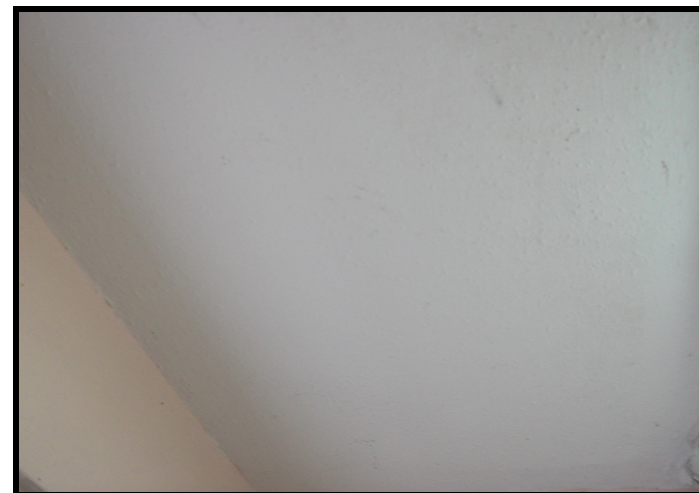
## SAMPLE REFERENCE 099

**No Asbestos Presumed in Sample**

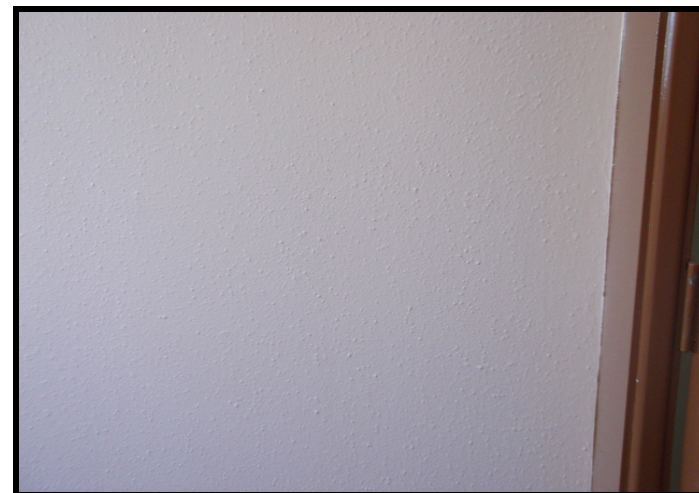
## SAMPLE REFERENCE 100

**No Asbestos Presumed in Sample**

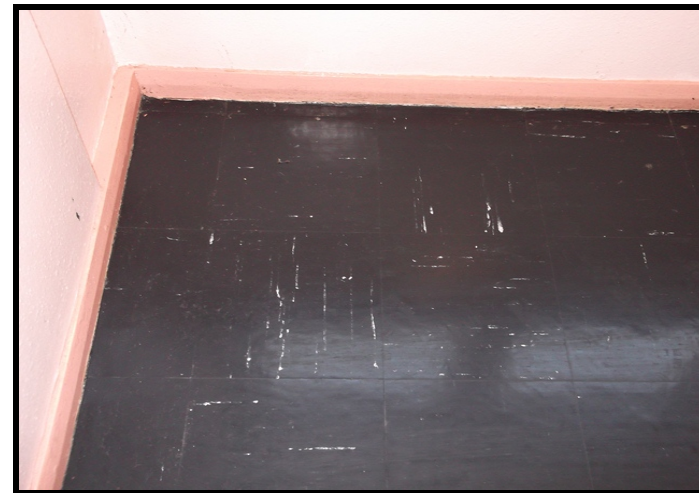
## SAMPLE REFERENCE 101

**No Asbestos Presumed in Sample**

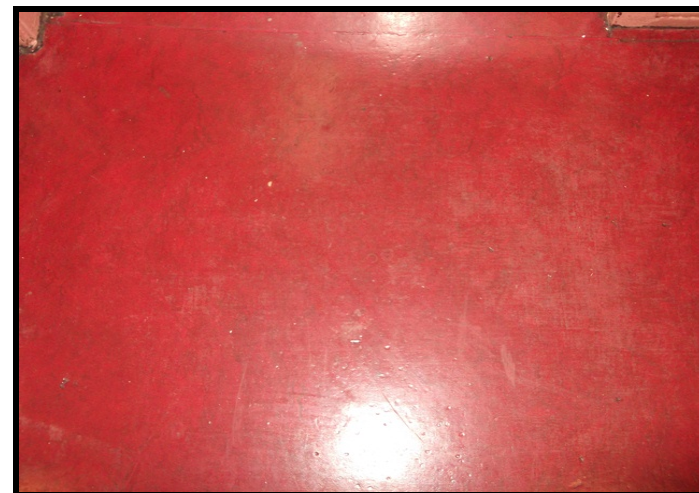
## SAMPLE REFERENCE 103

**No Asbestos Presumed in Sample**

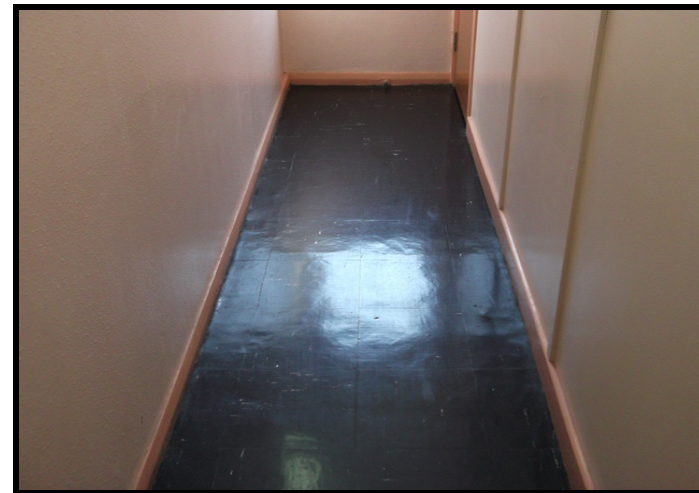
## SAMPLE REFERENCE 105

**No Asbestos Presumed in Sample**

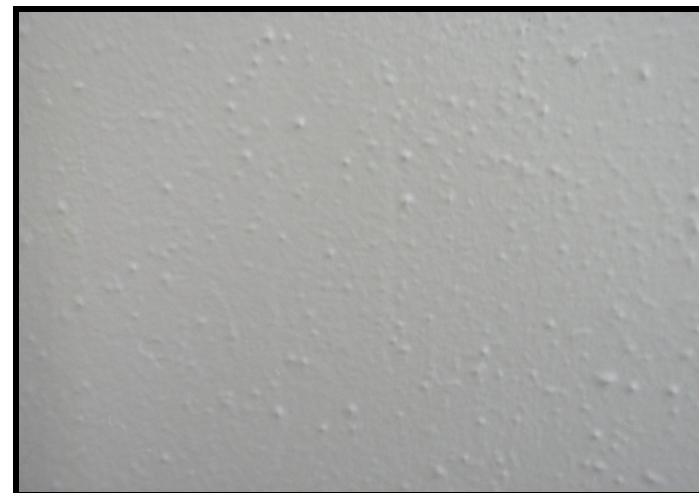
## SAMPLE REFERENCE 106

**No Asbestos Presumed in Sample**

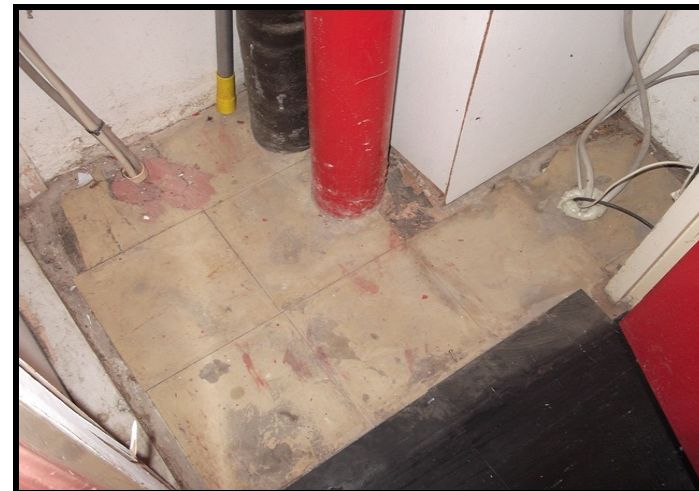
## SAMPLE REFERENCE 107

Asbestos Presumed in Sample

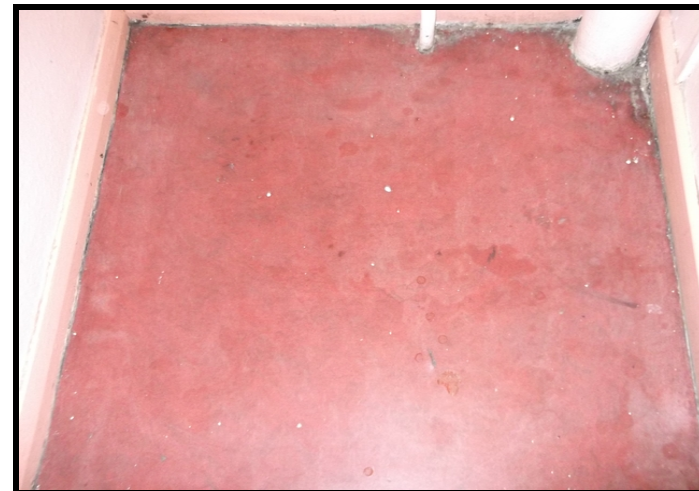
SAMPLE REFERENCE 108

**No Asbestos Presumed in Sample**

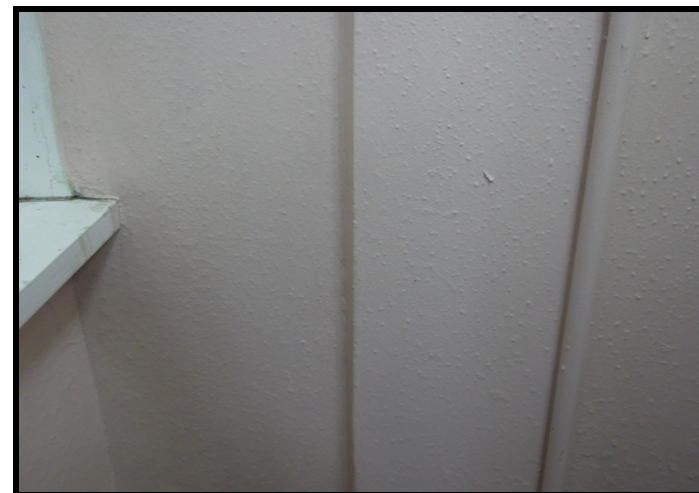
## SAMPLE REFERENCE 109

**No Asbestos Presumed in Sample**

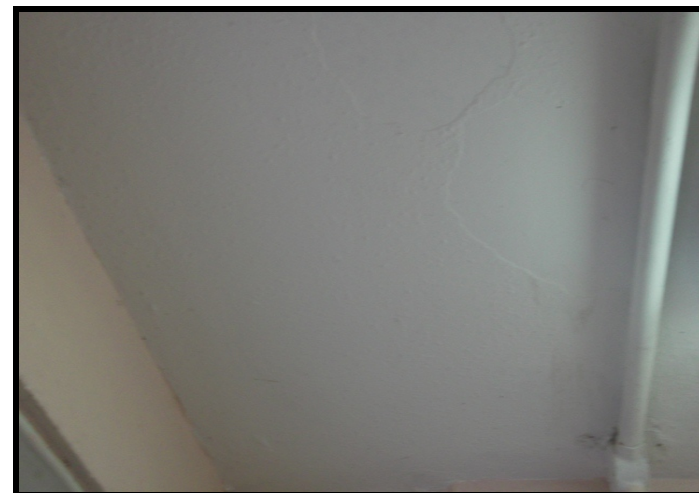
## SAMPLE REFERENCE 110

**No Asbestos Presumed in Sample**

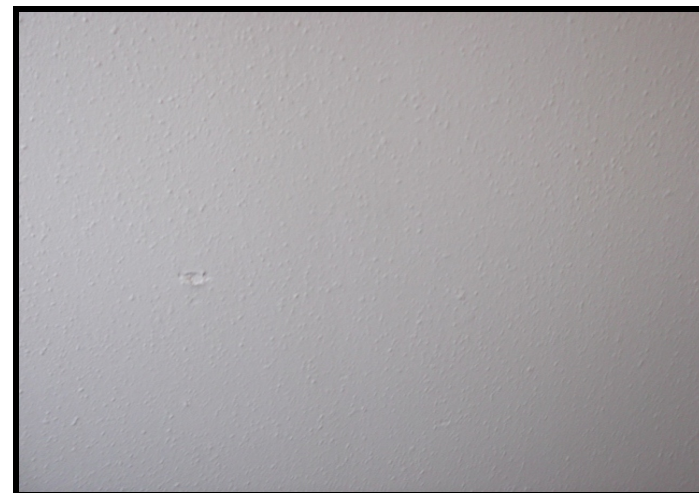
## SAMPLE REFERENCE I12

**No Asbestos Presumed in Sample**

| Building | Floor | Room | Location | |
|---|---|---|---|---|
| Product Type | Textured Coating | Extent of Damage | Low damage | - |

| Building | Floor | Room | Location | |
|---|---|---|---|---|
| Recommendation | NO ACTION REQUIRED | | | - |

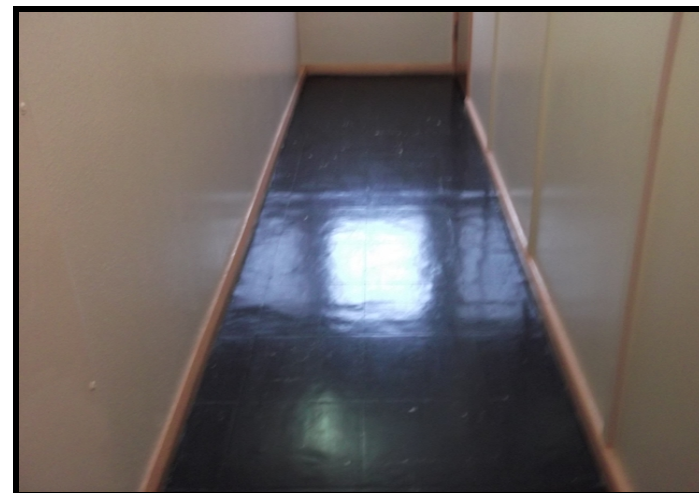
## SAMPLE REFERENCE 117

**No Asbestos Presumed in Sample**

| MATERIAL ASSESSMENT | | | | SCORE |
|---|---|---|---|---|
| <b>Product Type</b> | Floor Tiles & Adhesive | <b>Extent of Damage</b> | Low damage | - |

| MANAGEMENT ACTION | | | | SCORE |
|---|---|---|---|---|
| <b>Recommendation</b> | NO ACTION REQUIRED | | | - |

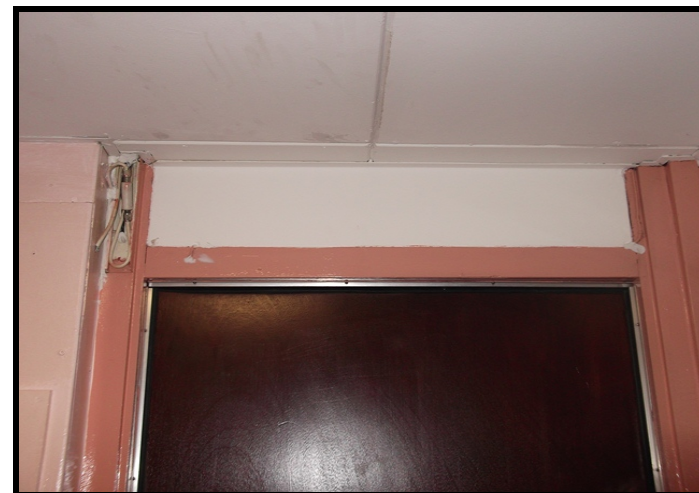
## SAMPLE REFERENCE 122

Asbestos not detected in Sample

| MATERIAL ASSESSMENT | | | | SCORE |
|---|---|---|---|---|
| <b>Product Type</b> | Board | <b>Extent of Damage</b> | Low damage | - |

| MANAGEMENT ACTION | | | | SCORE |
|---|---|---|---|---|
| <b>Recommendation</b> | NO ACTION REQUIRED | | | - |

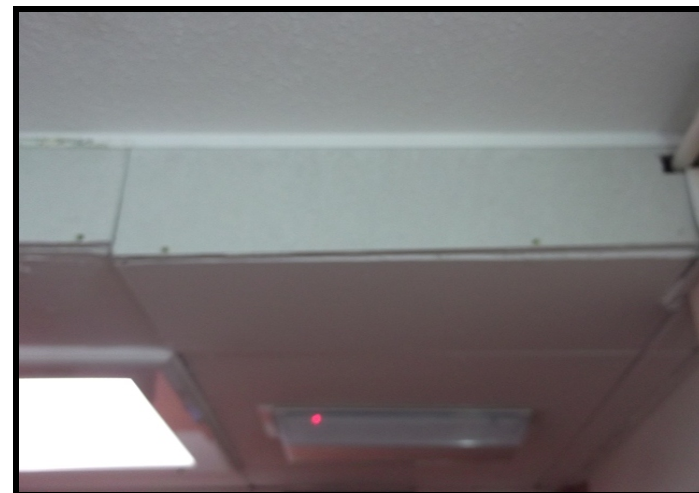
## SAMPLE REFERENCE 124

**Asbestos not detected in Sample**

| Building | Floor | Room | Location | |
|---|---|---|---|---|
| Product Type | Board | Extent of Damage | Low damage | - |

| Building | Floor | Room | Location | |
|---|---|---|---|---|
| Recommendation | NO ACTION REQUIRED | | | - |

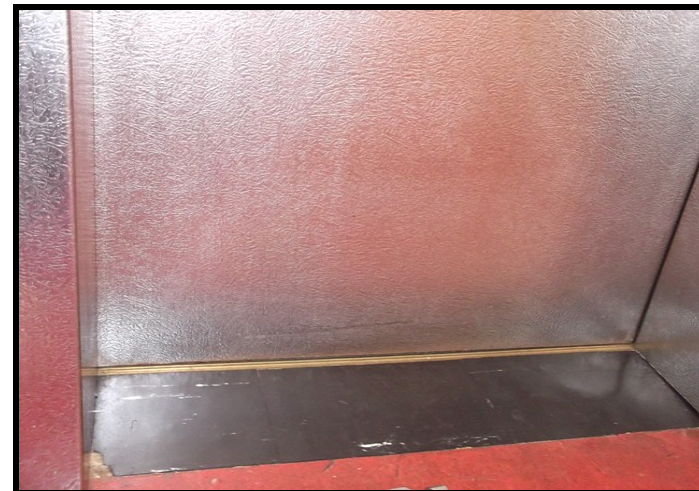
## SAMPLE REFERENCE 126

Asbestos not detected in Sample

| MATERIAL ASSESSMENT | | | | SCORE |
|---|---|---|---|---|
| <b>Product Type</b> | Board | <b>Extent of Damage</b> | Low damage | - |

| MANAGEMENT ACTION | | | | SCORE |
|---|---|---|---|---|
| <b>Recommendation</b> | NO ACTION REQUIRED | | | - |

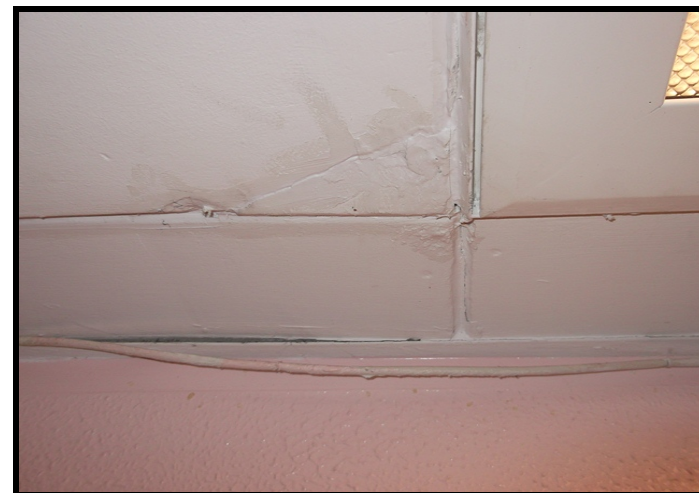
## SAMPLE REFERENCE 127

Asbestos not detected in Sample

| Building | Floor | Room | Location | |
|---|---|---|---|---|
| Product Type | Textured Coating | Extent of Damage | Low damage | - |

| Building | Floor | Room | Location | |
|---|---|---|---|---|
| Recommendation | NO ACTION REQUIRED | | | - |
