Site ID: **a-309621**

Management with Targeted Refurbishment Survey – PART 1

1-61 Pembroke House
Barle Grove
Chelmsley Wood
Solihull
West Midlands
B36 0UA
United Kingdom

12th June 2021

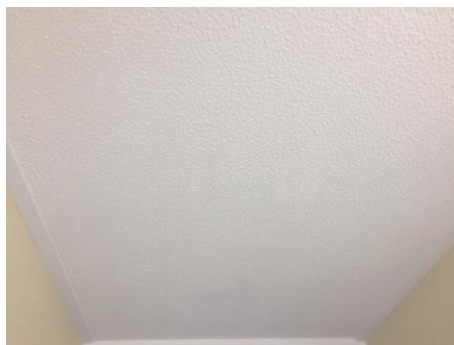
Stipple pattern textured coating.

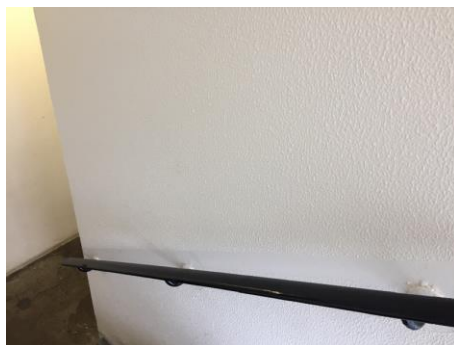
Stipple pattern textured coating.

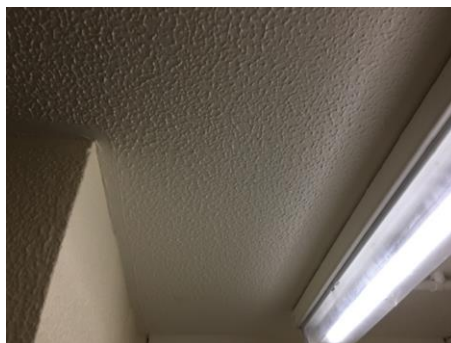
Stipple pattern textured coating.

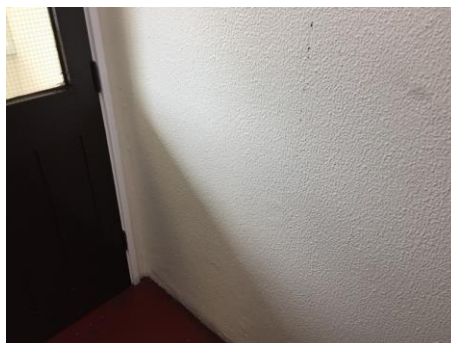
Stipple pattern textured coating.

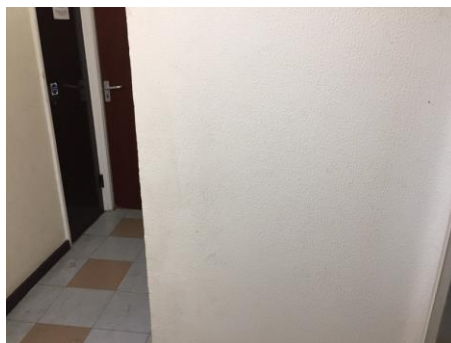
Stipple pattern textured coating.

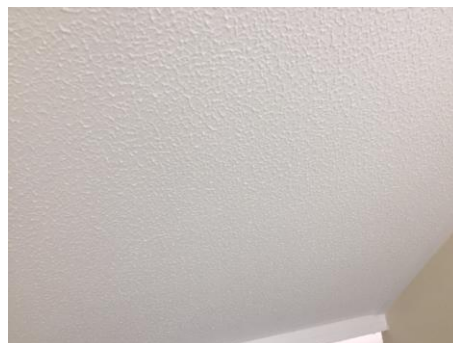
Stipple pattern textured coating.

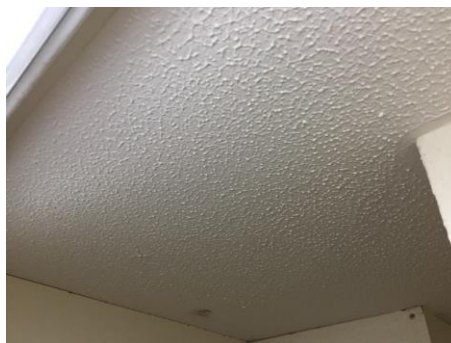
Stipple pattern textured coating.

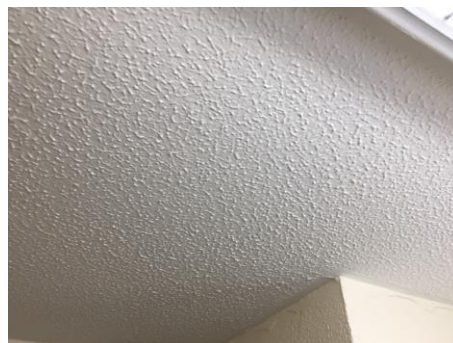
Stipple pattern textured coating.

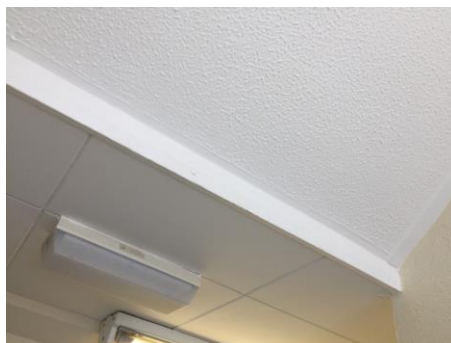
Spatter pattern textured coating above suspended ceiling.

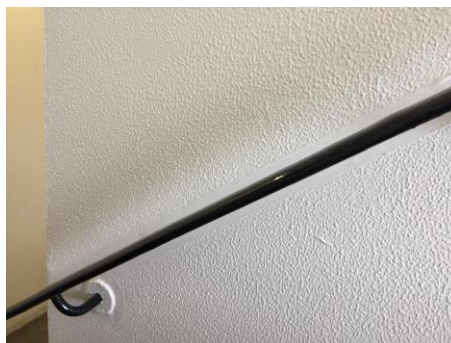
Stipple pattern textured coating.

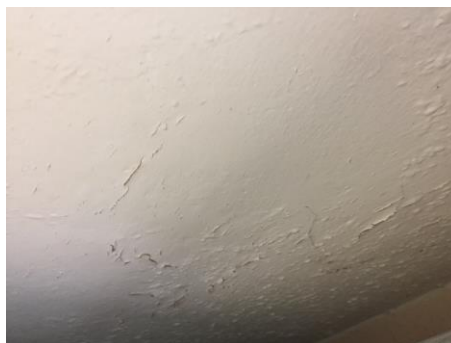
Spatter pattern textured coating.

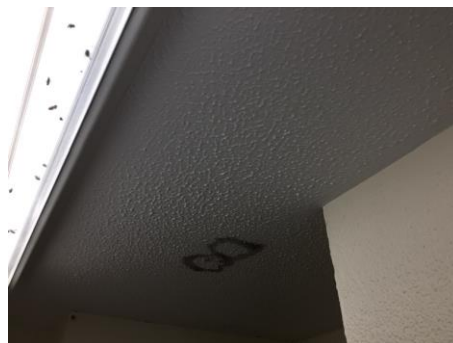
Stipple pattern textured coating.

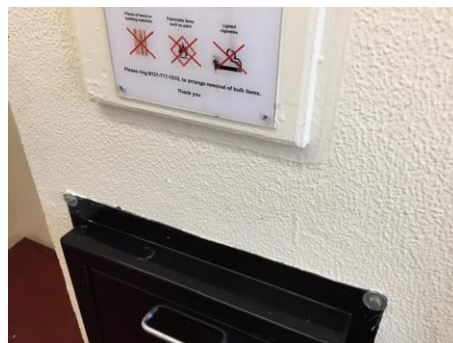
Stipple pattern textured coating.

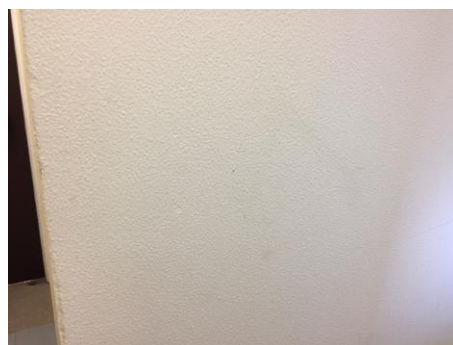
Stipple pattern textured coating.

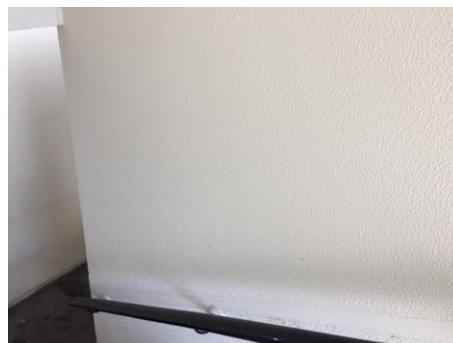
Stipple pattern textured coating.

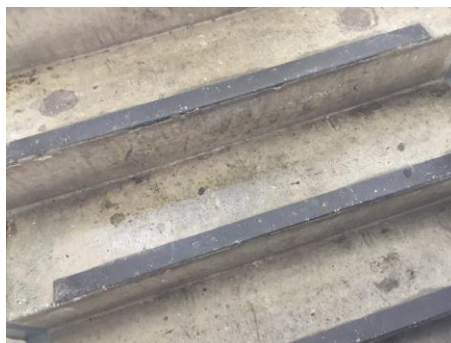
Resin nosing to edge of stairs.

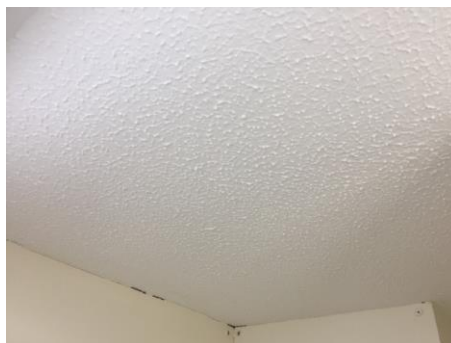
Stipple pattern textured coating.

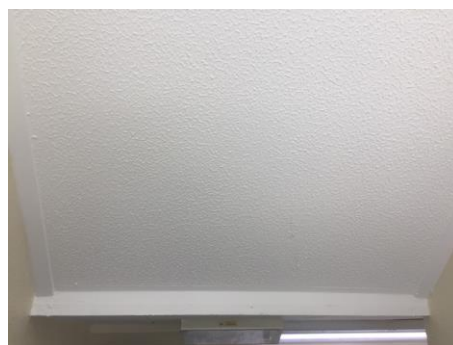
Stipple pattern textured coating.

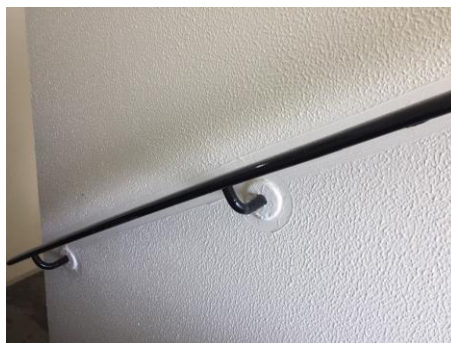
Stipple pattern textured coating.

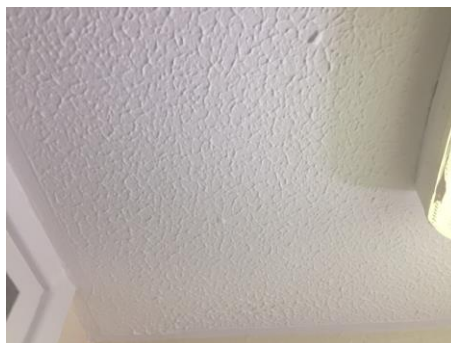
Stipple pattern textured coating.

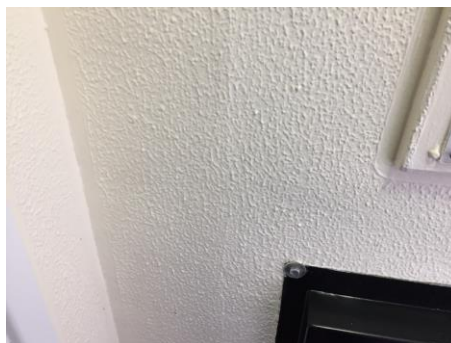
Stipple pattern textured coating.

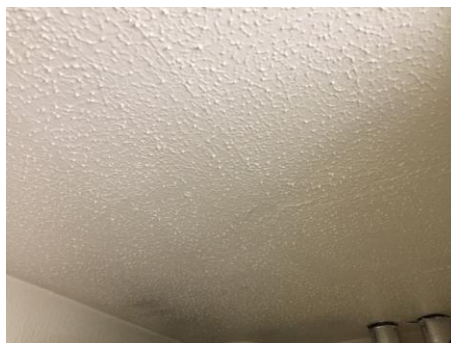
Stipple pattern textured coating.

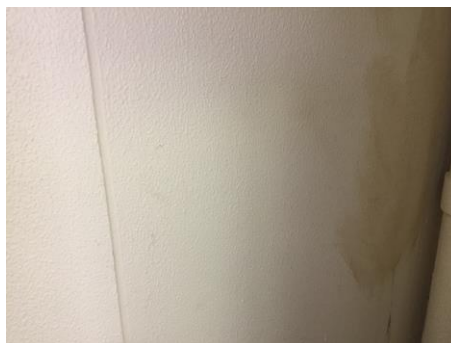
Stipple pattern textured coating.

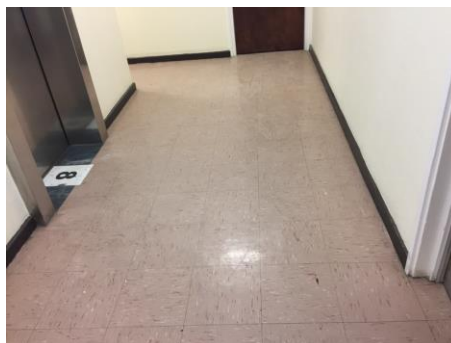
Bitumen adhesive beneath floor tiles.

The material was seen to be in fair condition at the time of the initial inspection.

The condition of the material should be managed by a competent person/company and its presence made aware to those at risk, as part of a Control of Asbestos Regulations (CAR) 2012 compliant management strategy.

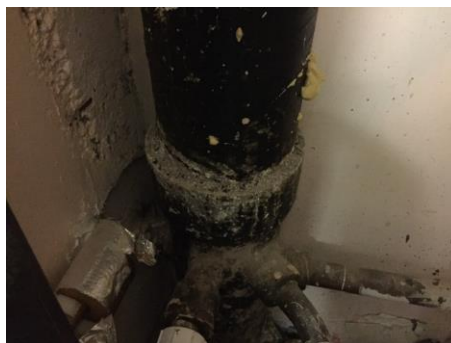
Lagging packing to joints of soil pipe.

The material was seen to be in fair condition at the time of the initial inspection.

The condition of the material should be managed by a competent person/company and its presence made aware to those at risk, as part of a Control of Asbestos Regulations (CAR) 2012 compliant management strategy.

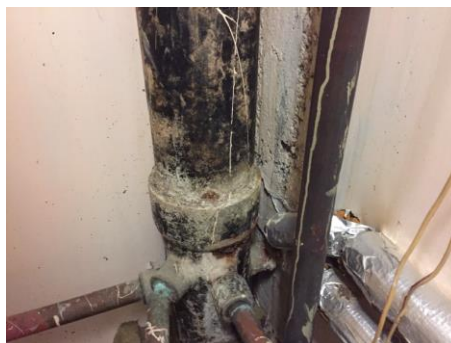
Lagging packing to joints of soil pipe.

The material was seen to be in fair condition at the time of the initial inspection.

The condition of the material should be managed by a competent person/company and its presence made aware to those at risk, as part of a Control of Asbestos Regulations (CAR) 2012 compliant management strategy.

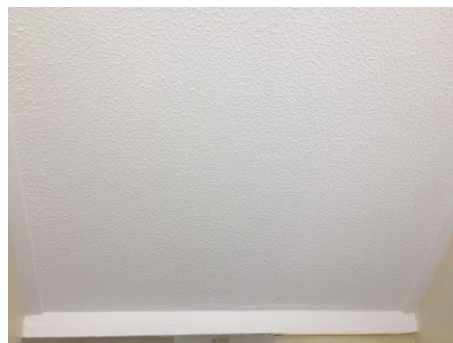
Stipple pattern textured coating.

The material was seen to be in fair condition at the time of the initial inspection.

The condition of the material should be managed by a competent person/company and its presence made aware to those at risk, as part of a Control of Asbestos Regulations (CAR) 2012 compliant management strategy.

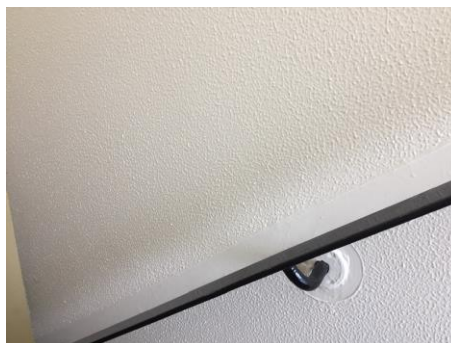
Stipple pattern textured coating.

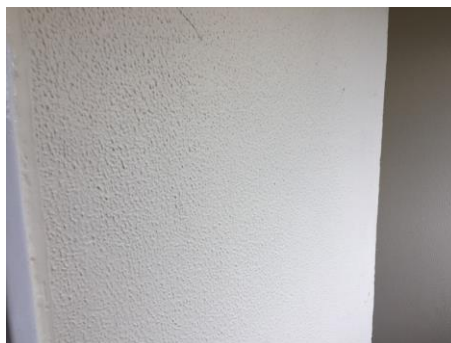
Stipple pattern textured coating.

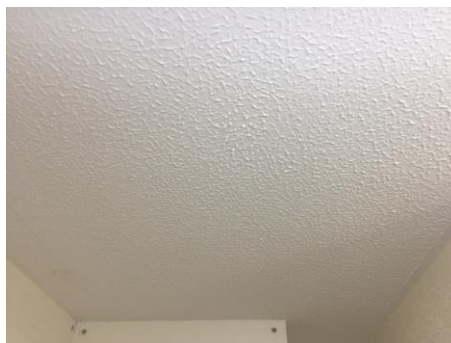
Stipple pattern textured coating.

The material was seen to be in fair condition at the time of the initial inspection.

The condition of the material should be managed by a competent person/company and its presence made aware to those at risk, as part of a Control of Asbestos Regulations (CAR) 2012 compliant management strategy.

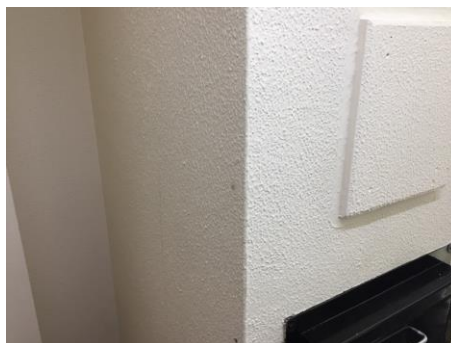
Stipple pattern textured coating.

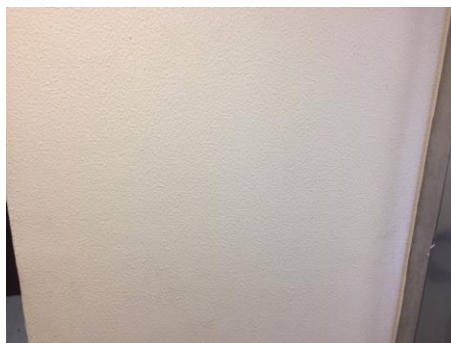
Stipple pattern textured coating.
