Management with Targeted Refurbishment Survey – PART 1

1-68 Redwood House
30 Broomcroft Road
Kingshurst
Solihull
West Midlands
B37 6HB
United Kingdom

21st April 2021

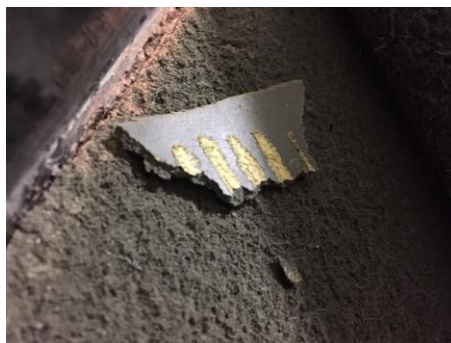
Condition **Low Damage**

Bitumen adhesive beneath floor tiles.

The material was seen to be in fair condition at the time of the initial inspection.

The condition of the material should be managed by a competent person/company and its presence made aware to those at risk, as part of a Control of Asbestos Regulations (CAR) 2012 compliant management strategy.

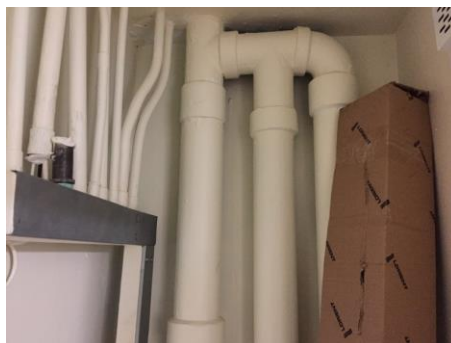
Condition **Low Damage**

Cement flues.

The material was seen to be in fair condition at the time of the initial inspection.

The condition of the material should be managed by a competent person/company and its presence made aware to those at risk, as part of a Control of Asbestos Regulations (CAR) 2012 compliant management strategy.

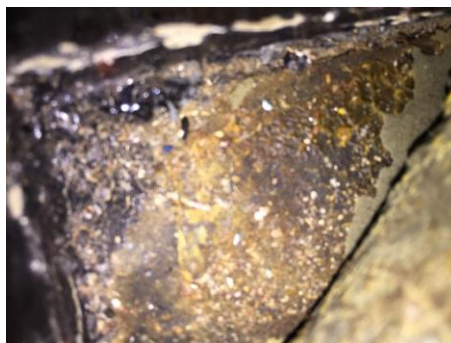
Condition **Low Damage**

Black floor tiles.

The material was seen to be in fair condition at the time of the initial inspection.

The condition of the material should be managed by a competent person/company and its presence made aware to those at risk, as part of a Control of Asbestos Regulations (CAR) 2012 compliant management strategy.

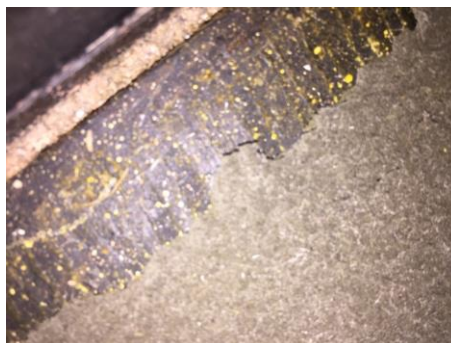
Condition **Low Damage**

Bitumen adhesive beneath floor tiles.

The material was seen to be in fair condition at the time of the initial inspection.

The condition of the material should be managed by a competent person/company and its presence made aware to those at risk, as part of a Control of Asbestos Regulations (CAR) 2012 compliant management strategy.

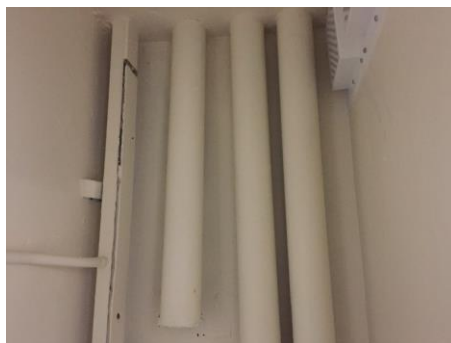
Condition **Low Damage**

Cement flues.

The material was seen to be in fair condition at the time of the initial inspection.

The condition of the material should be managed by a competent person/company and its presence made aware to those at risk, as part of a Control of Asbestos Regulations (CAR) 2012 compliant management strategy.

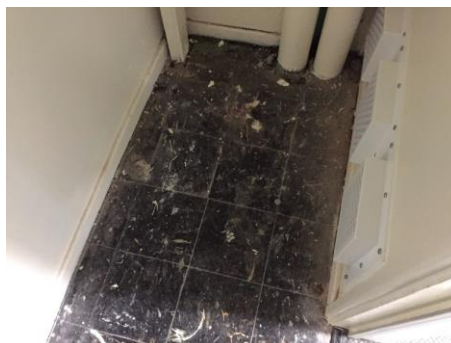
Condition **Low Damage**

Black floor tiles.

The material was seen to be in fair condition at the time of the initial inspection.

The condition of the material should be managed by a competent person/company and its presence made aware to those at risk, as part of a Control of Asbestos Regulations (CAR) 2012 compliant management strategy.

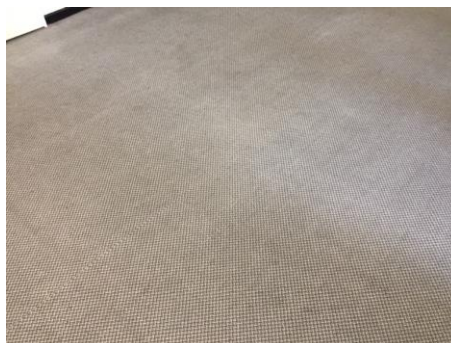
Condition **Low Damage**

Bitumen adhesive beneath floor tiles.

The material was seen to be in fair condition at the time of the initial inspection.

The condition of the material should be managed by a competent person/company and its presence made aware to those at risk, as part of a Control of Asbestos Regulations (CAR) 2012 compliant management strategy.

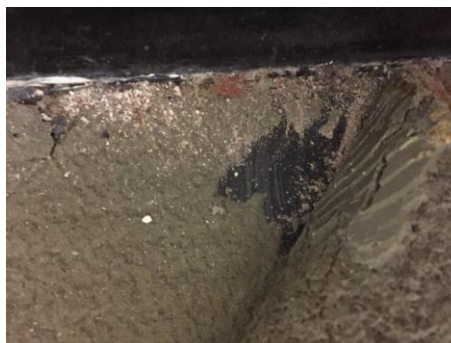
Condition **Low Damage**

Black floor tiles.

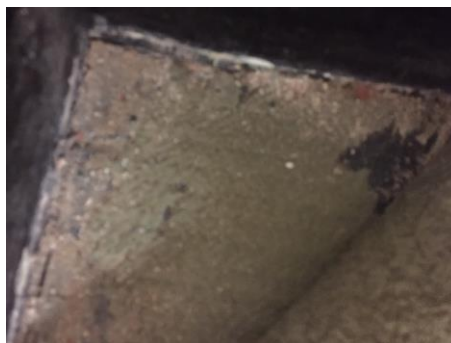
Bitumen adhesive beneath floor tiles.

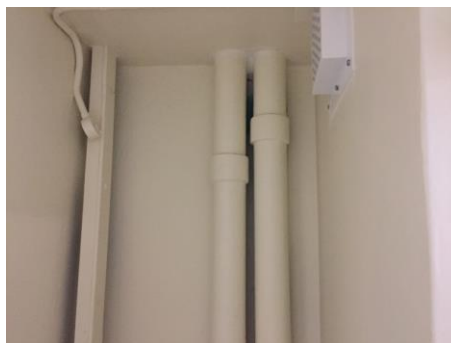
Cement flues.

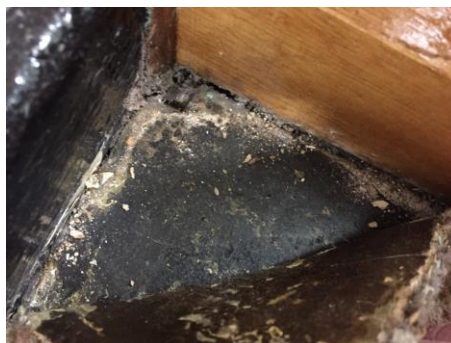
Bitumen adhesive beneath floor tiles.

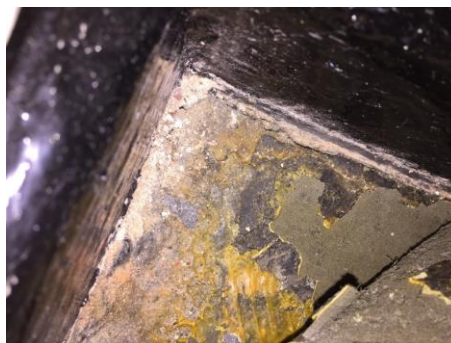
Bitumen adhesive beneath floor tiles.

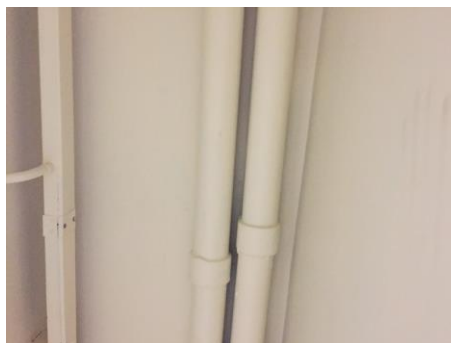
Cement flues.

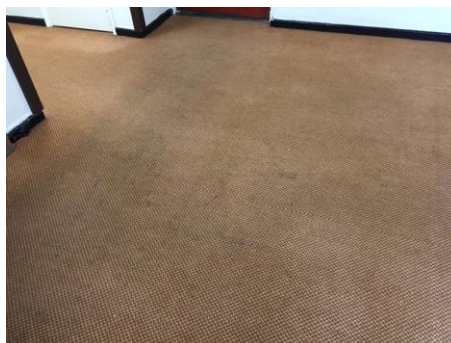
Black floor tiles.

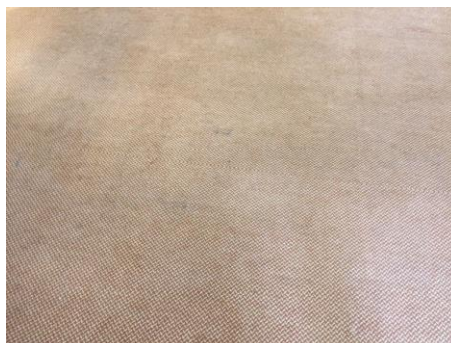
Bitumen adhesive beneath floor tiles.

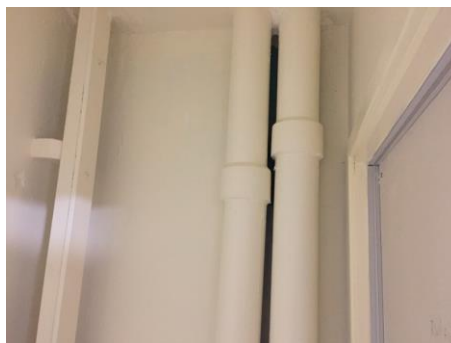
Cement flues.

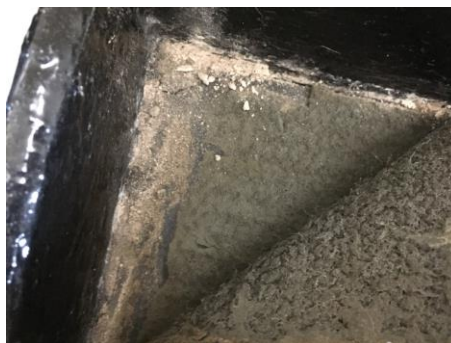
Black floor tiles.

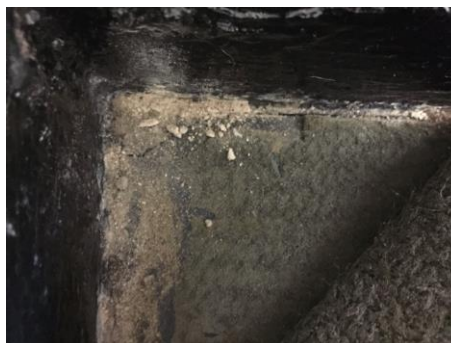
Bitumen adhesive beneath floor tiles.

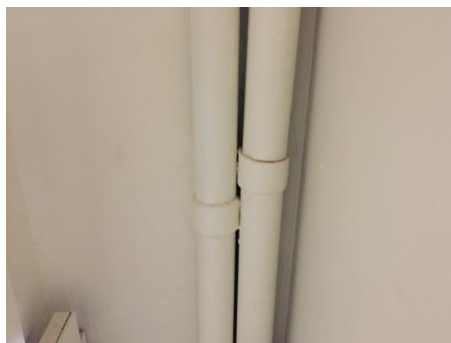
Cement flues.

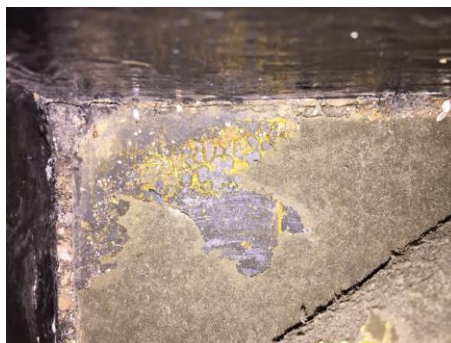
Black floor tiles.

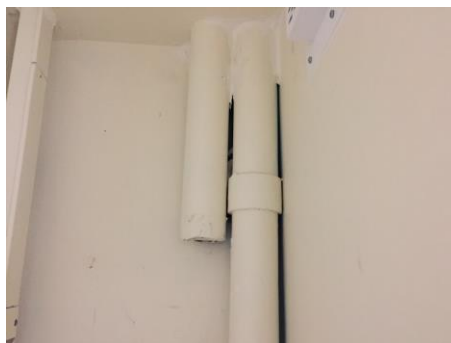
Cement flues.

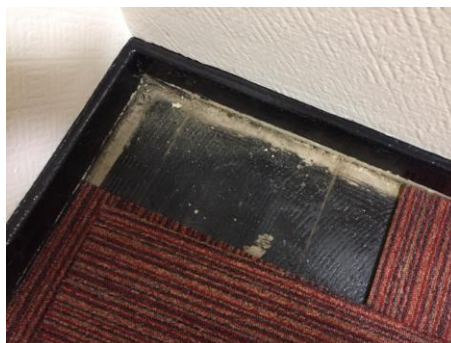
Bitumen adhesive beneath carpet.

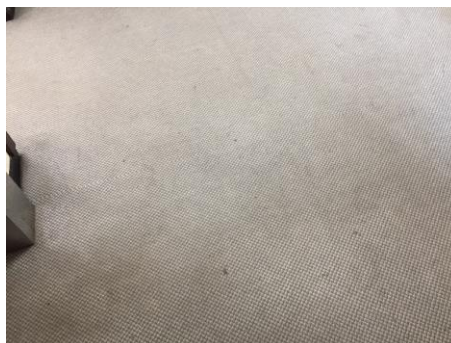
Black floor tiles.

The material was seen to be in fair condition at the time of the initial inspection.

The condition of the material should be managed by a competent person/company and its presence made aware to those at risk, as part of a Control of Asbestos Regulations (CAR) 2012 compliant management strategy.

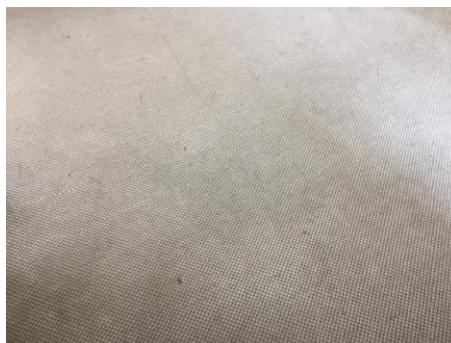
Bitumen adhesive beneath floor tiles.

The material was seen to be in fair condition at the time of the initial inspection.

The condition of the material should be managed by a competent person/company and its presence made aware to those at risk, as part of a Control of Asbestos Regulations (CAR) 2012 compliant management strategy.

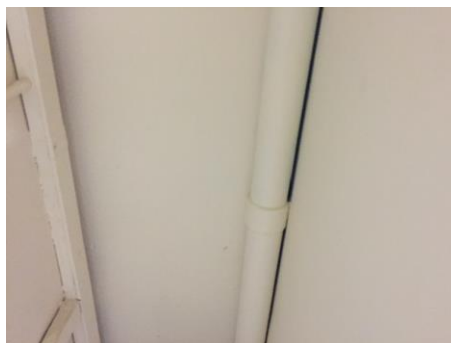
Cement flues.

The material was seen to be in fair condition at the time of the initial inspection.

The condition of the material should be managed by a competent person/company and its presence made aware to those at risk, as part of a Control of Asbestos Regulations (CAR) 2012 compliant management strategy.

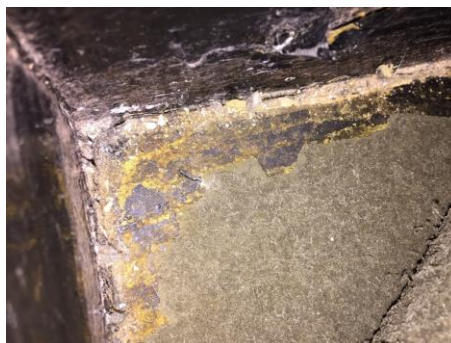
Black floor tiles.

The material was seen to be in fair condition at the time of the initial inspection.

The condition of the material should be managed by a competent person/company and its presence made aware to those at risk, as part of a Control of Asbestos Regulations (CAR) 2012 compliant management strategy.

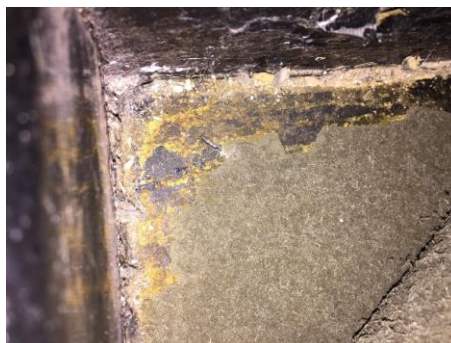
Bitumen adhesive beneath floor tiles.

The material was seen to be in fair condition at the time of the initial inspection.

The condition of the material should be managed by a competent person/company and its presence made aware to those at risk, as part of a Control of Asbestos Regulations (CAR) 2012 compliant management strategy.

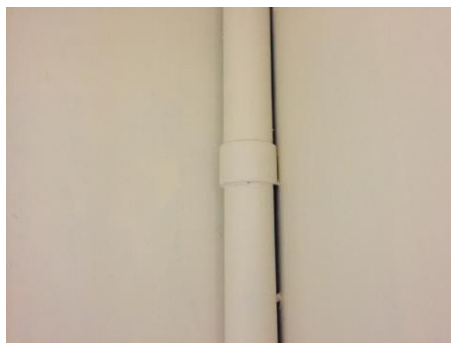
Cement flues.

The material was seen to be in fair condition at the time of the initial inspection.

The condition of the material should be managed by a competent person/company and its presence made aware to those at risk, as part of a Control of Asbestos Regulations (CAR) 2012 compliant management strategy.

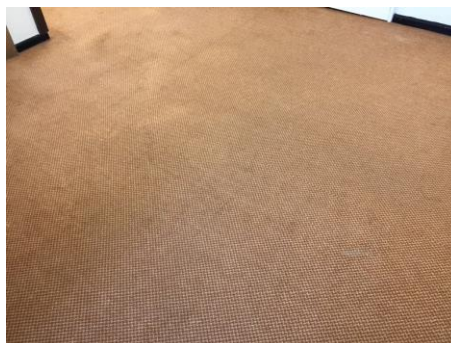
Bitumen adhesive beneath floor tiles.

The material was seen to be in fair condition at the time of the initial inspection.

The condition of the material should be managed by a competent person/company and its presence made aware to those at risk, as part of a Control of Asbestos Regulations (CAR) 2012 compliant management strategy.

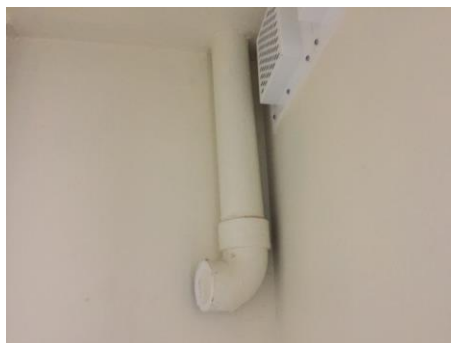
Cement flues.

The material was seen to be in fair condition at the time of the initial inspection.

The condition of the material should be managed by a competent person/company and its presence made aware to those at risk, as part of a Control of Asbestos Regulations (CAR) 2012 compliant management strategy.

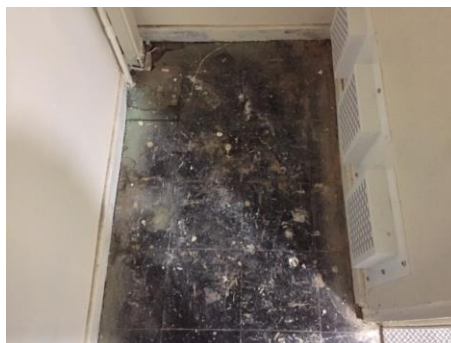
Black floor tiles.

The material was seen to be in fair condition at the time of the initial inspection.

The condition of the material should be managed by a competent person/company and its presence made aware to those at risk, as part of a Control of Asbestos Regulations (CAR) 2012 compliant management strategy.

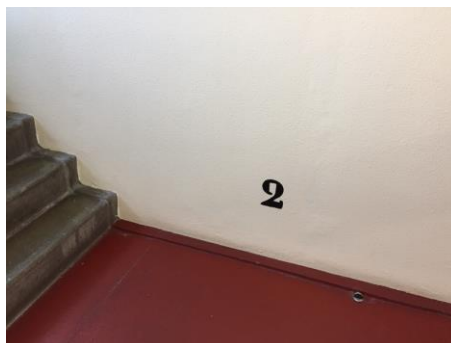
Spatter pattern textured coating.

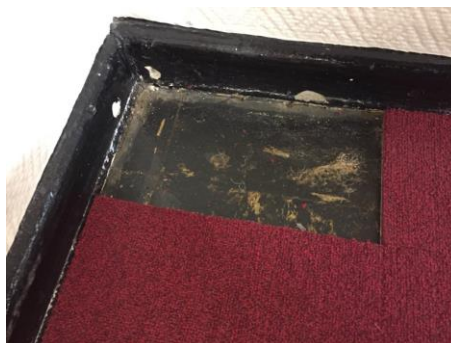
Bitumen adhesive beneath floor tiles.

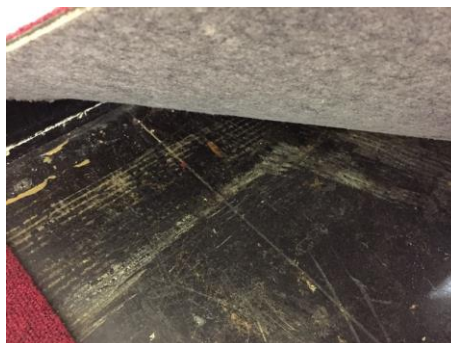
Bitumen adhesive beneath floor tiles.

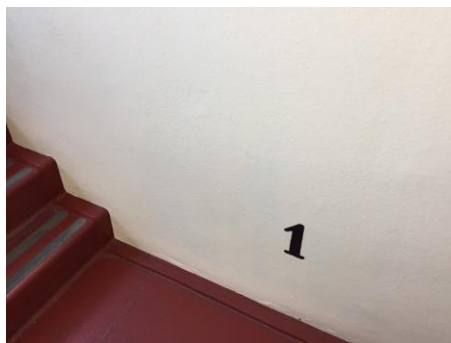
Spatter pattern textured coating.

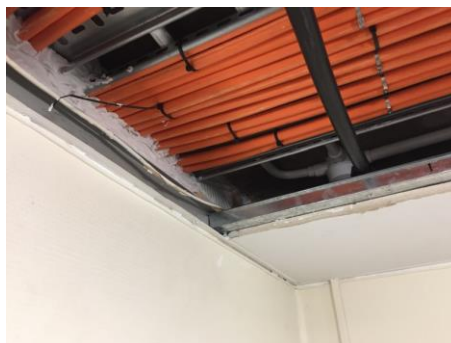
Spatter pattern textured coating behind wallpaper.

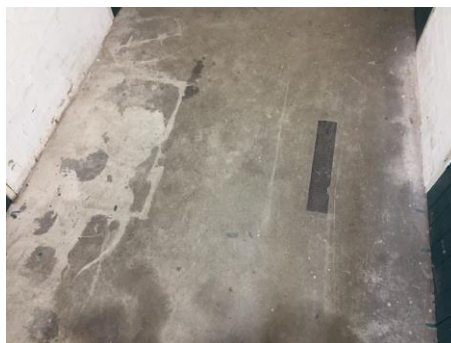
Small patch of resin to floor.

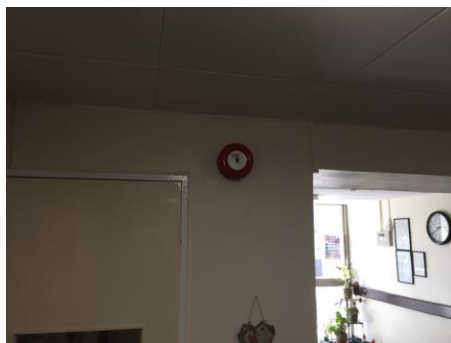
Spatter pattern textured coating behind wallpaper.
