Site ID: **a-312479** Management with Targeted Refurbishment Survey

Solihull Community Housing

1-53 Selwyn House
2 Waterson Croft
Chelmsley Wood
Solihull
B37 6TT
United Kingdom

23rd June 2021

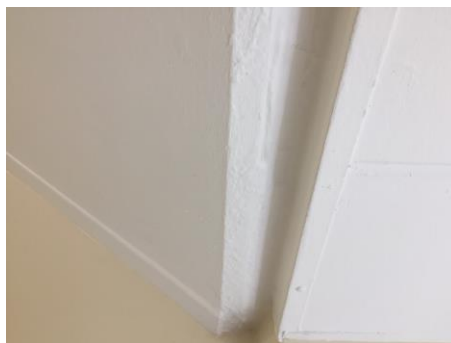
Spatter pattern textured coating.

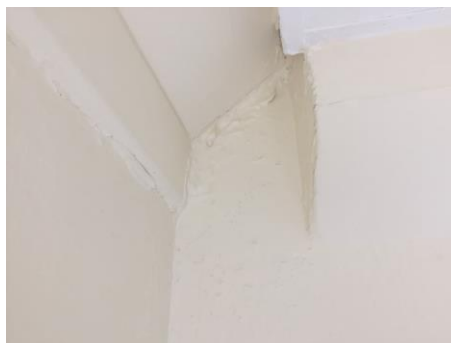
Spatter pattern textured coating, only visible in certain areas of wall. Possible previous poor removal works.

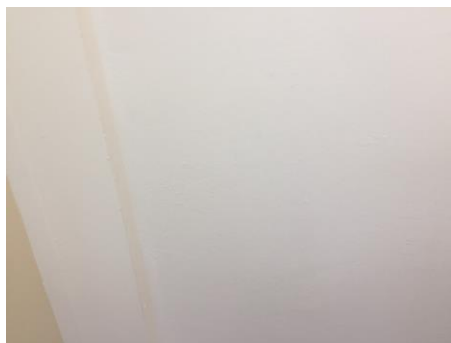
Spatter pattern textured coating visible to certain areas only. Possible previous poor removal works.

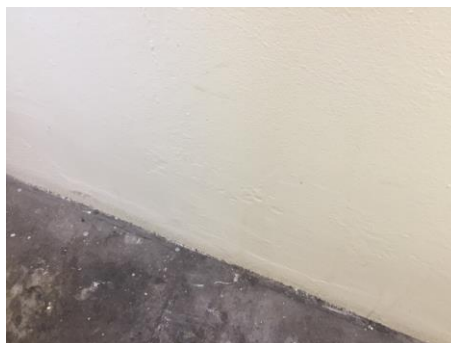
Spatter pattern textured coating, only visible in certain areas of wall. Possible previous poor removal works.

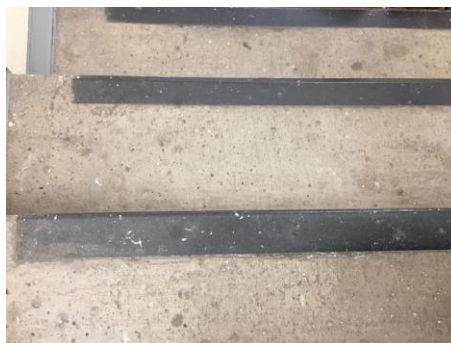
Resin nosing to edge of stairs.

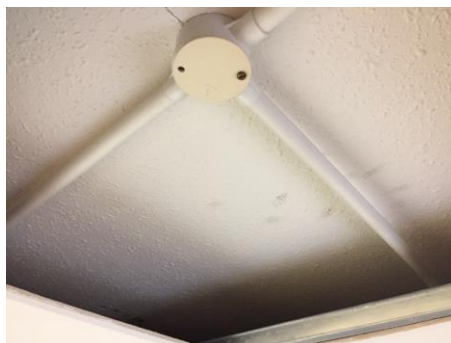
Spatter pattern textured coating above suspended ceiling.

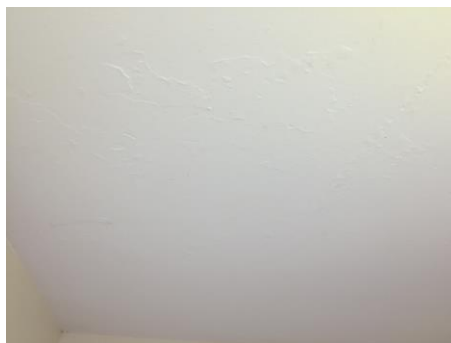
Spatter pattern textured coating. Visible only in certain areas. Possible previous poor removal works.

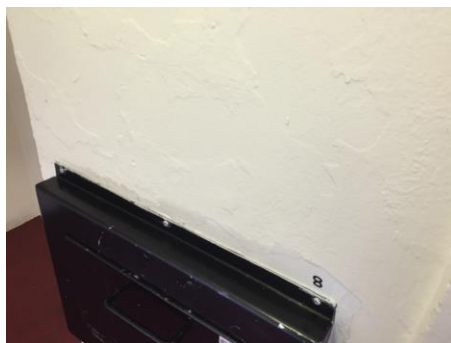
Spatter pattern textured coating.

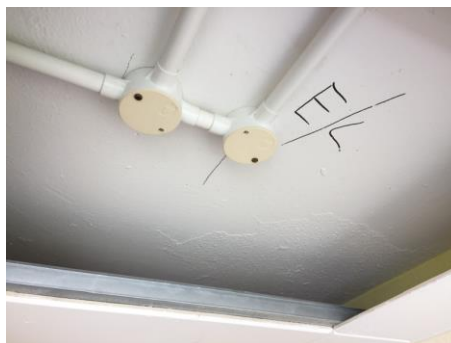
Spatter pattern textured coating above suspended ceiling.

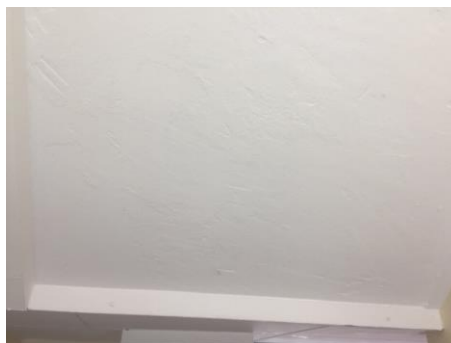
Spatter pattern textured coating.

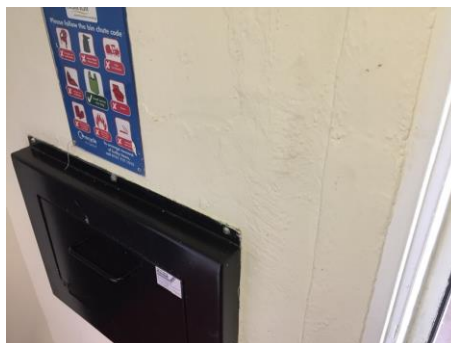
Spatter pattern textured coating.

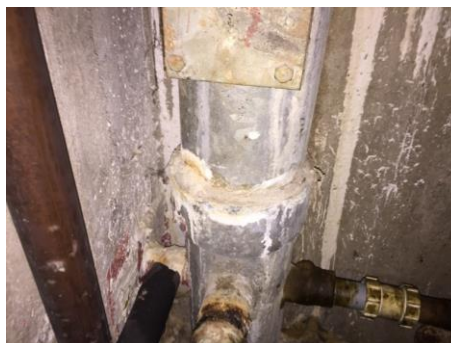
Rope seal to joint of soil pipe.

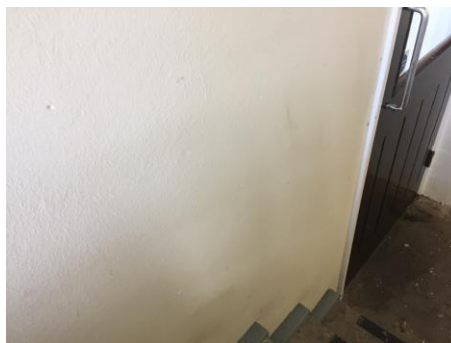
Spatter pattern textured coating, only visible in certain areas of wall. Possible previous poor removal works.

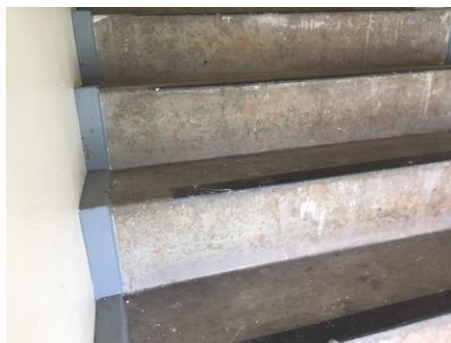
Resin nosing to edge of stairs.

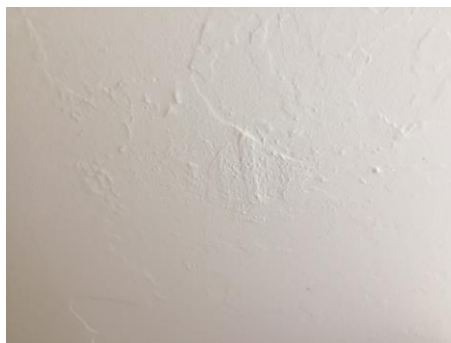
Spatter pattern textured coating. Visible only in certain areas. Possible previous poor removal works.

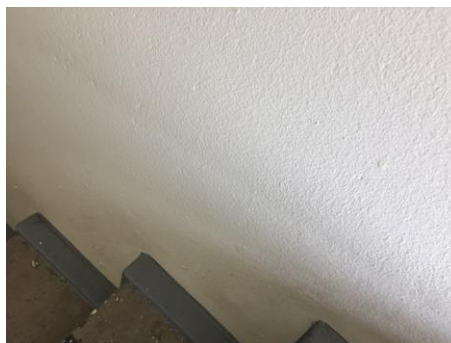
Spatter pattern textured coating, only visible in certain areas of wall. Possible previous poor removal works.

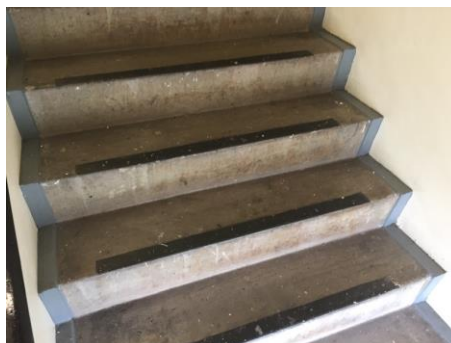
Resin nosing to edge of stairs.

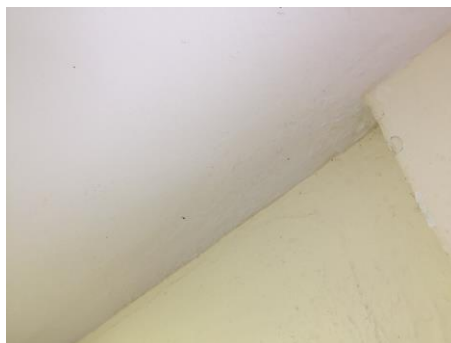
Spatter pattern textured coating. Visible only in certain areas. Possible previous poor removal works.

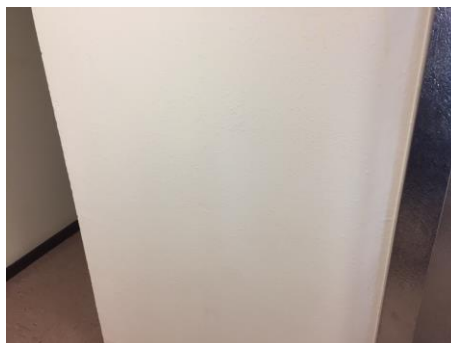
Spatter pattern textured coating.

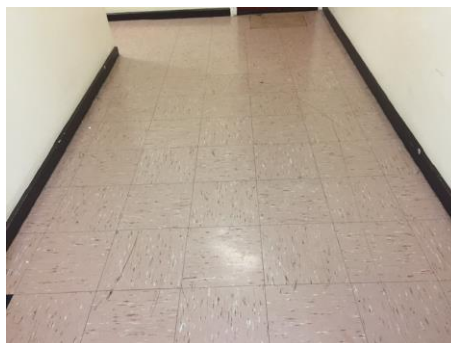
Pink floor tiles.

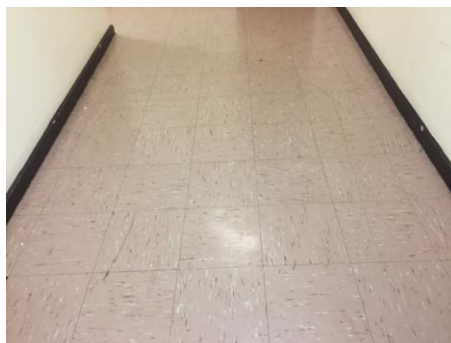
Bitumen adhesive beneath floor tiles.

The material was seen to be in fair condition at the time of the initial inspection.

The condition of the material should be managed by a competent person/company and its presence made aware to those at risk, as part of a Control of Asbestos Regulations (CAR) 2012 compliant management strategy.

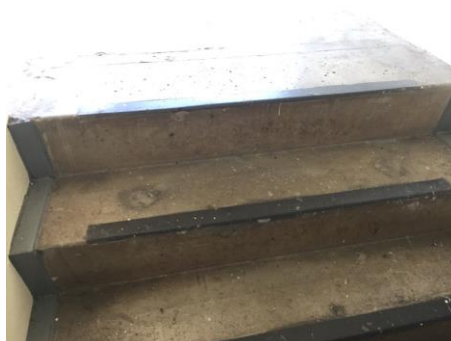
Resin nosing to edge of stairs.

The material was seen to be in fair condition at the time of the initial inspection.

The condition of the material should be managed by a competent person/company and its presence made aware to those at risk, as part of a Control of Asbestos Regulations (CAR) 2012 compliant management strategy.

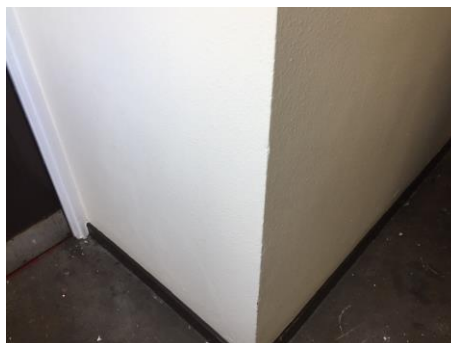
Spatter pattern textured coating.

The material was seen to be in fair condition at the time of the initial inspection.

The condition of the material should be managed by a competent person/company and its presence made aware to those at risk, as part of a Control of Asbestos Regulations (CAR) 2012 compliant management strategy.

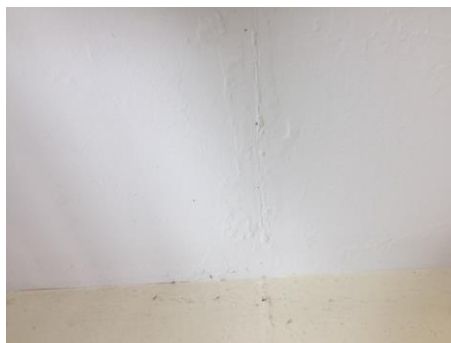
Spatter pattern textured coating. Visible only in certain areas. Possible previous poor removal works.

The material was seen to be in fair condition at the time of the initial inspection.

The condition of the material should be managed by a competent person/company and its presence made aware to those at risk, as part of a Control of Asbestos Regulations (CAR) 2012 compliant management strategy.

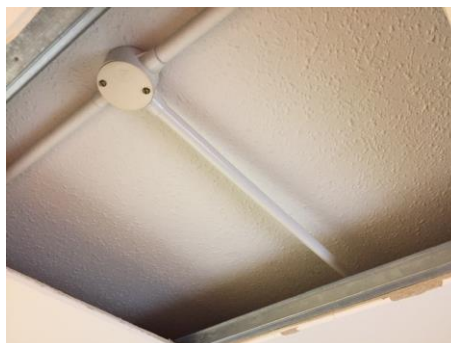
Spatter pattern textured coating above suspended ceiling.

The material was seen to be in fair condition at the time of the initial inspection.

The condition of the material should be managed by a competent person/company and its presence made aware to those at risk, as part of a Control of Asbestos Regulations (CAR) 2012 compliant management strategy.

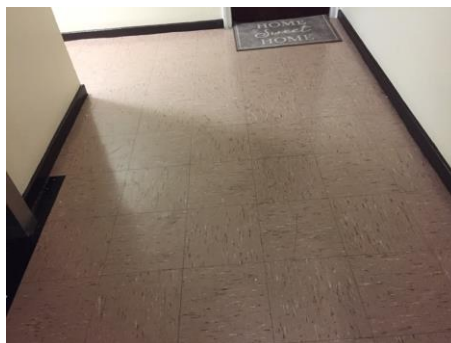
Pink floor tiles.

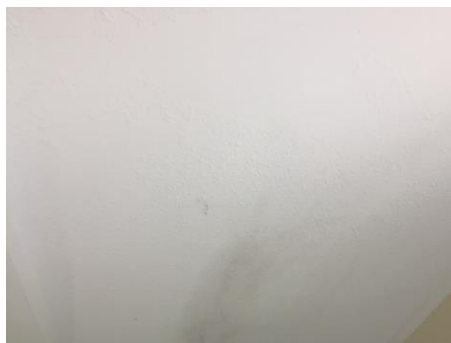
Spatter pattern textured coating.

The material was seen to be in fair condition at the time of the initial inspection.

The condition of the material should be managed by a competent person/company and its presence made aware to those at risk, as part of a Control of Asbestos Regulations (CAR) 2012 compliant management strategy.

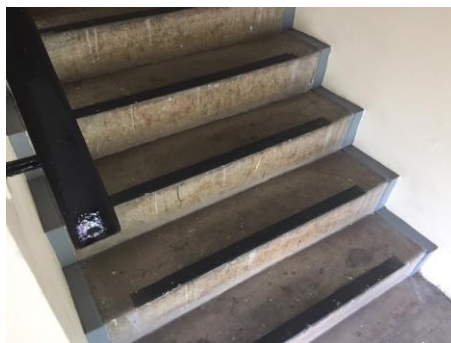
Resin nosing to edge of stairs.

The material was seen to be in fair condition at the time of the initial inspection.

The condition of the material should be managed by a competent person/company and its presence made aware to those at risk, as part of a Control of Asbestos Regulations (CAR) 2012 compliant management strategy.

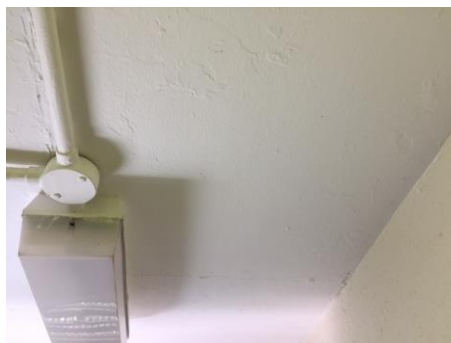
Spatter pattern textured coating. Visible only in certain areas. Possible previous poor removal works.

The material was seen to be in fair condition at the time of the initial inspection.

The condition of the material should be managed by a competent person/company and its presence made aware to those at risk, as part of a Control of Asbestos Regulations (CAR) 2012 compliant management strategy.

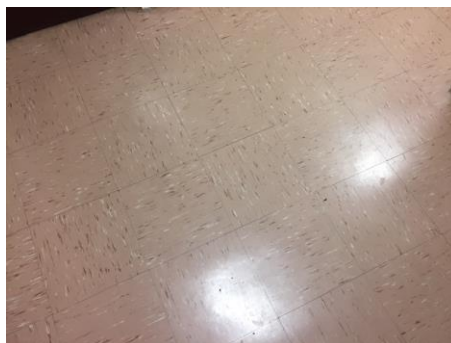
Pink floor tiles.

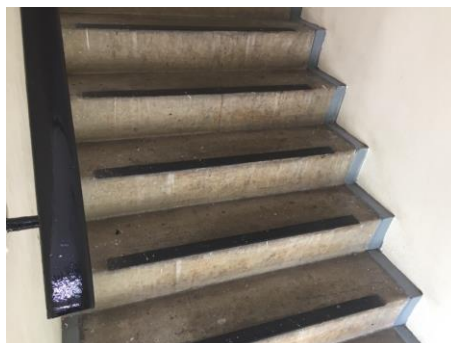
Resin nosing to edge of stairs.

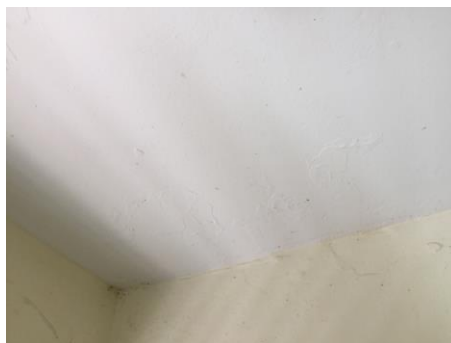
Spatter pattern textured coating. Visible only in certain areas. Possible previous poor removal works.

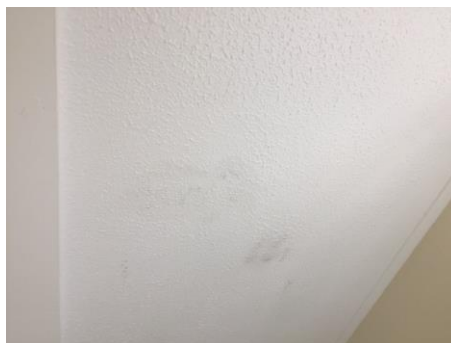
Spatter pattern textured coating.

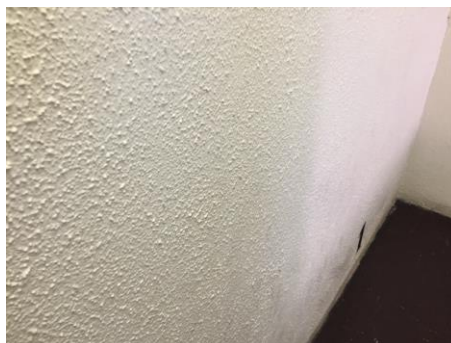
Spatter pattern textured coating behind more modern stipple pattern.

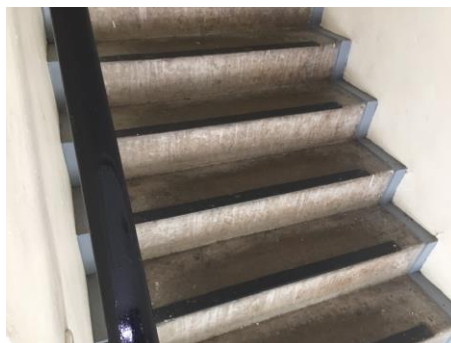
Resin nosing to edge of stairs.

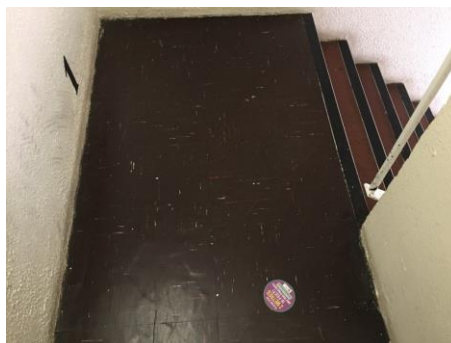
Bitumen adhesive beneath floor tiles.

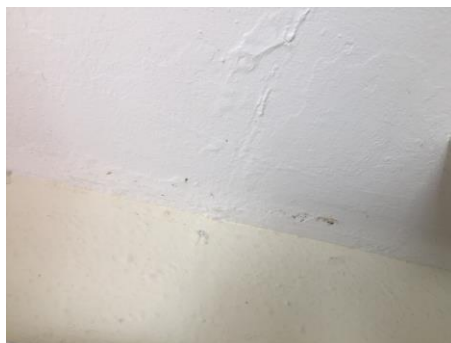
Spatter pattern textured coating. Visible only in certain areas. Possible previous poor removal works.

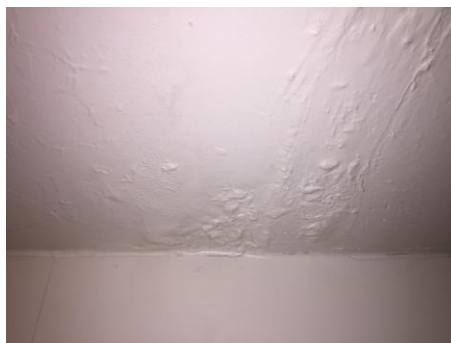
Spatter pattern textured coating. Visible only in certain areas. Possible previous poor removal works.

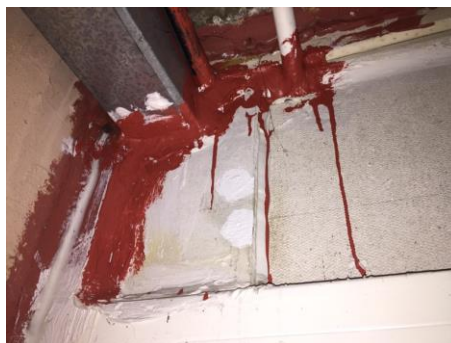
Insulating board panel fixed to modern Supalux transom panel.

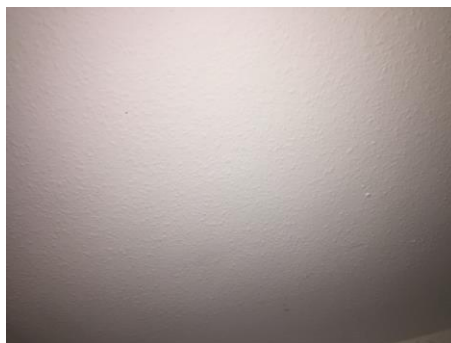
Spatter pattern textured coating.

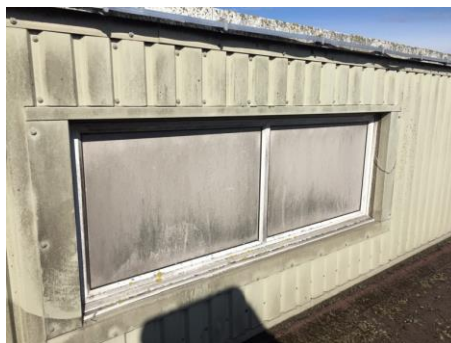
Insulating board infill panels to window frames at roof level.
