# **Solihull Community Housing**

## **Asbestos Management Survey Report**

**I - 53 (Communal) Somerville  
House  
Waterson Croft  
Solihull  
B37 6TY**

**Date of Report: 23 Jan 2013**  
**Survey Ref: 159910000A**

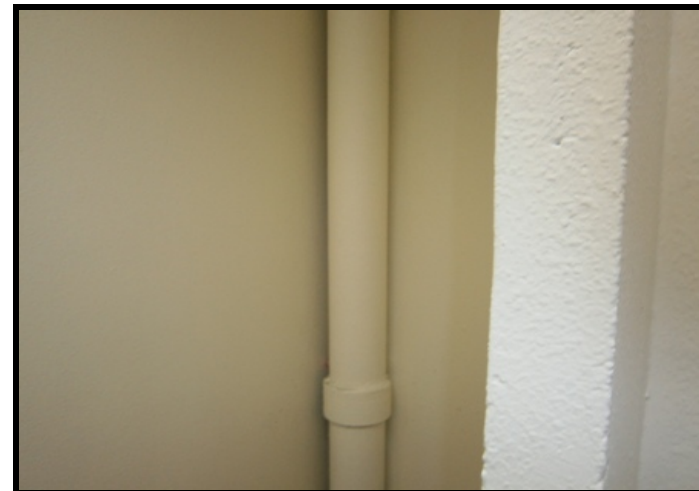
## SAMPLE REFERENCE 086

Asbestos Presumed in Sample

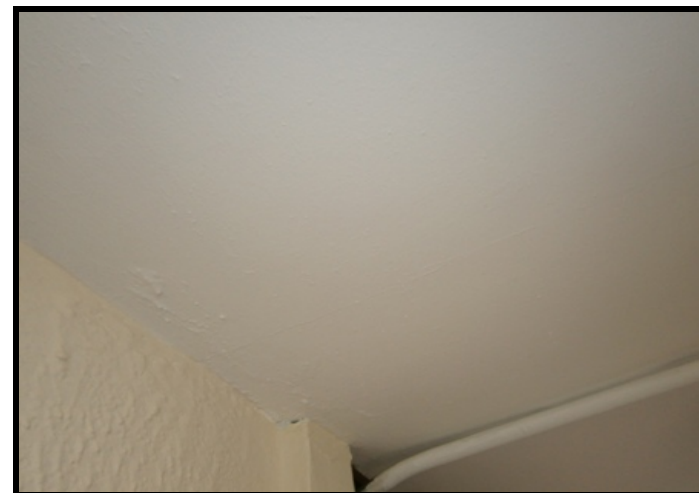
## SAMPLE REFERENCE 181

**Asbestos Presumed in Sample**

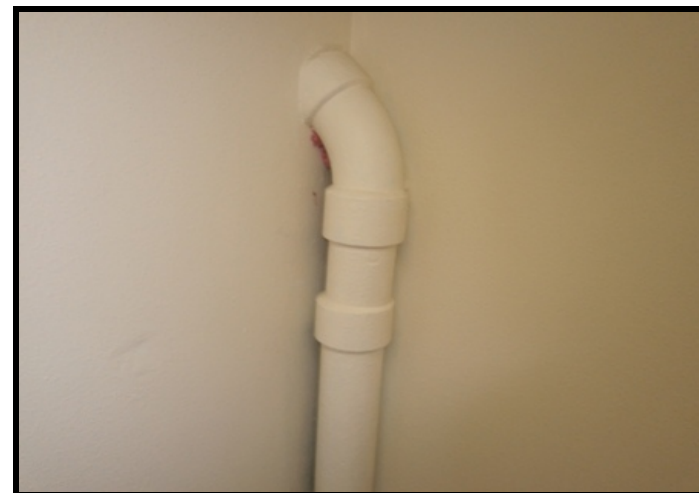
## SAMPLE REFERENCE 183

Asbestos Presumed in Sample

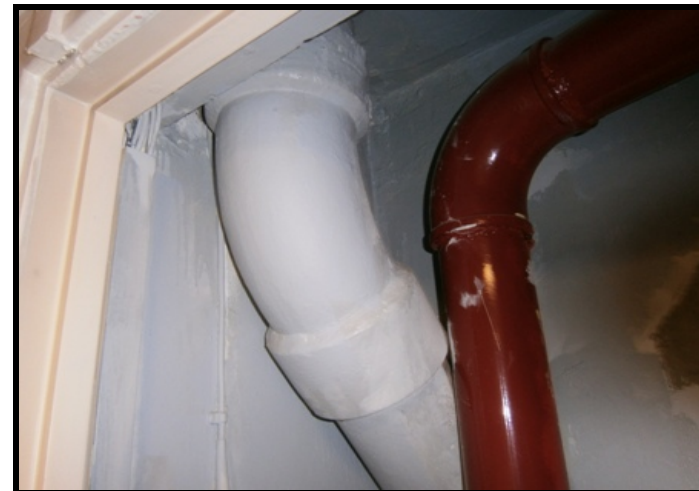
## SAMPLE REFERENCE 186

**Asbestos detected in Sample**

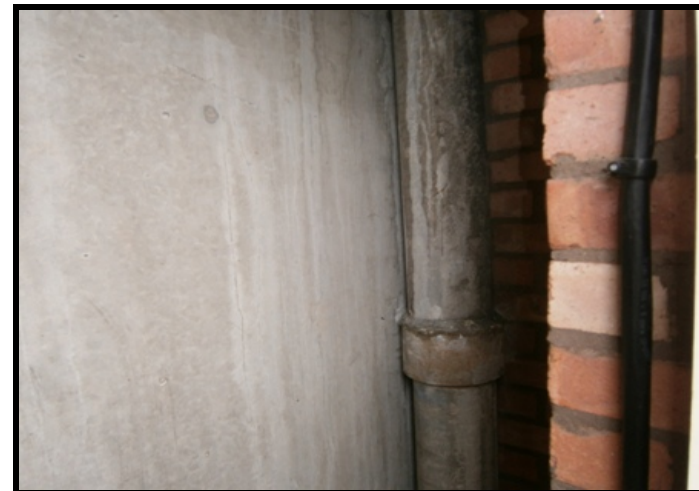
## SAMPLE REFERENCE 189

Asbestos Presumed in Sample

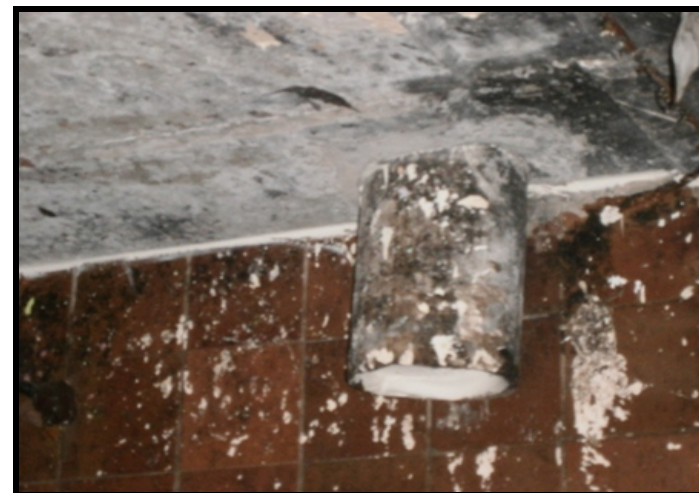
## SAMPLE REFERENCE 195

Asbestos Presumed in Sample
