Site ID: **a-301467** Management with Targeted Refurbishment Survey

Wedgewood House
Forth Drive
Chelmsley Wood
Solihull
B37 6PX
United Kingdom

15th April 2021

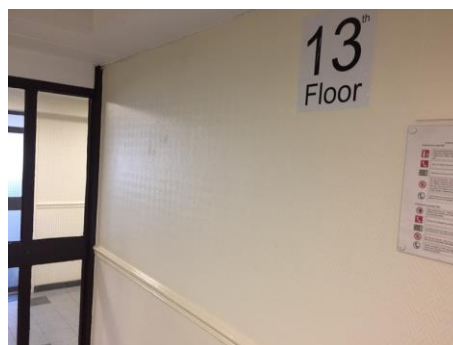
Spatter pattern textured coating behind wallpaper.

The material was seen to be in fair condition at the time of the initial inspection.

The condition of the material should be managed by a competent person/company and its presence made aware to those at risk, as part of a Control of Asbestos Regulations (CAR) 2012 compliant management strategy.

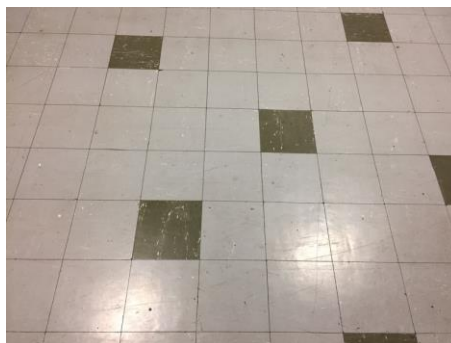
Green and grey floor tiles.

The material was seen to be in fair condition at the time of the initial inspection.

The condition of the material should be managed by a competent person/company and its presence made aware to those at risk, as part of a Control of Asbestos Regulations (CAR) 2012 compliant management strategy.

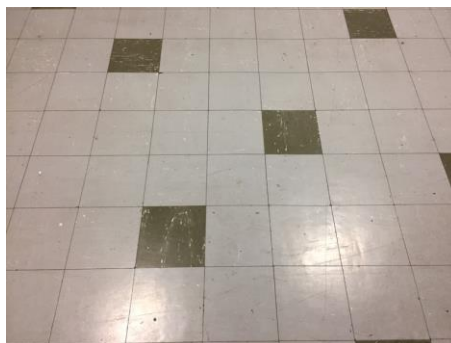
Bitumen adhesive beneath floor tiles.

The material was seen to be in fair condition at the time of the initial inspection.

The condition of the material should be managed by a competent person/company and its presence made aware to those at risk, as part of a Control of Asbestos Regulations (CAR) 2012 compliant management strategy.

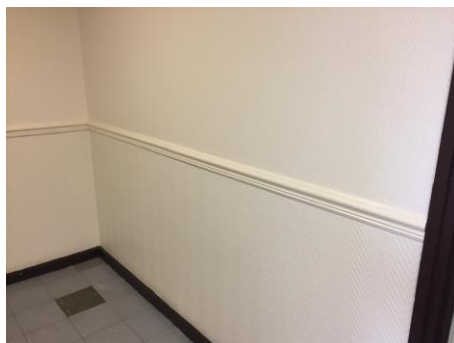
Spatter pattern textured coating behind wallpaper.

The material was seen to be in fair condition at the time of the initial inspection.

The condition of the material should be managed by a competent person/company and its presence made aware to those at risk, as part of a Control of Asbestos Regulations (CAR) 2012 compliant management strategy.

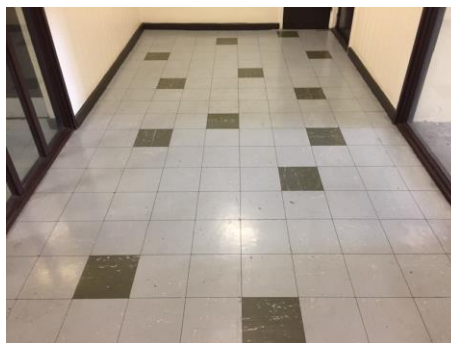
Green and grey floor tiles.

The material was seen to be in fair condition at the time of the initial inspection.

The condition of the material should be managed by a competent person/company and its presence made aware to those at risk, as part of a Control of Asbestos Regulations (CAR) 2012 compliant management strategy.

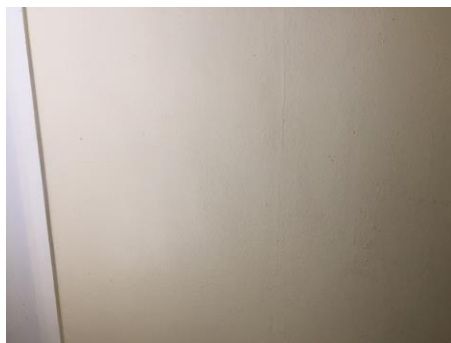
Spatter pattern textured coating.

The material was seen to be in fair condition at the time of the initial inspection.

The condition of the material should be managed by a competent person/company and its presence made aware to those at risk, as part of a Control of Asbestos Regulations (CAR) 2012 compliant management strategy.

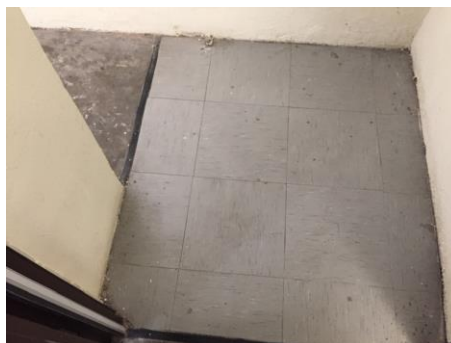
Grey floor tiles.

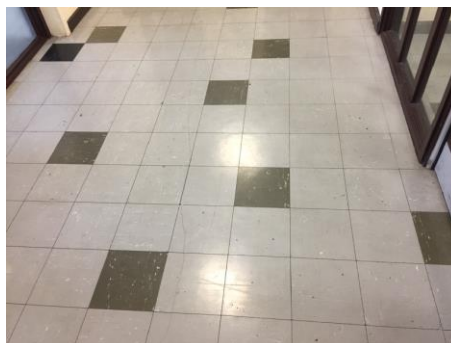
Green and grey floor tiles.

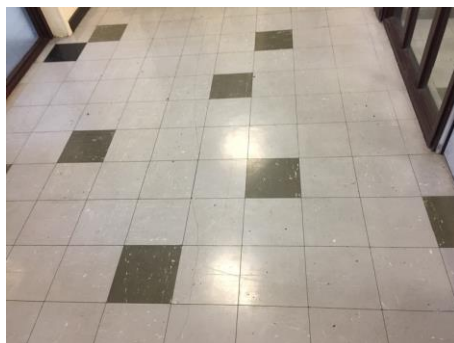
Bitumen adhesive beneath floor tiles.

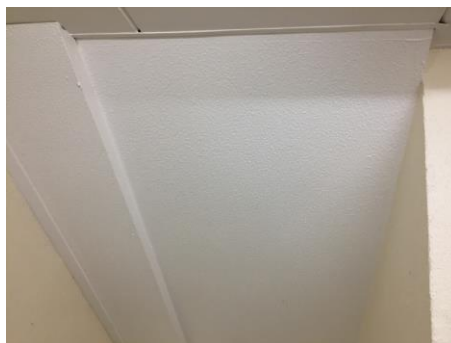
Stipple pattern textured coating.

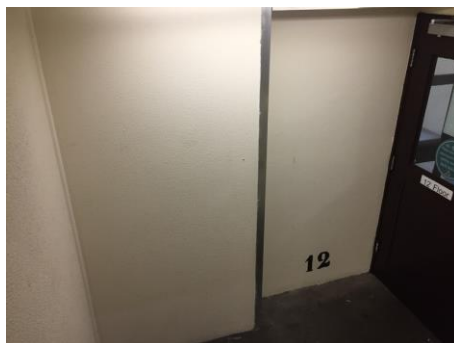
Insulating board sub main riser with texture coated timber cladding.

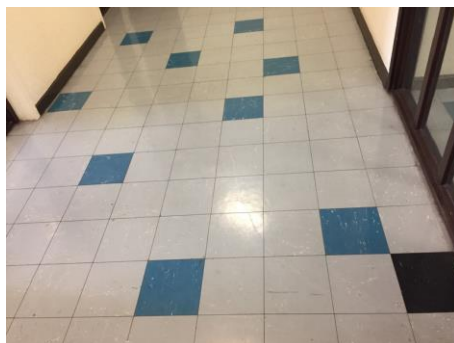
Blue and grey floor tiles.

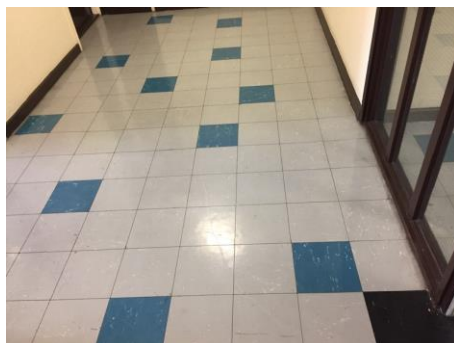
Bitumen adhesive beneath floor tiles.

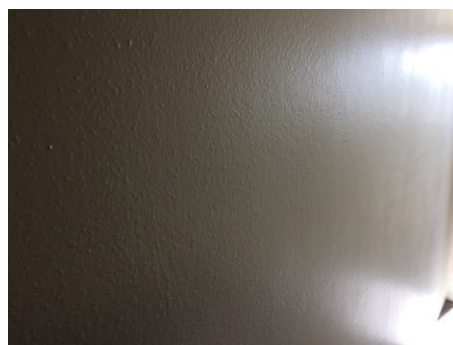
Spatter pattern textured coating.

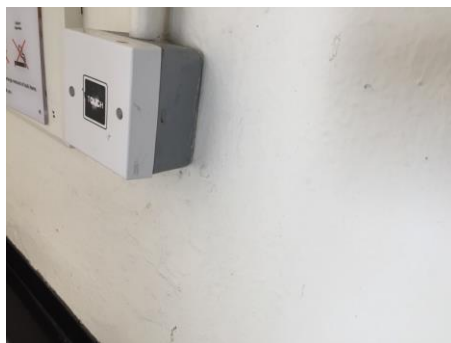
Spatter pattern textured coating.

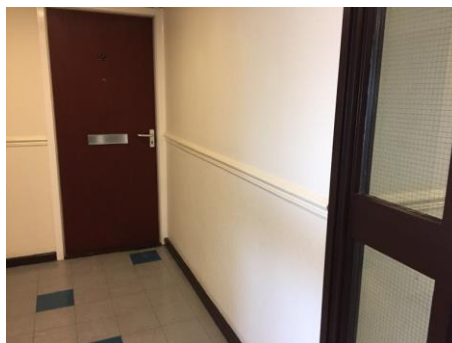
Spatter pattern textured coating behind wallpaper.

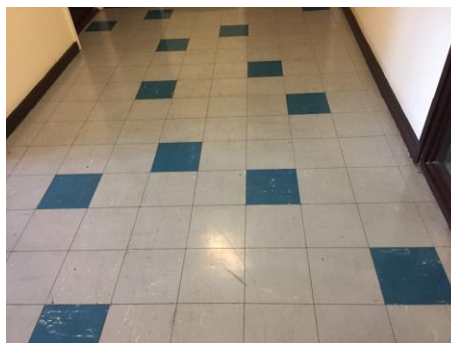
Blue and grey floor tiles.

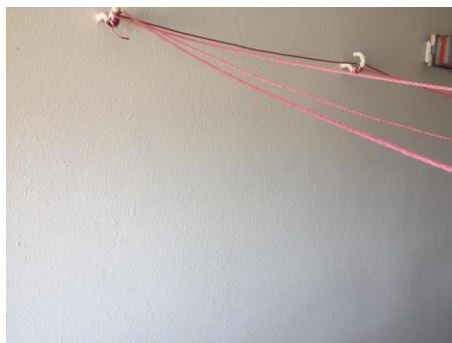
Spatter pattern textured coating.

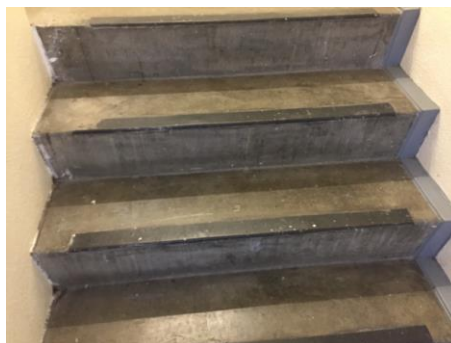
Resin nosing to edge of stairs.

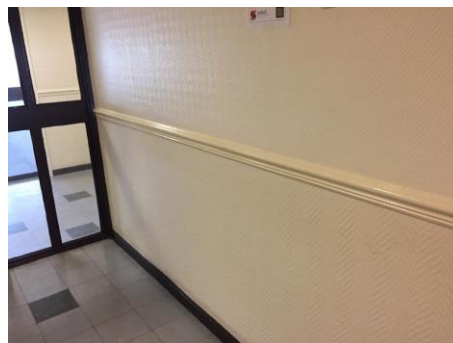
Spatter pattern textured coating behind wallpaper.

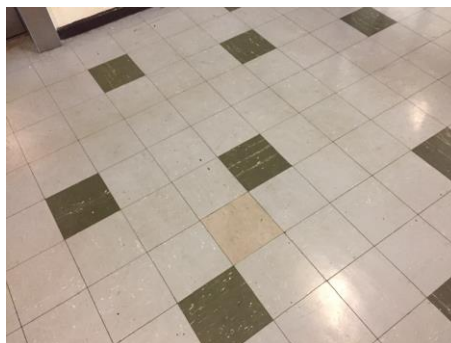
Green and grey floor tiles.

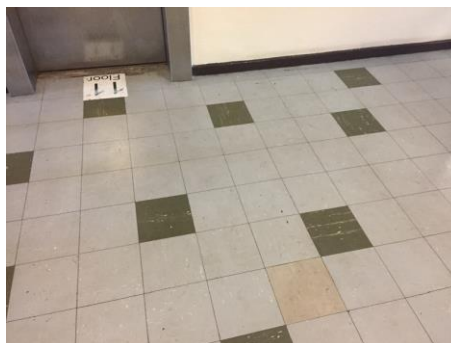
Bitumen adhesive beneath floor tiles.

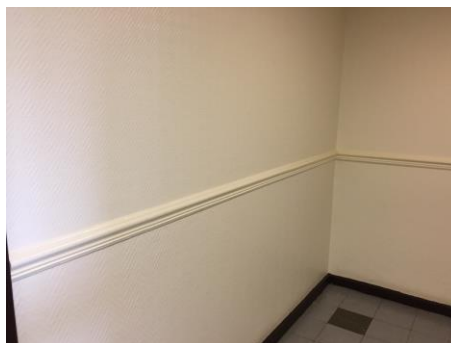
Spatter pattern textured coating behind wallpaper.

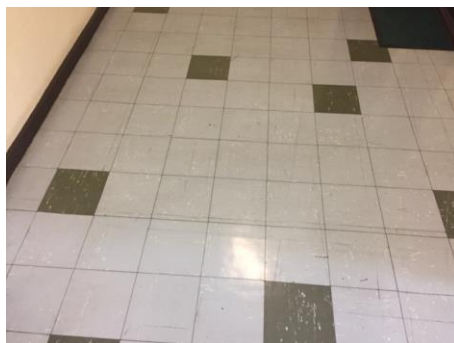
Bitumen adhesive beneath floor tiles.

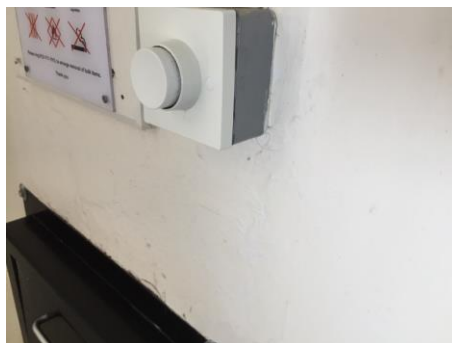
Spatter pattern textured coating.

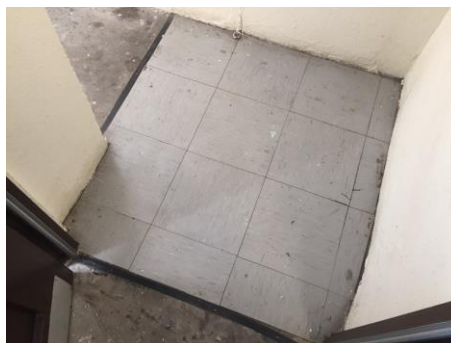
Grey floor tiles.

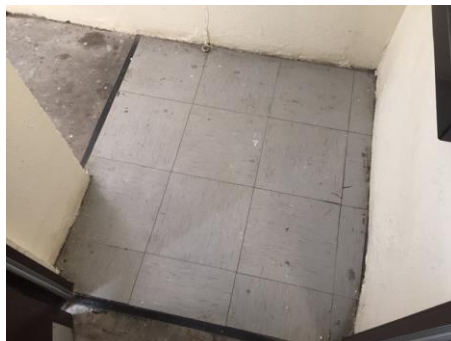
Bitumen adhesive beneath floor tiles.

The material was seen to be in fair condition at the time of the initial inspection.

The condition of the material should be managed by a competent person/company and its presence made aware to those at risk, as part of a Control of Asbestos Regulations (CAR) 2012 compliant management strategy.

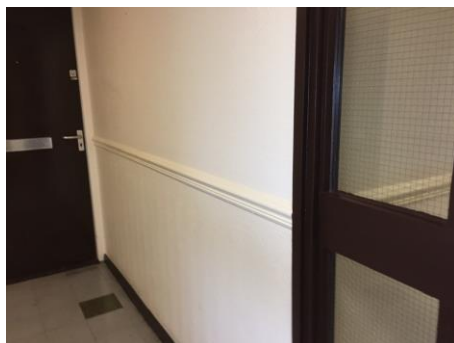
Spatter pattern textured coating behind wallpaper.

The material was seen to be in fair condition at the time of the initial inspection.

The condition of the material should be managed by a competent person/company and its presence made aware to those at risk, as part of a Control of Asbestos Regulations (CAR) 2012 compliant management strategy.

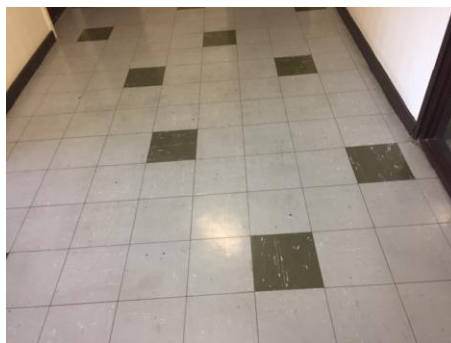
Green and grey floor tiles.

The material was seen to be in fair condition at the time of the initial inspection.

The condition of the material should be managed by a competent person/company and its presence made aware to those at risk, as part of a Control of Asbestos Regulations (CAR) 2012 compliant management strategy.

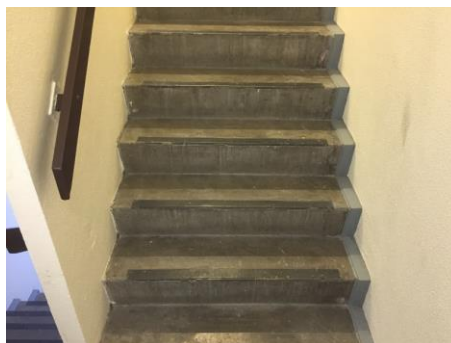
Resin nosing to edge of stairs.

The material was seen to be in fair condition at the time of the initial inspection.

The condition of the material should be managed by a competent person/company and its presence made aware to those at risk, as part of a Control of Asbestos Regulations (CAR) 2012 compliant management strategy.

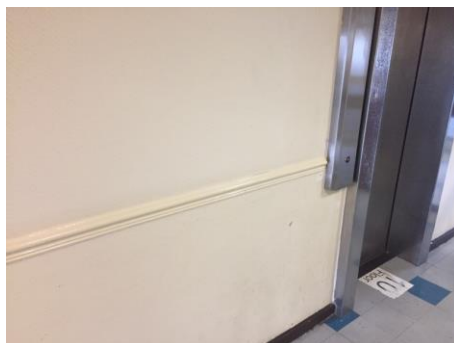
Spatter pattern textured coating behind wallpaper.

The material was seen to be in fair condition at the time of the initial inspection.

The condition of the material should be managed by a competent person/company and its presence made aware to those at risk, as part of a Control of Asbestos Regulations (CAR) 2012 compliant management strategy.

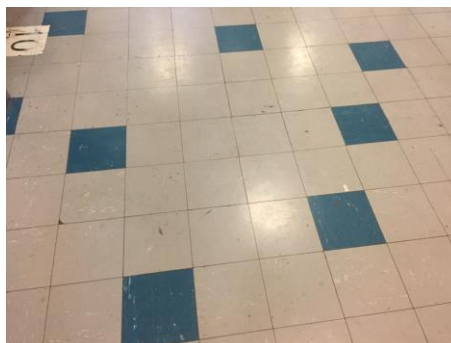
Blue and grey floor tiles.

The material was seen to be in fair condition at the time of the initial inspection.

The condition of the material should be managed by a competent person/company and its presence made aware to those at risk, as part of a Control of Asbestos Regulations (CAR) 2012 compliant management strategy.

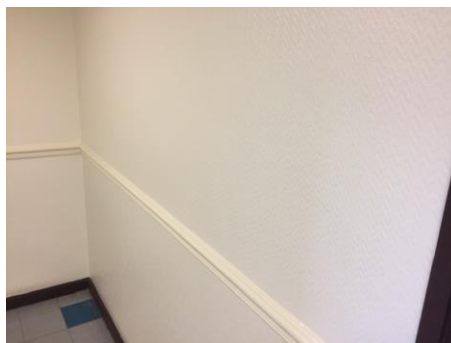
Spatter pattern textured coating behind wallpaper.

The material was seen to be in fair condition at the time of the initial inspection.

The condition of the material should be managed by a competent person/company and its presence made aware to those at risk, as part of a Control of Asbestos Regulations (CAR) 2012 compliant management strategy.

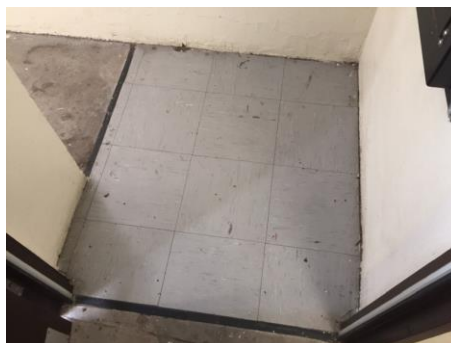
Grey floor tiles.

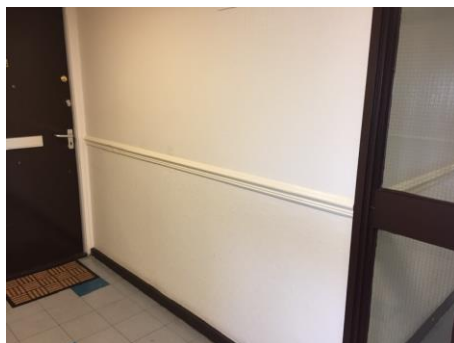
Spatter pattern textured coating behind wallpaper.

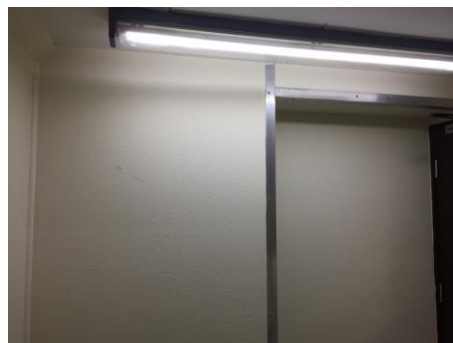
Insulating board sub main riser with texture coated timber cladding.

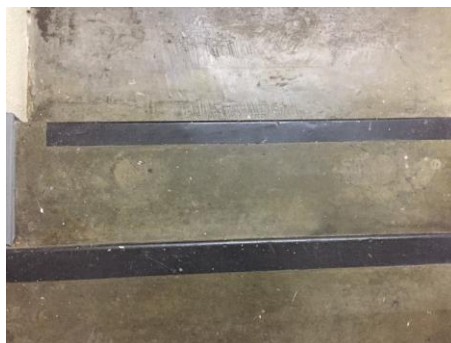
Resin nosing to edge of stairs.

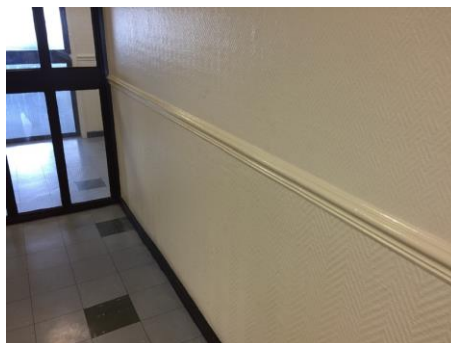
Spatter pattern textured coating behind wallpaper.

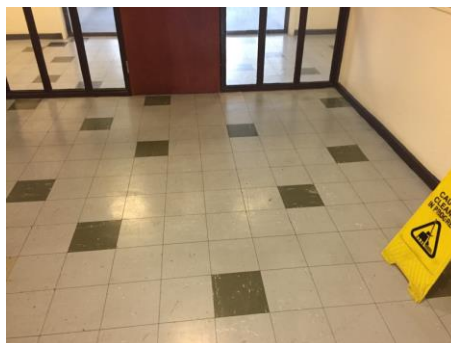
Bitumen adhesive beneath floor tiles.

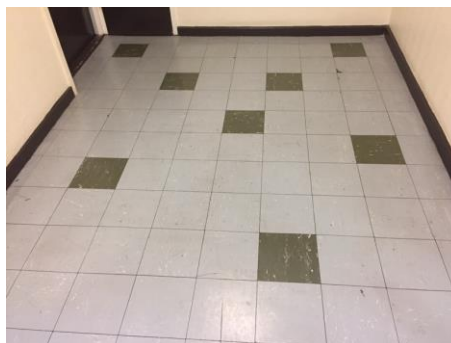
Green and grey floor tiles.

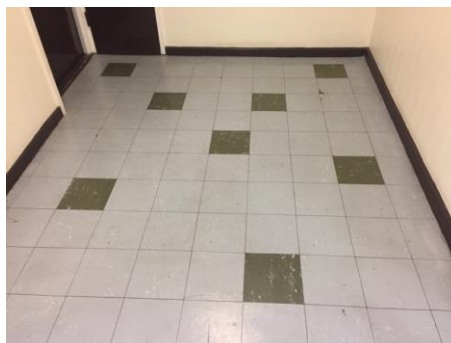
Bitumen adhesive beneath floor tiles.

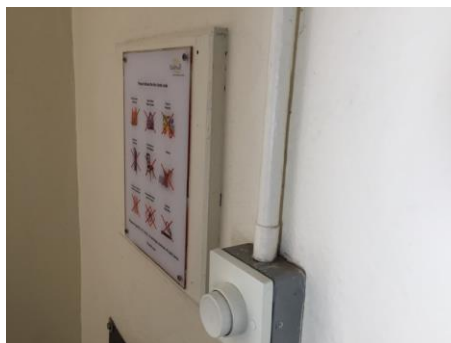
Spatter pattern textured coating.

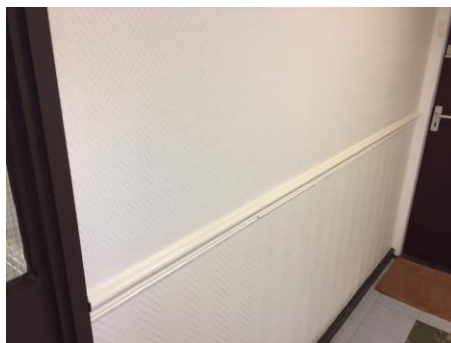
Spatter pattern textured coating behind wallpaper.

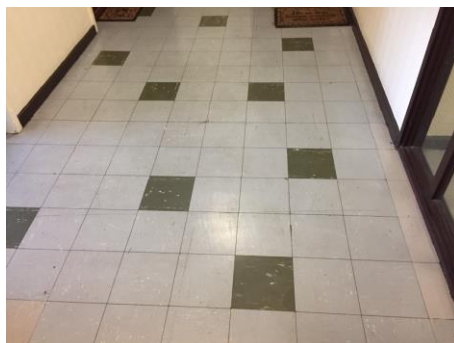
Green and grey floor tiles.

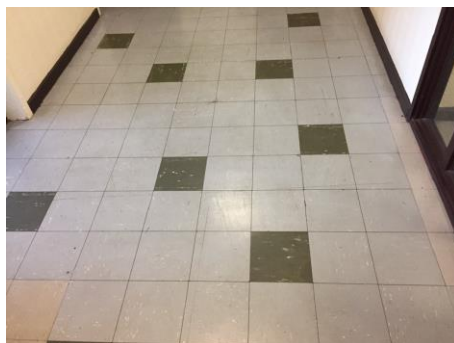
Bitumen adhesive beneath floor tiles.

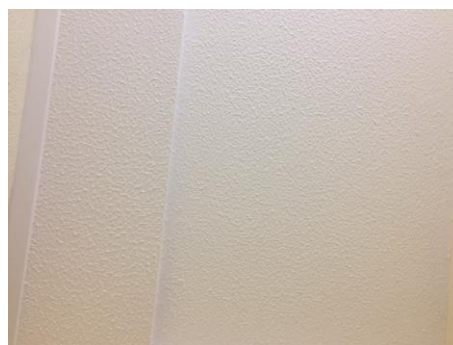
Stipple pattern textured coating.

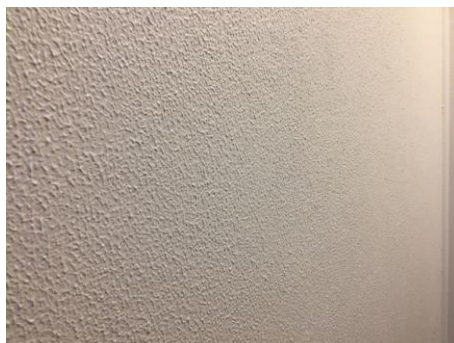
Stipple pattern textured coating.

The material was seen to be in fair condition at the time of the initial inspection.

The condition of the material should be managed by a competent person/company and its presence made aware to those at risk, as part of a Control of Asbestos Regulations (CAR) 2012 compliant management strategy.

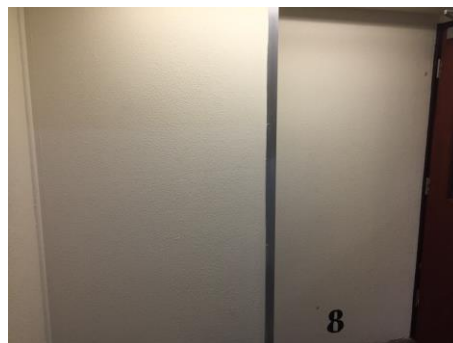
Insulating board sub main riser with texture coated timber cladding.

The material was seen to be in fair condition at the time of the initial inspection.

The condition of the material should be managed by a competent person/company and its presence made aware to those at risk, as part of a Control of Asbestos Regulations (CAR) 2012 compliant management strategy.

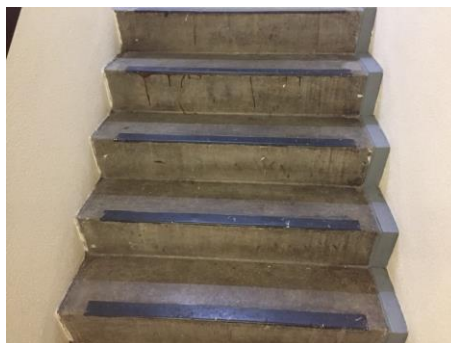
Resin nosing to edge of stairs.

The material was seen to be in fair condition at the time of the initial inspection.

The condition of the material should be managed by a competent person/company and its presence made aware to those at risk, as part of a Control of Asbestos Regulations (CAR) 2012 compliant management strategy.

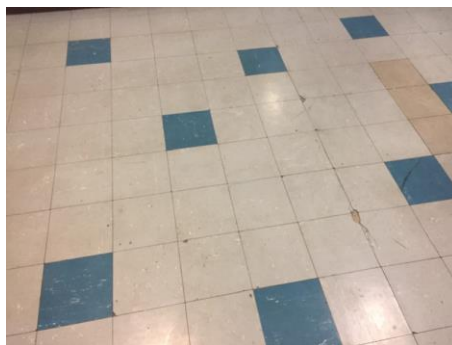
Bitumen adhesive beneath floor tiles.

The material was seen to be in fair condition at the time of the initial inspection.

The condition of the material should be managed by a competent person/company and its presence made aware to those at risk, as part of a Control of Asbestos Regulations (CAR) 2012 compliant management strategy.

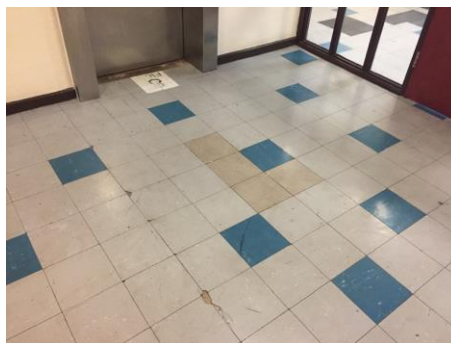
Grey floor tiles.

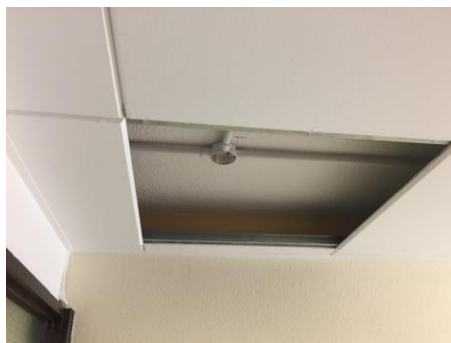
Bubble pattern textured coating above Supalux suspended ceiling.

The material was seen to be in fair condition at the time of the initial inspection.

The condition of the material should be managed by a competent person/company and its presence made aware to those at risk, as part of a Control of Asbestos Regulations (CAR) 2012 compliant management strategy.

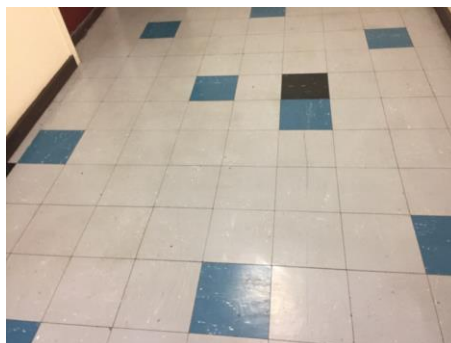
Blue and grey floor tiles.

The material was seen to be in fair condition at the time of the initial inspection.

The condition of the material should be managed by a competent person/company and its presence made aware to those at risk, as part of a Control of Asbestos Regulations (CAR) 2012 compliant management strategy.

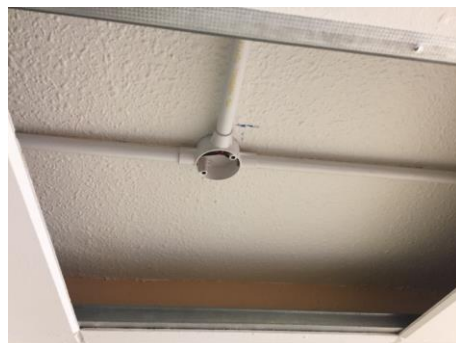
Bubble pattern textured coating above Supalux suspended ceiling.

The material was seen to be in fair condition at the time of the initial inspection.

The condition of the material should be managed by a competent person/company and its presence made aware to those at risk, as part of a Control of Asbestos Regulations (CAR) 2012 compliant management strategy.

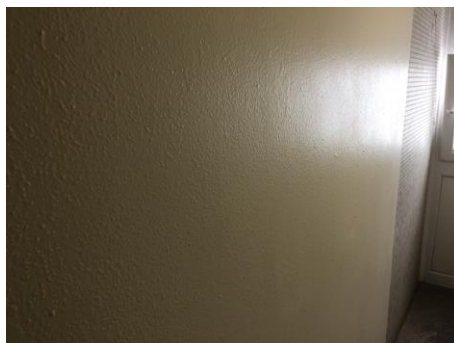
Spatter pattern textured coating.

The material was seen to be in fair condition at the time of the initial inspection.

The condition of the material should be managed by a competent person/company and its presence made aware to those at risk, as part of a Control of Asbestos Regulations (CAR) 2012 compliant management strategy.

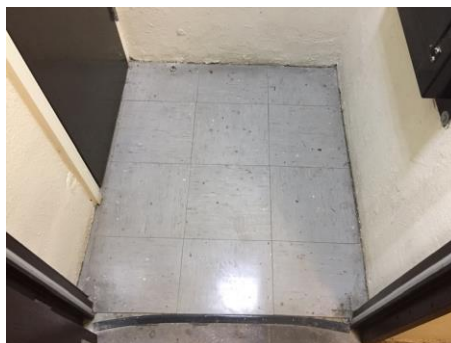
Grey floor tiles.

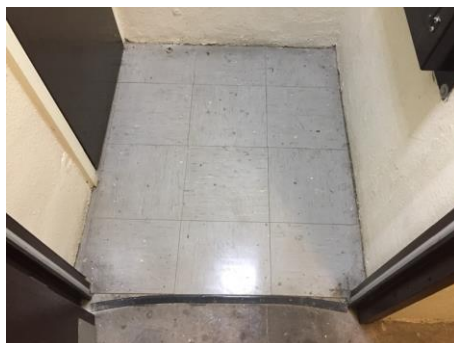
Bitumen adhesive beneath floor tiles.

The material was seen to be in fair condition at the time of the initial inspection.

The condition of the material should be managed by a competent person/company and its presence made aware to those at risk, as part of a Control of Asbestos Regulations (CAR) 2012 compliant management strategy.

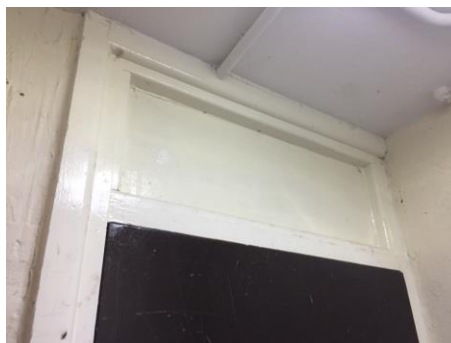
Supalux transom panel.

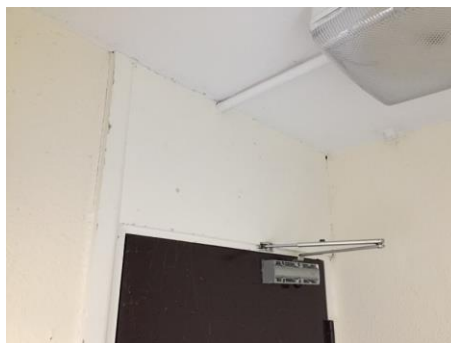
Supalux transom panel.

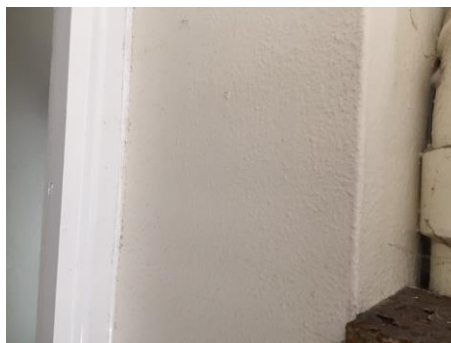
Spatter pattern textured coating.

The material was seen to be in fair condition at the time of the initial inspection.

The condition of the material should be managed by a competent person/company and its presence made aware to those at risk, as part of a Control of Asbestos Regulations (CAR) 2012 compliant management strategy.

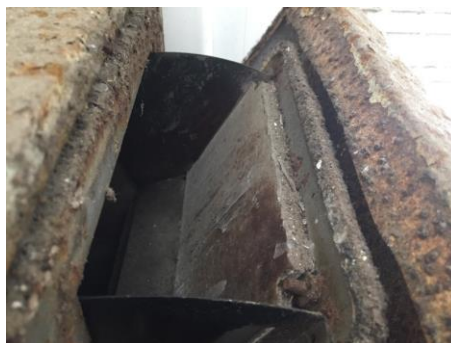
Cement lining to incinerator drawer.

The material was seen to be in fair condition at the time of the initial inspection.

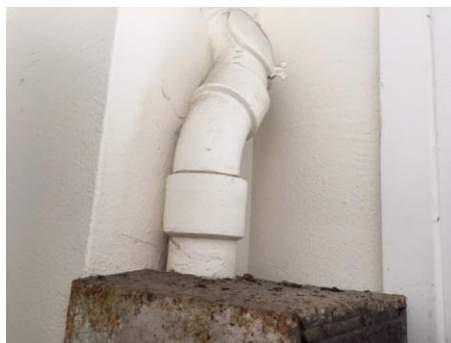
Cement flue to Bunnie Incinerator.

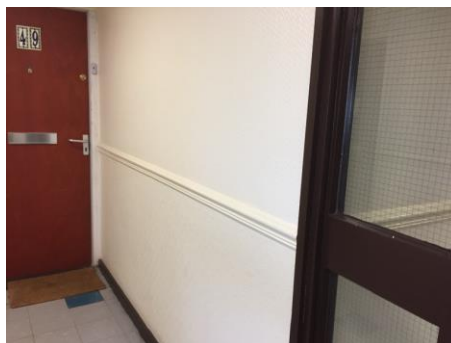
Spatter pattern textured coating behind wallpaper.

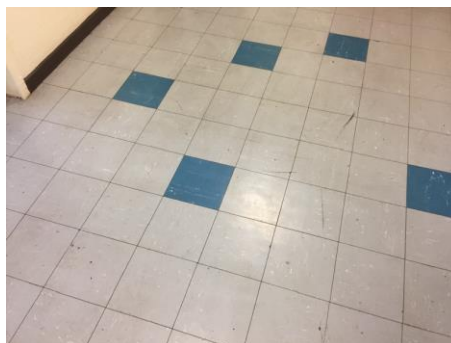
Blue and grey floor tiles.

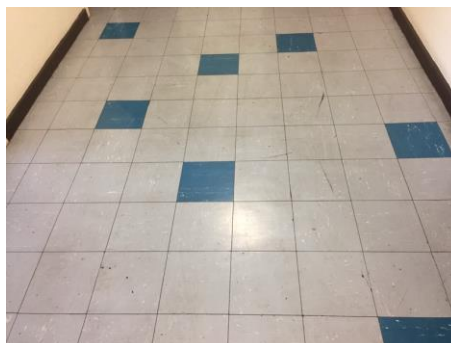
Bitumen adhesive beneath floor tiles.

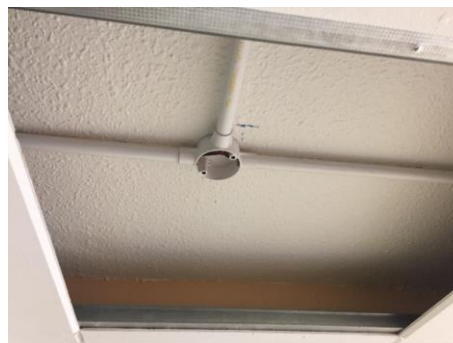
Bubble pattern textured coating above Supalux suspended ceiling.

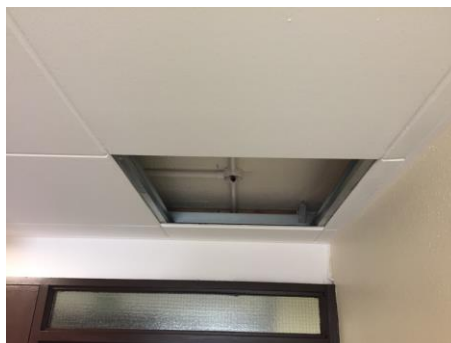
Bubble pattern textured coating.

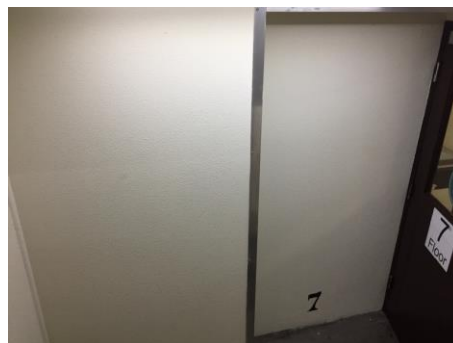
Insulating board sub main riser with texture coated timber cladding.

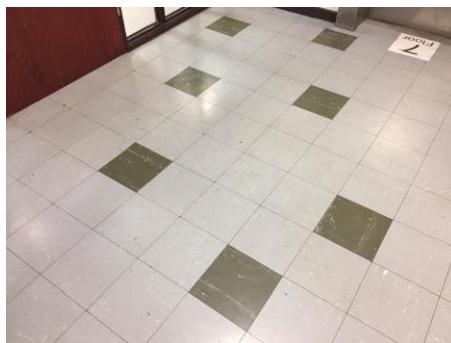
Green and grey floor tiles.

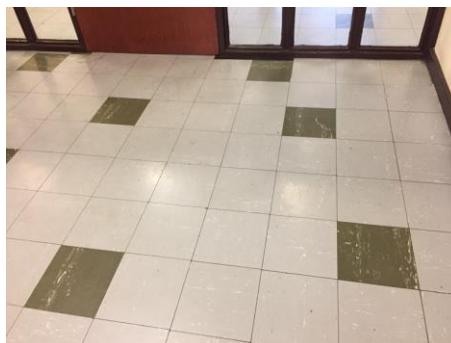
Bitumen adhesive beneath floor tiles.

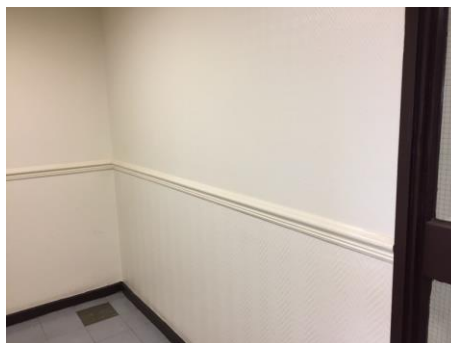
Spatter pattern textured coating behind wallpaper.

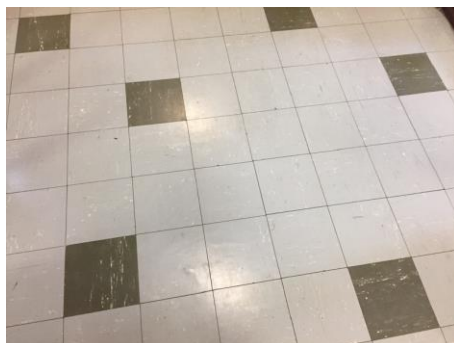
Green and grey floor tiles.

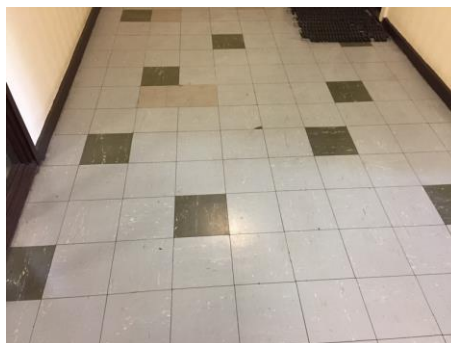
Bitumen adhesive beneath floor tiles.

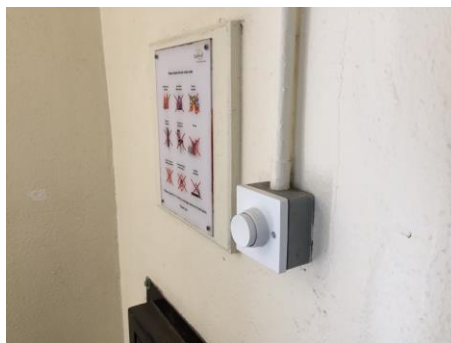
Spatter pattern textured coating.

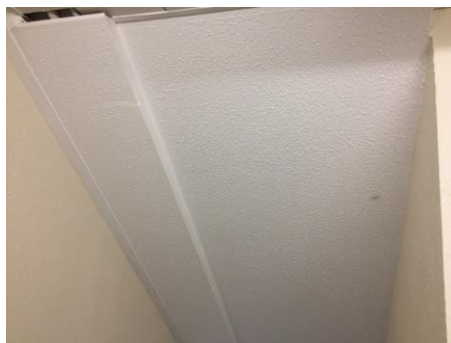
Stipple pattern textured coating.

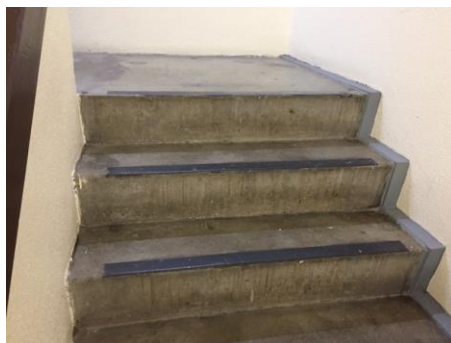
Resin nosing to edge of stairs.

The material was seen to be in fair condition at the time of the initial inspection.

The condition of the material should be managed by a competent person/company and its presence made aware to those at risk, as part of a Control of Asbestos Regulations (CAR) 2012 compliant management strategy.

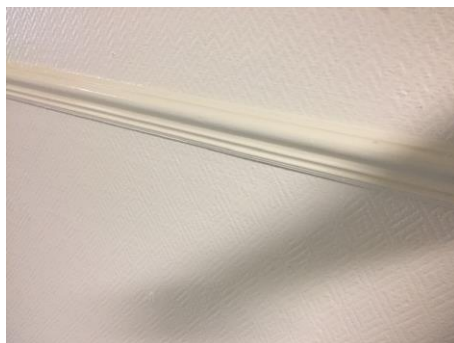
Spatter pattern textured coating behind wallpaper.

The material was seen to be in fair condition at the time of the initial inspection.

The condition of the material should be managed by a competent person/company and its presence made aware to those at risk, as part of a Control of Asbestos Regulations (CAR) 2012 compliant management strategy.

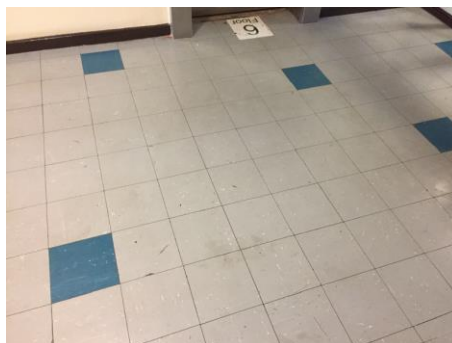
Blue and grey floor tiles.

The material was seen to be in fair condition at the time of the initial inspection.

The condition of the material should be managed by a competent person/company and its presence made aware to those at risk, as part of a Control of Asbestos Regulations (CAR) 2012 compliant management strategy.

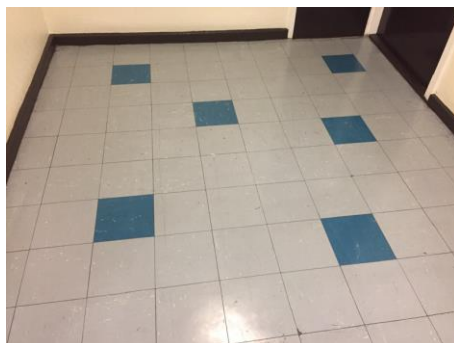
Bitumen adhesive beneath floor tiles.

The material was seen to be in fair condition at the time of the initial inspection.

The condition of the material should be managed by a competent person/company and its presence made aware to those at risk, as part of a Control of Asbestos Regulations (CAR) 2012 compliant management strategy.

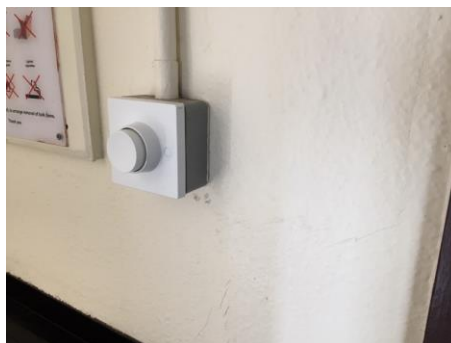
Spatter pattern textured coating.

The material was seen to be in fair condition at the time of the initial inspection.

The condition of the material should be managed by a competent person/company and its presence made aware to those at risk, as part of a Control of Asbestos Regulations (CAR) 2012 compliant management strategy.

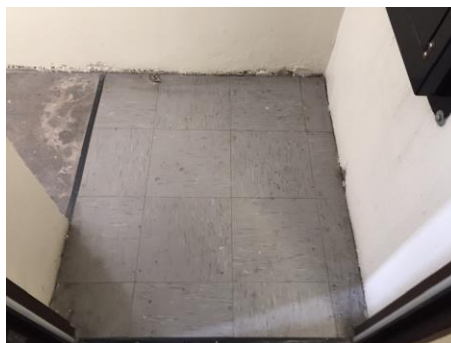
Grey floor tiles.

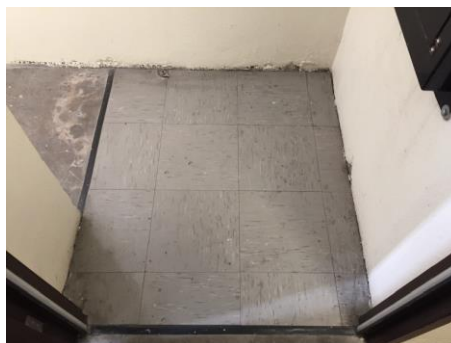
Bitumen adhesive beneath floor tiles.

The material was seen to be in fair condition at the time of the initial inspection.

The condition of the material should be managed by a competent person/company and its presence made aware to those at risk, as part of a Control of Asbestos Regulations (CAR) 2012 compliant management strategy.

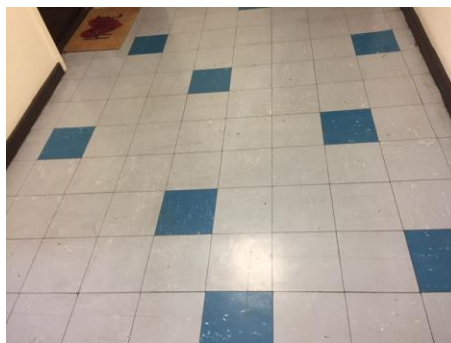
Bitumen adhesive beneath floor tiles.

The material was seen to be in fair condition at the time of the initial inspection.

The condition of the material should be managed by a competent person/company and its presence made aware to those at risk, as part of a Control of Asbestos Regulations (CAR) 2012 compliant management strategy.

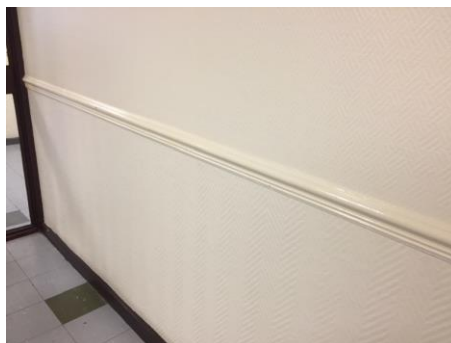
Spatter pattern textured coating behind wallpaper.

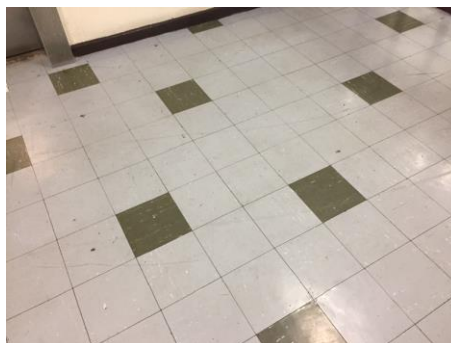
Green and grey floor tiles.

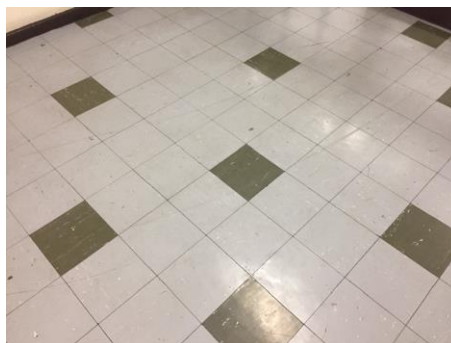
Bitumen adhesive beneath floor tiles.

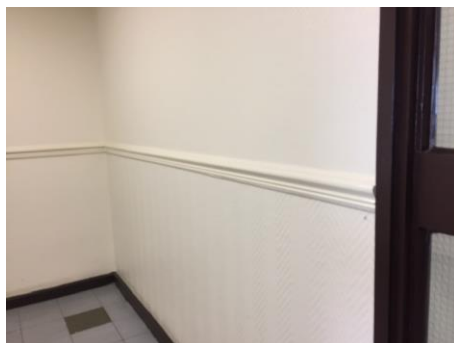
Spatter pattern textured coating behind wallpaper.

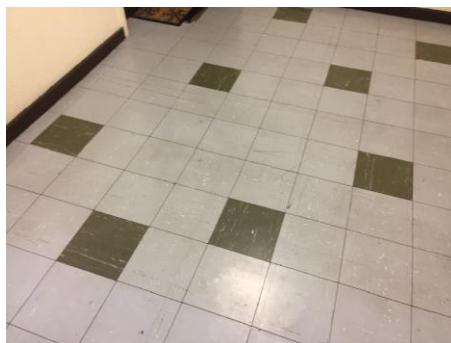
Green and grey floor tiles.

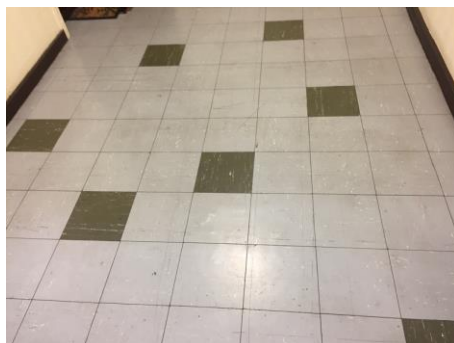
Bitumen adhesive beneath floor tiles.

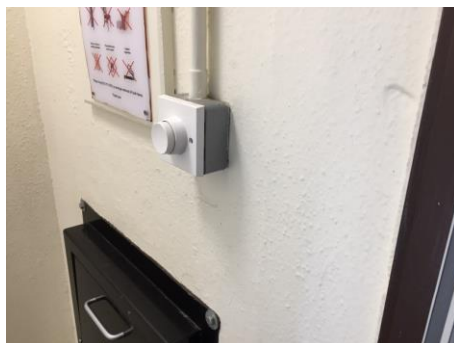
Spatter pattern textured coating.

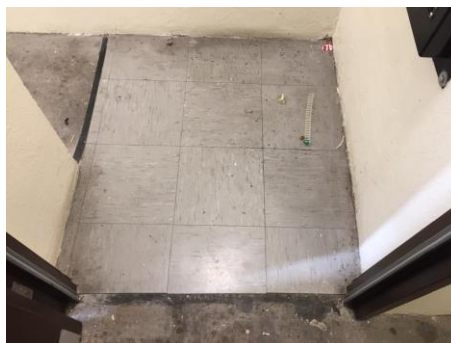
Grey floor tiles.

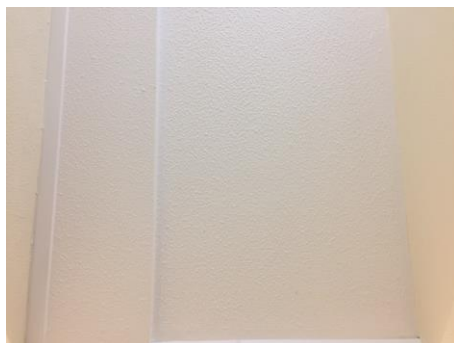
Stipple pattern textured coating.

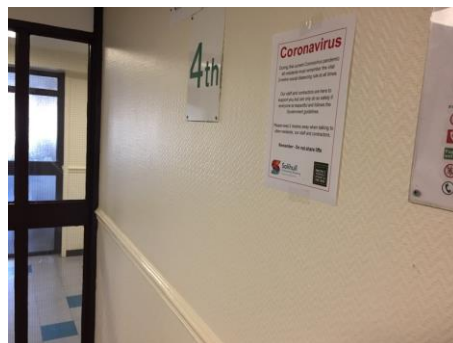
Spatter pattern textured coating behind wallpaper.

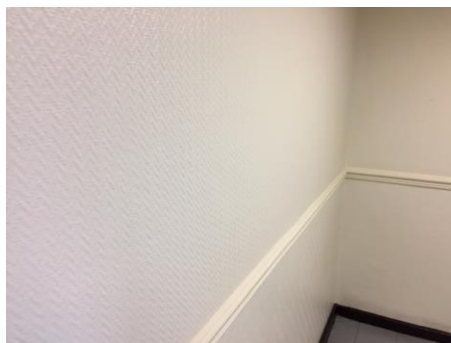
Spatter pattern textured coating behind wallpaper.

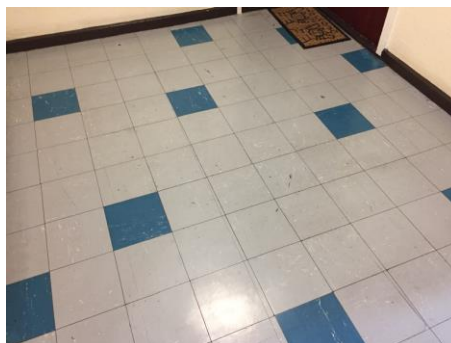
Blue and grey floor tiles.

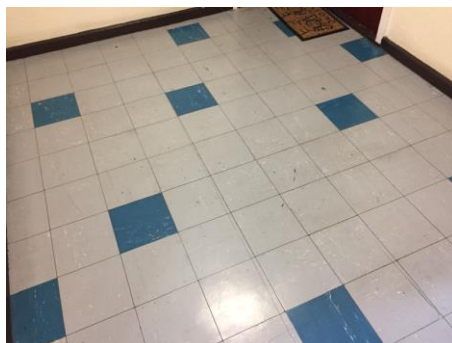
Bitumen adhesive beneath floor tiles.

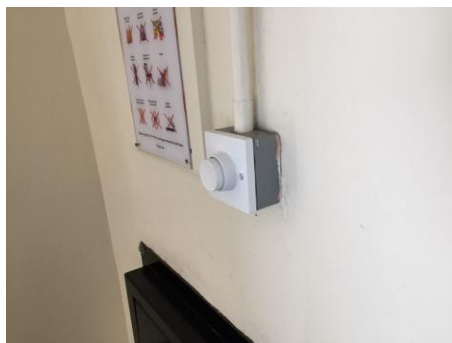
Spatter pattern textured coating.

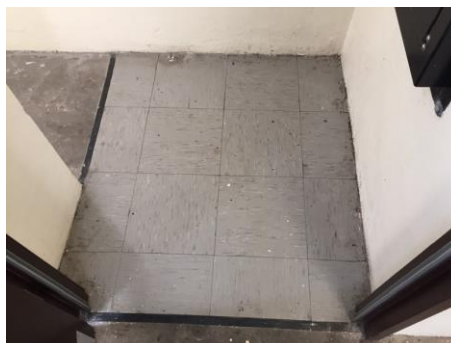
Grey floor tiles.

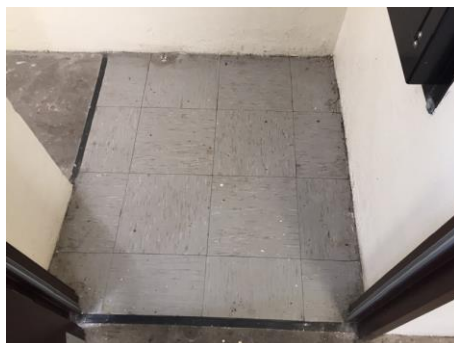
Bitumen adhesive beneath floor tiles.

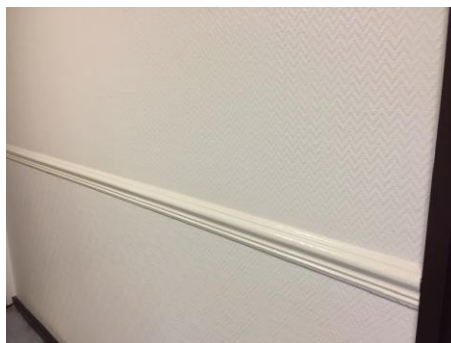
Spatter pattern textured coating behind wallpaper.

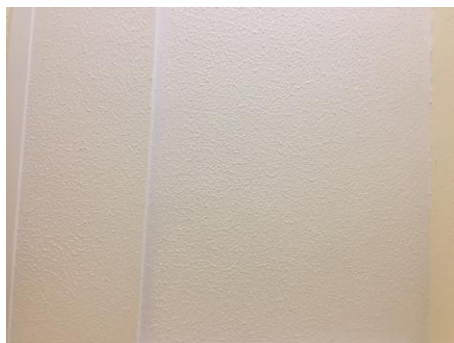
Stipple pattern textured coating.

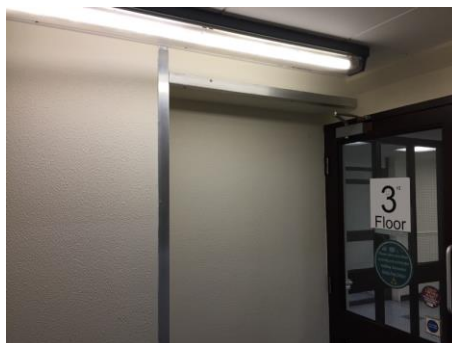
Insulating board sub main riser with texture coated timber cladding.

The material was seen to be in fair condition at the time of the initial inspection.

The condition of the material should be managed by a competent person/company and its presence made aware to those at risk, as part of a Control of Asbestos Regulations (CAR) 2012 compliant management strategy.

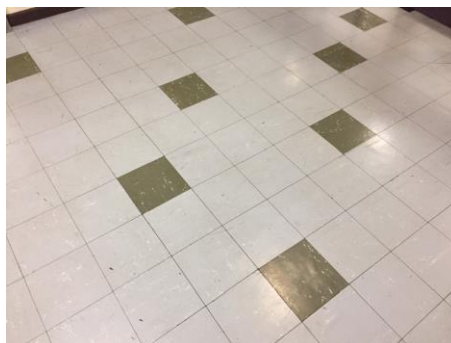
Green and grey floor tiles.

The material was seen to be in fair condition at the time of the initial inspection.

The condition of the material should be managed by a competent person/company and its presence made aware to those at risk, as part of a Control of Asbestos Regulations (CAR) 2012 compliant management strategy.

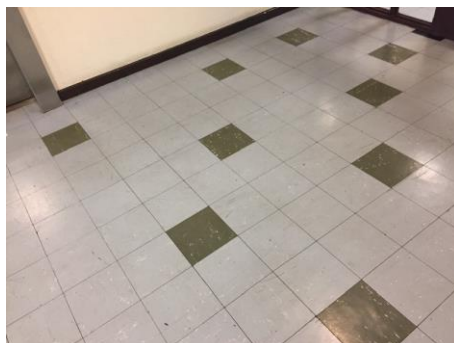
Bitumen adhesive beneath floor tiles.

The material was seen to be in fair condition at the time of the initial inspection.

The condition of the material should be managed by a competent person/company and its presence made aware to those at risk, as part of a Control of Asbestos Regulations (CAR) 2012 compliant management strategy.

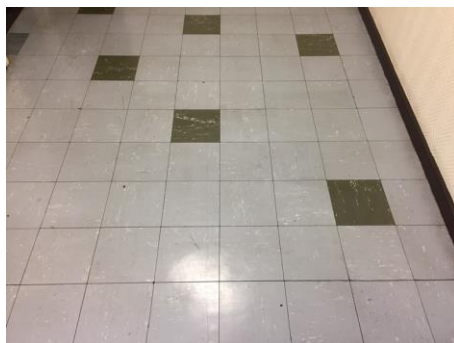
Green and grey floor tiles.

The material was seen to be in fair condition at the time of the initial inspection.

The condition of the material should be managed by a competent person/company and its presence made aware to those at risk, as part of a Control of Asbestos Regulations (CAR) 2012 compliant management strategy.

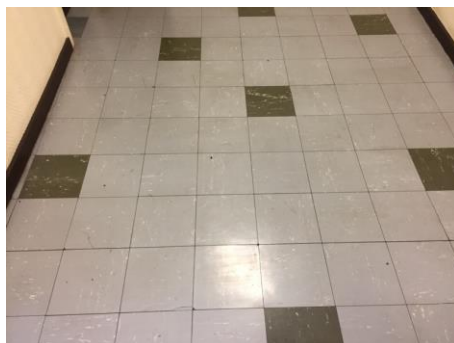
Bitumen adhesive beneath floor tiles.

The material was seen to be in fair condition at the time of the initial inspection.

The condition of the material should be managed by a competent person/company and its presence made aware to those at risk, as part of a Control of Asbestos Regulations (CAR) 2012 compliant management strategy.

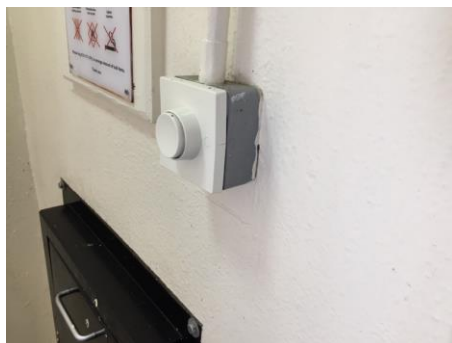
Spatter pattern textured coating.

The material was seen to be in fair condition at the time of the initial inspection.

The condition of the material should be managed by a competent person/company and its presence made aware to those at risk, as part of a Control of Asbestos Regulations (CAR) 2012 compliant management strategy.

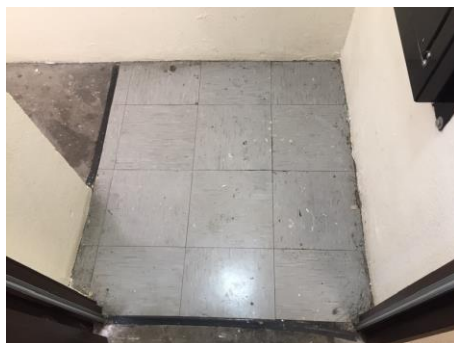
Grey floor tiles.

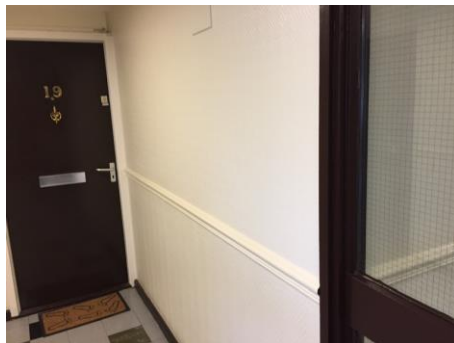
Spatter pattern textured coating behind wallpaper.

The material was seen to be in fair condition at the time of the initial inspection.

The condition of the material should be managed by a competent person/company and its presence made aware to those at risk, as part of a Control of Asbestos Regulations (CAR) 2012 compliant management strategy.

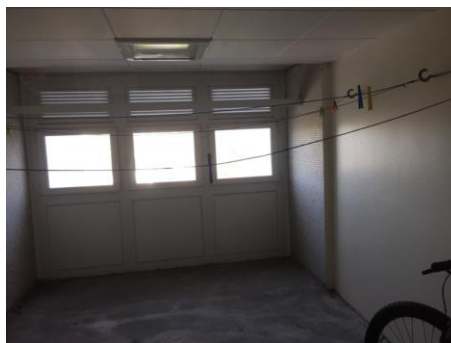
Spatter pattern textured coating.

The material was seen to be in fair condition at the time of the initial inspection.

The condition of the material should be managed by a competent person/company and its presence made aware to those at risk, as part of a Control of Asbestos Regulations (CAR) 2012 compliant management strategy.

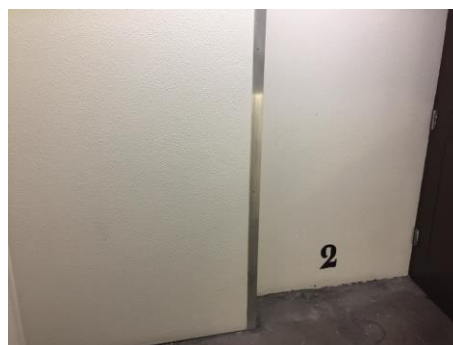
Insulating board sub main riser with texture coated timber cladding.

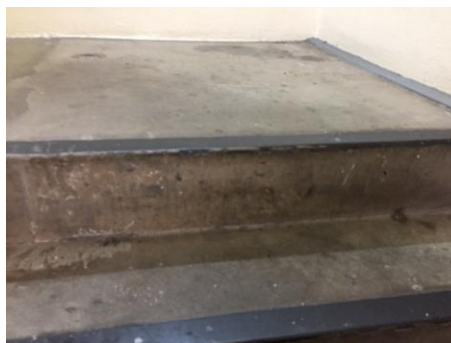
Resin nosing to edge of stairs.

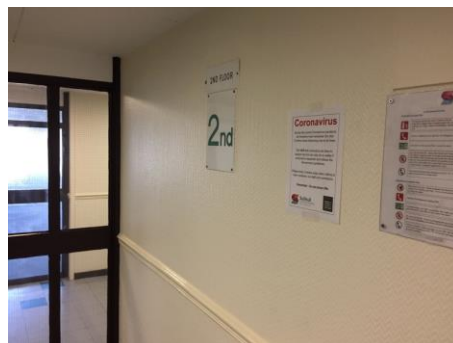
Spatter pattern textured coating behind wallpaper.

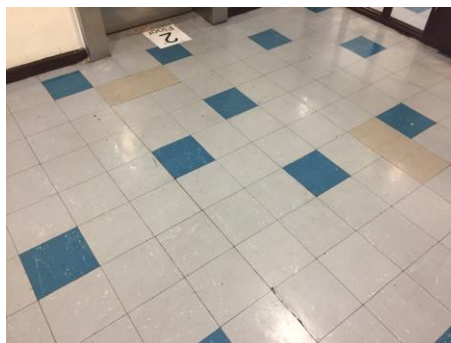
Bitumen adhesive beneath floor tiles.

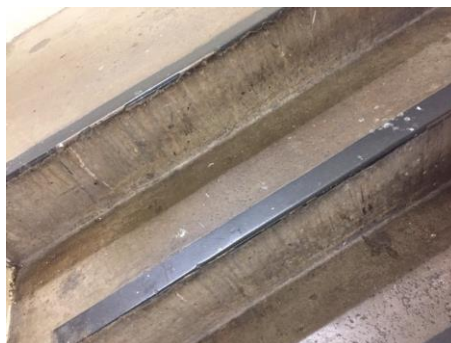
Resin nosing to edge of stairs.

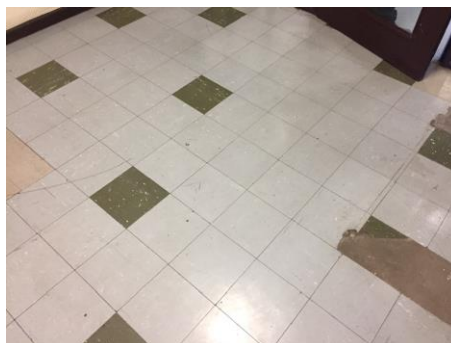
Green and grey floor tiles.

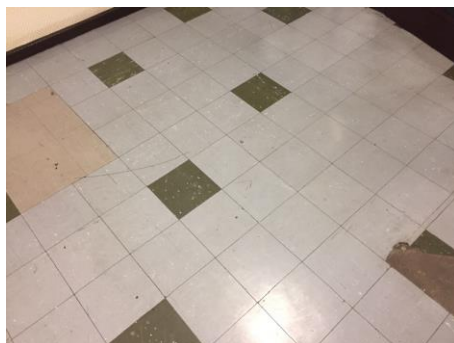
Bitumen adhesive beneath floor tiles.

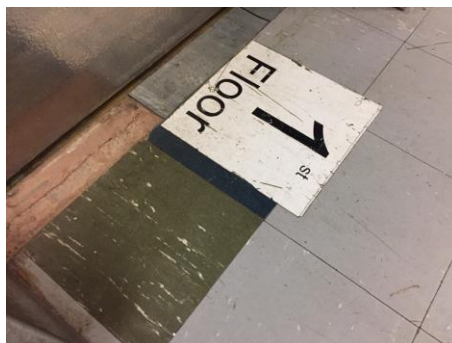
Blue floor tile.
