Site ID: **a-301467** Management with Targeted Refurbishment Survey

Wedgewood House
Forth Drive
Chelmsley Wood
Solihull
B37 6PX
United Kingdom

15th April 2021

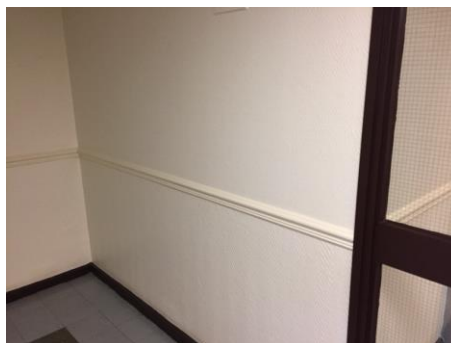
Spatter pattern textured coating behind wallpaper.

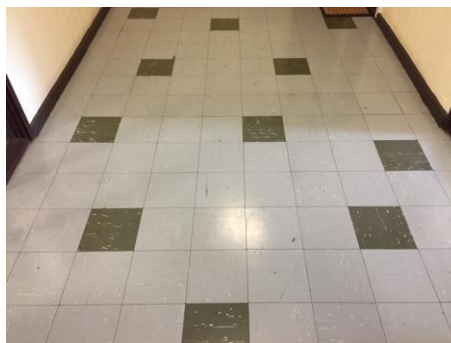
Green and grey floor tiles.

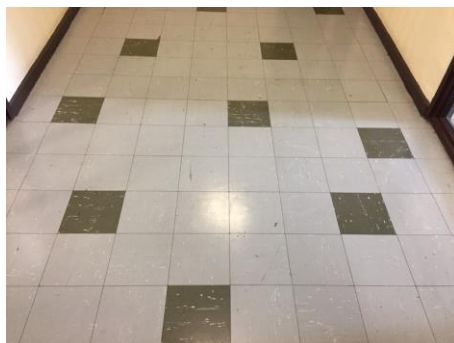
Bitumen adhesive beneath floor tiles.

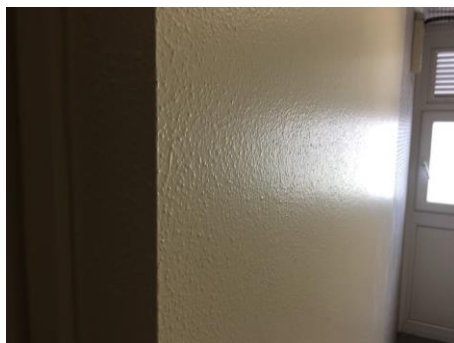
Spatter pattern textured coating.

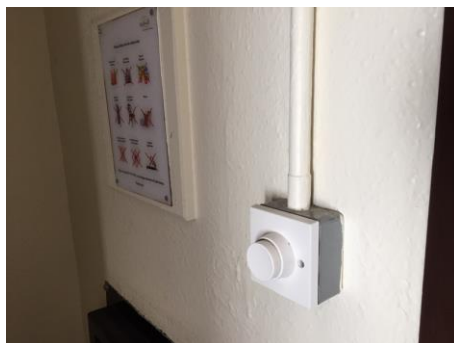
Spatter pattern textured coating.

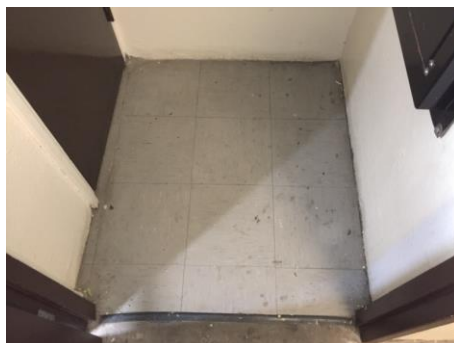
Grey floor tiles.

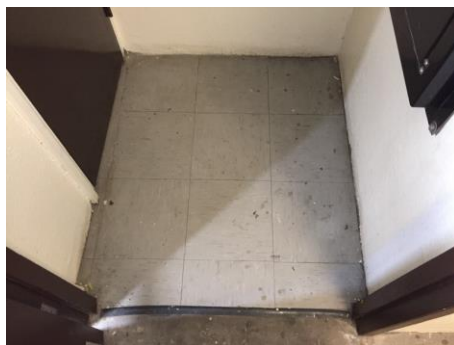
Bitumen adhesive beneath floor tiles.

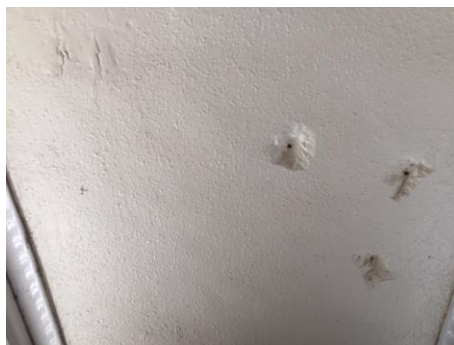
Spatter pattern textured coating.

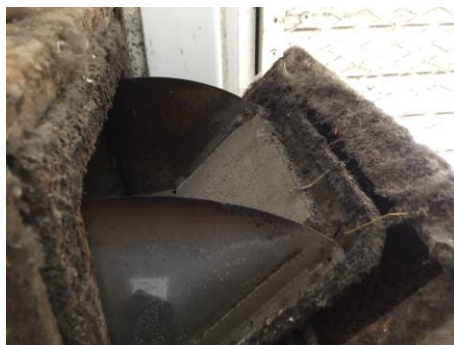
Cement lining to incinerator drawer.

The material was seen to be in fair condition at the time of the initial inspection.

The condition of the material should be managed by a competent person/company and its presence made aware to those at risk, as part of a Control of Asbestos Regulations (CAR) 2012 compliant management strategy.

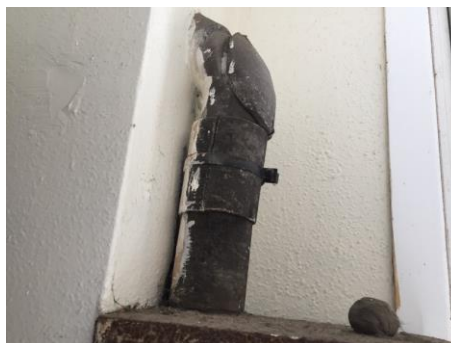
Cement flue to Bunnie Incinerator.

The material was seen to be in fair condition at the time of the initial inspection.

The condition of the material should be managed by a competent person/company and its presence made aware to those at risk, as part of a Control of Asbestos Regulations (CAR) 2012 compliant management strategy.

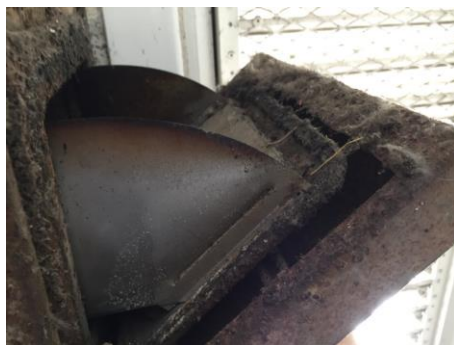
Rope seal to drawer.

The material was seen to be in fair condition at the time of the initial inspection.

The condition of the material should be managed by a competent person/company and its presence made aware to those at risk, as part of a Control of Asbestos Regulations (CAR) 2012 compliant management strategy.

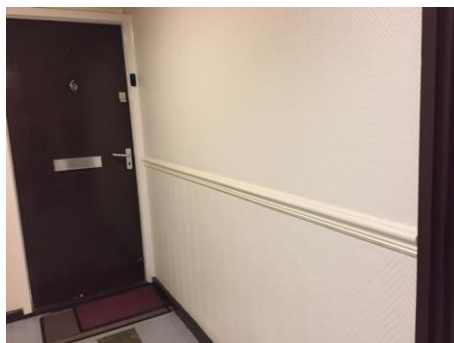
Spatter pattern textured coating behind wallpaper.

The material was seen to be in fair condition at the time of the initial inspection.

The condition of the material should be managed by a competent person/company and its presence made aware to those at risk, as part of a Control of Asbestos Regulations (CAR) 2012 compliant management strategy.

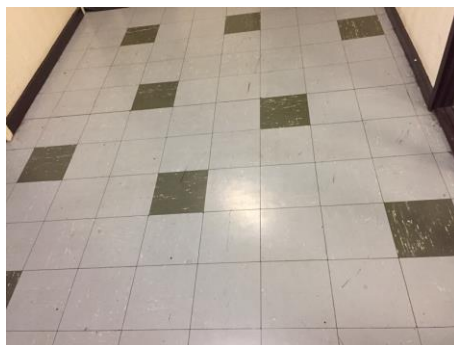
Green and grey floor tiles.

The material was seen to be in fair condition at the time of the initial inspection.

The condition of the material should be managed by a competent person/company and its presence made aware to those at risk, as part of a Control of Asbestos Regulations (CAR) 2012 compliant management strategy.

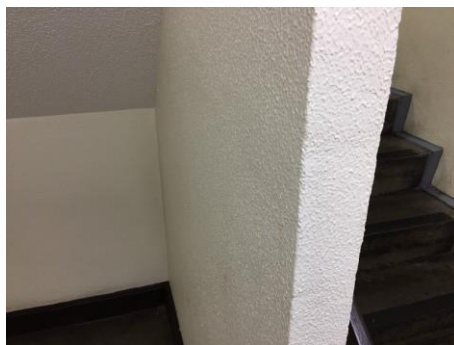
Stipple pattern textured coating.

The material was seen to be in fair condition at the time of the initial inspection.

The condition of the material should be managed by a competent person/company and its presence made aware to those at risk, as part of a Control of Asbestos Regulations (CAR) 2012 compliant management strategy.

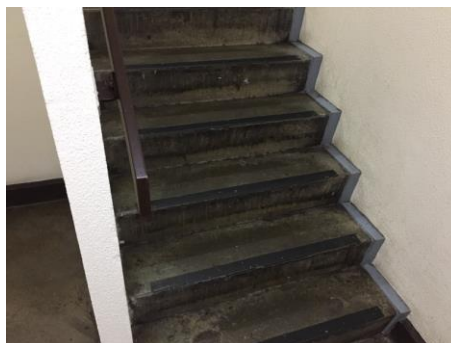
Resin nosing to edge of stairs.

The material was seen to be in fair condition at the time of the initial inspection.

The condition of the material should be managed by a competent person/company and its presence made aware to those at risk, as part of a Control of Asbestos Regulations (CAR) 2012 compliant management strategy.

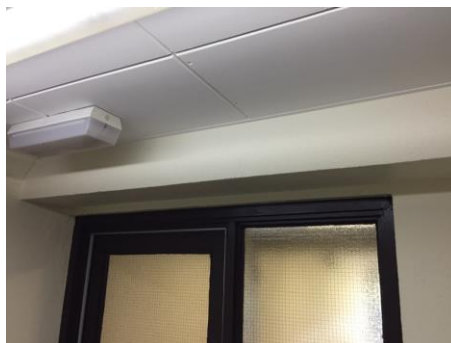
Cement boxing with textured coating above door.

The material was seen to be in fair condition at the time of the initial inspection.

The condition of the material should be managed by a competent person/company and its presence made aware to those at risk, as part of a Control of Asbestos Regulations (CAR) 2012 compliant management strategy.

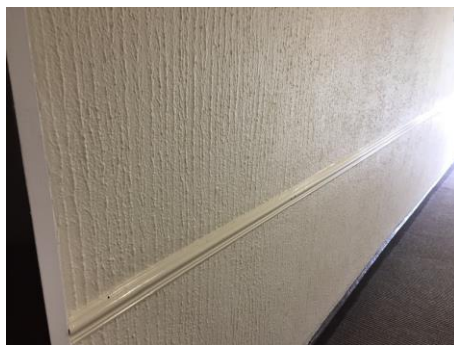
Lined stipple pattern.

The material was seen to be in fair condition at the time of the initial inspection.

The condition of the material should be managed by a competent person/company and its presence made aware to those at risk, as part of a Control of Asbestos Regulations (CAR) 2012 compliant management strategy.

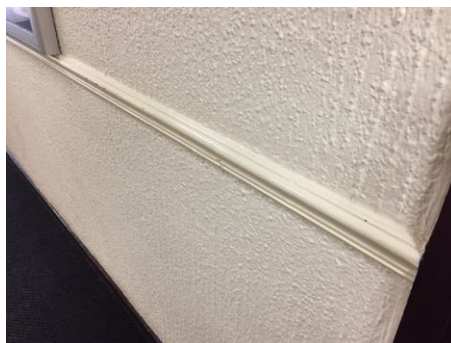
Lined stipple pattern.

The material was seen to be in fair condition at the time of the initial inspection.

The condition of the material should be managed by a competent person/company and its presence made aware to those at risk, as part of a Control of Asbestos Regulations (CAR) 2012 compliant management strategy.

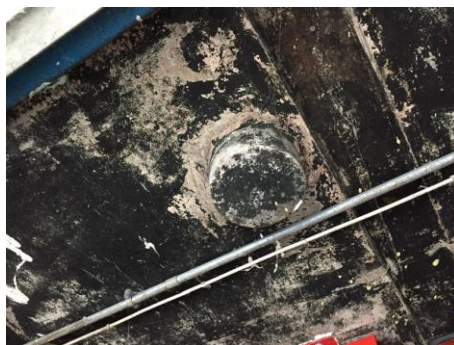
Cement blanking cap for bottom end of Incinerator flue.

The material was seen to be in fair condition at the time of the initial inspection.

The condition of the material should be managed by a competent person/company and its presence made aware to those at risk, as part of a Control of Asbestos Regulations (CAR) 2012 compliant management strategy.
